Survey Report: No. 6

**Survey of Cruik-na-Dhuine, Cushendun, County Antrim
UAS/06/06**

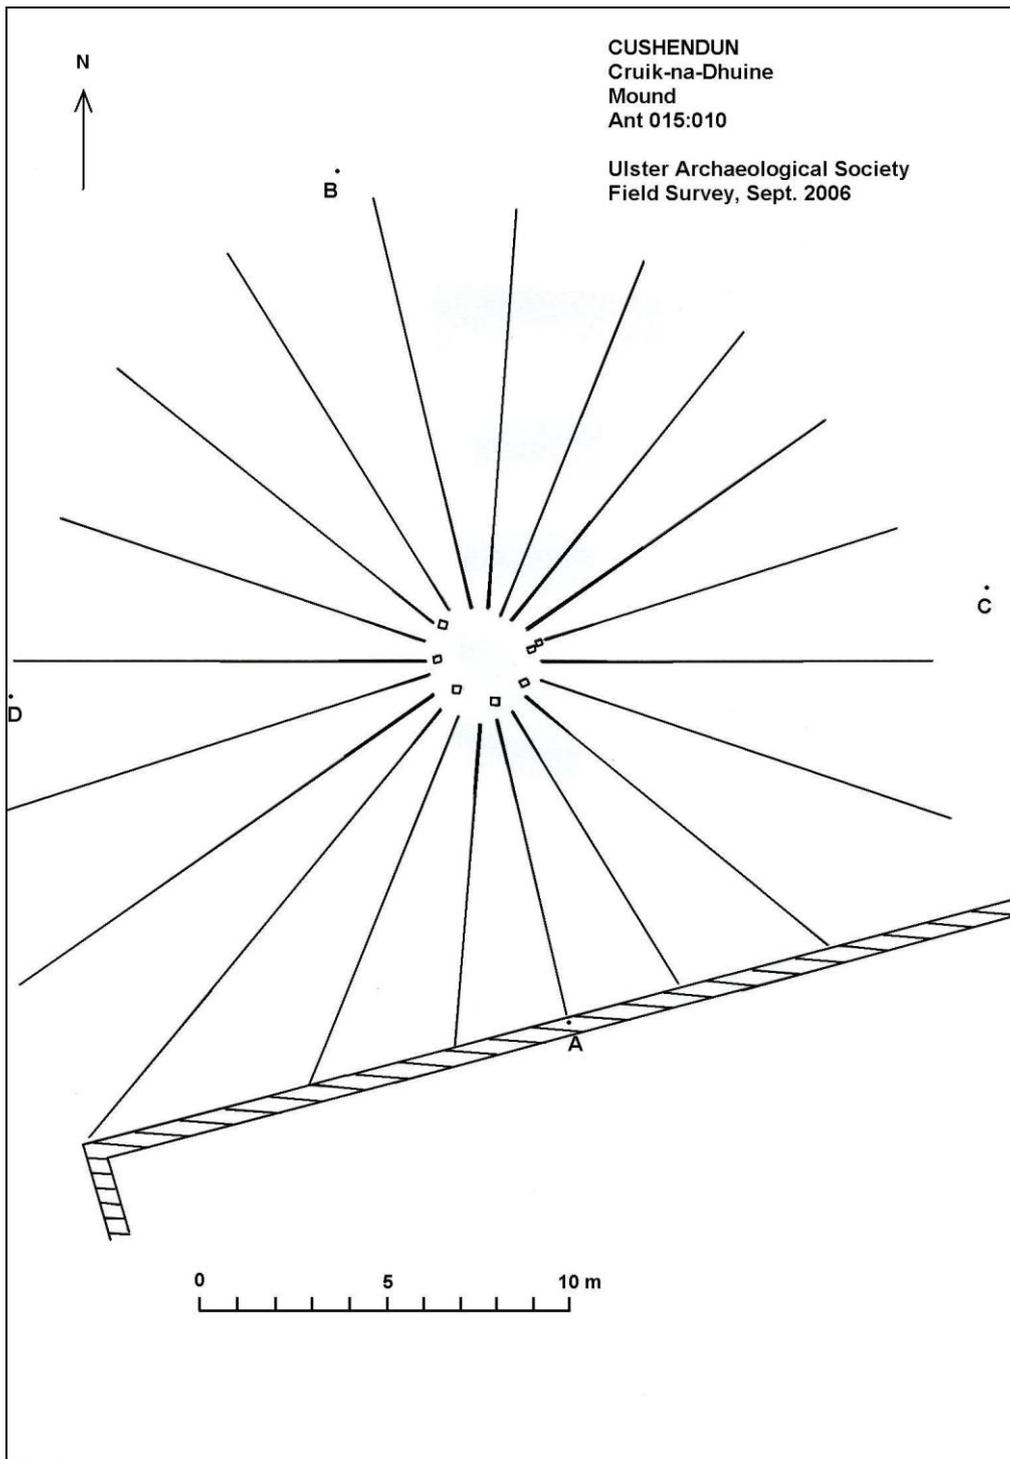
Figure 9: Plan of Cruik-na-Dhuine

Plan and profile drawings were completed, using data obtained from a field survey. Measurements were obtained by using the society's *Leica Sprinter 100* electronic measuring device. Sketch plans at 1:200 scale were completed on site by recording these measurements on drafting film secured to a plane table and backing up the data on a field notebook for subsequent reference. Field plans were later transferred to a computer-based format for printing.

The mound of Cruik-na-Dhuine is sub-circular in plan, truncated to the south by the boundary wall of the old parish church. It is approximately 28 metres in diameter and rises to a height of 3.5 metres at its highest point. At the top, an area of metallated surface was visible, consisting of oval rounded stones (approximately 8-10 centimetres in length) embedded in what appeared to be lime mortar.

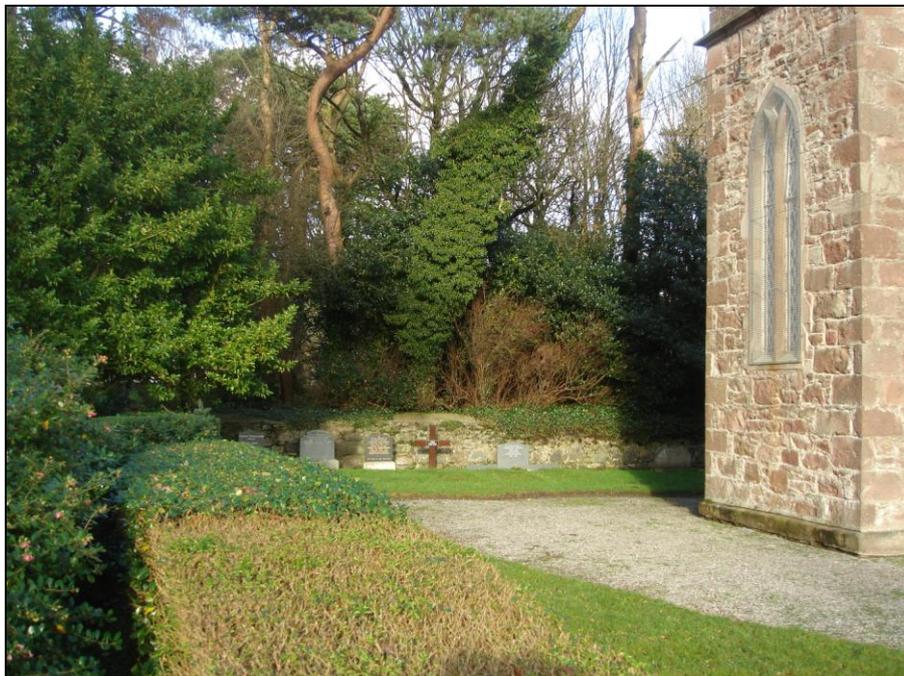
Figure 11: View of church wall and mound, looking north

The plan drawing confirmed photographic evidence that the northern boundary wall of Cushendun parish church truncated the lower part of the Cruik-na-Dhuine mound, suggesting that the mound pre-dated the construction of the wall.

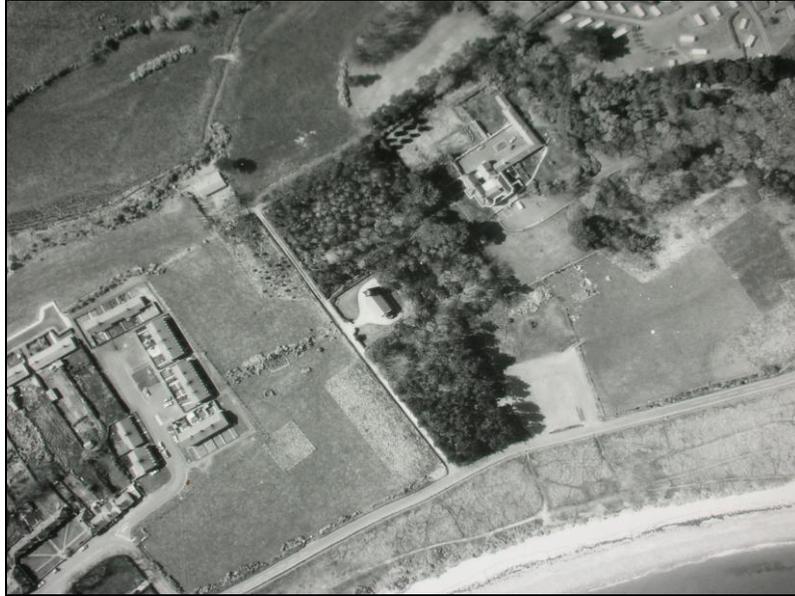
Figure 12: Aerial photograph of Cushendun. *Crown Copyright*

The reason that the presence of the mound went unnoticed during this inspection could be that it was hidden by plant cover (see aerial photograph below). This aerial photograph also recorded the presence of a circular crop mark in the grounds of the Glenmona Lodge Resource centre, which may have been confused with the Cruik-na-Dhuine monument. It is probable that the crop mark relates to a completely different feature that has so far not been recorded on any maps or received any archaeological investigation.

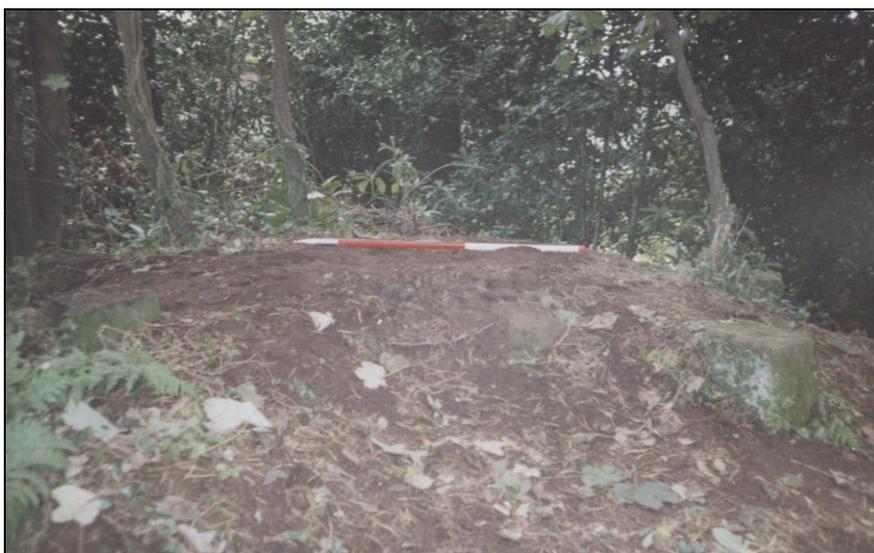
Figure 15: View of sandstone blocks, looking south

At regular intervals round this metallated surface, five sandstone blocks were present and a local historian present suggested these were the foundations of a gazebo that had been taken down some time previously by the National Trust. Subsequent inquiries revealed that a gazebo had indeed been removed by the National Trust, but this had been from a paved area nearby and nothing had been removed from the mound as far as was known. The area of metallating, along with the sandstone blocks suggests that the summit of the mound may have been used by the Harrison family as a viewing point to enjoy their formal gardens, traces of which are still visible in the grounds nearby.

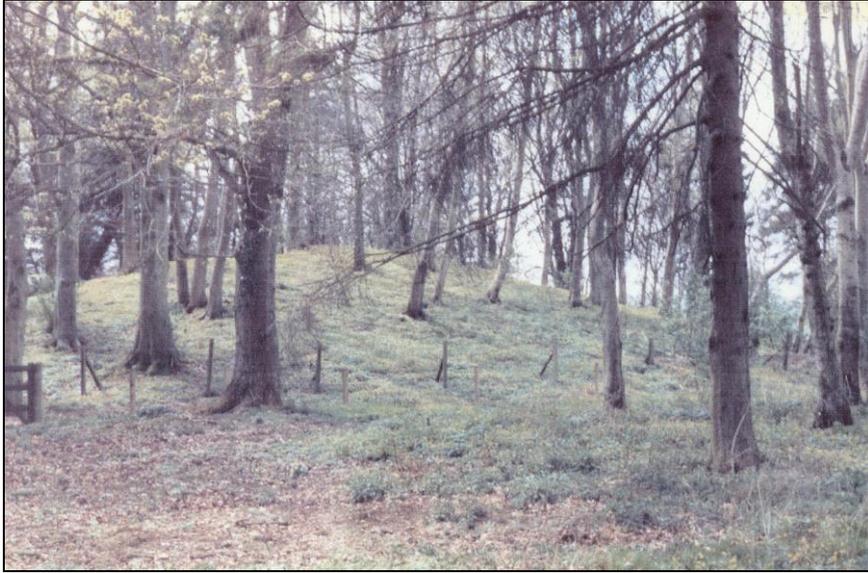
Figure 16: Mound [ANT 051:058] at Templepatrick in 1982. *William Dunlop*

During the survey at Cruik-na-Dhuine, it was observed that the profile bore a striking similarity to another mound in the grounds of Castle Upton at Templepatrick, also in County Antrim (ANT 051:058). The mound there is somewhat larger, at approximately 40 metres in diameter and 5 metres in height. Little is known about this monument, although it has been scheduled under the Historic Monuments and Archaeological objects (Northern Ireland) Order 1985.
