ULSTER ARCHAEOLOGICAL SOCIETY

Survey Report: No. 35

**Survey of Ballyaghagan Cashel,
County Antrim
UAS/11/08**

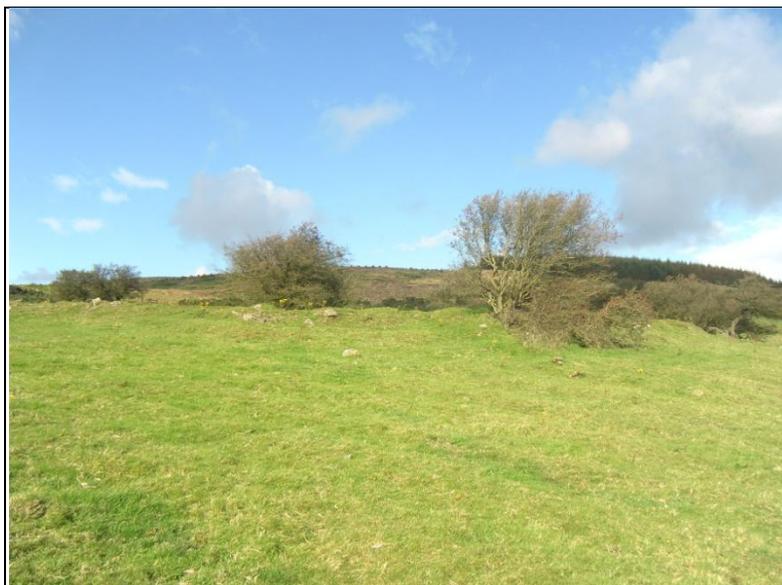
Figure 02: View of Ballyaghagan Cashel, looking north-west

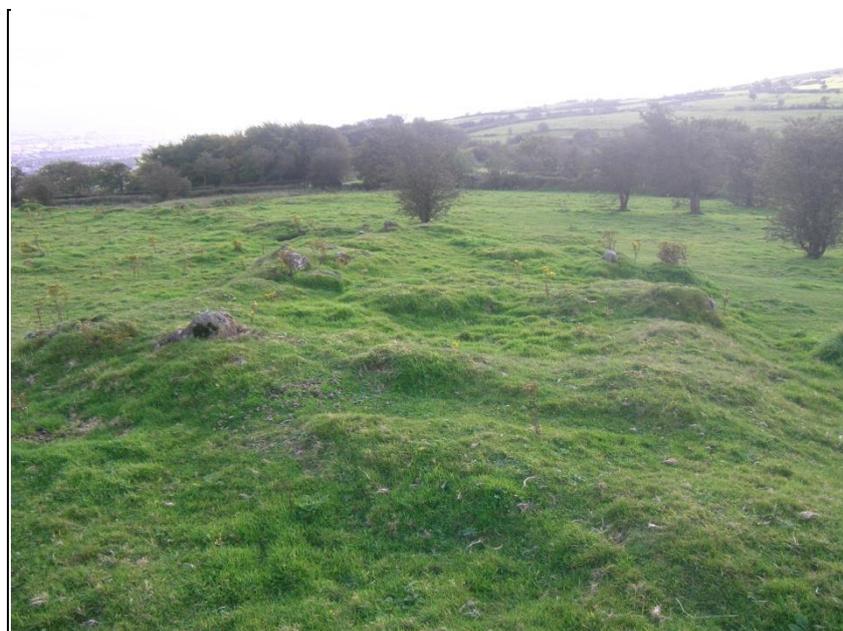
Figure 03: View of vernacular house remains, looking south-west

The 2011 plan showed that the later vernacular house was constructed partly within and partly across the cashel bank at the north-west and did not respect the alignment of the bank here. The builders were clearly not interested in employing the cashel bank as a defensive feature and it can only be speculated that the dwelling was so aligned for another purpose. The south gable faces south-west, into the prevailing wind and this was perhaps the reason for this alignment. The position of the door into the dwelling was not positively identified during the excavation, but it is thought to be in the east wall. This would allow for uninterrupted views across the valley below and as far away as Strangford Lough, so perhaps the view alone was sufficient reason for the alignment of the house.

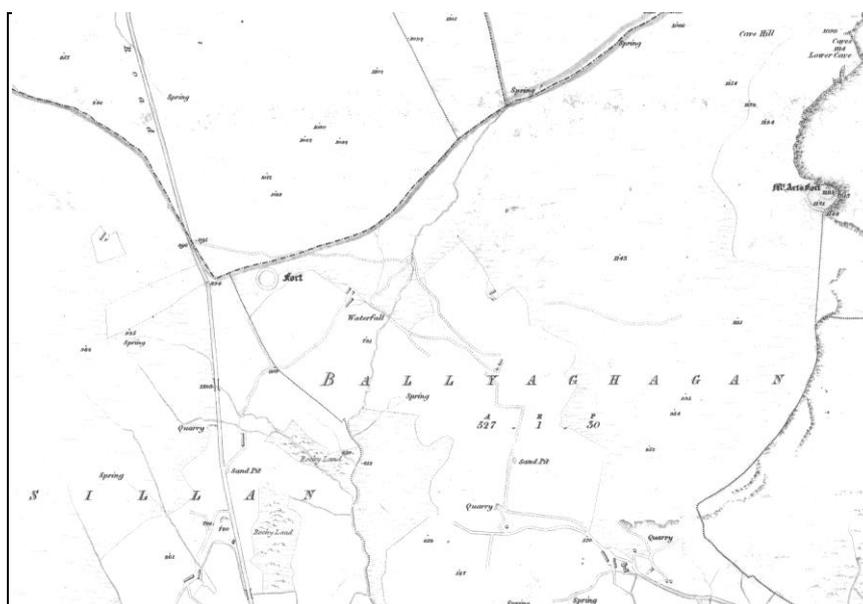
The cashel is marked *Fort* on the 1833 Ordnance Survey (OS) County Series Antrim Sheet 56 (fig. 04). It is shown as a completely circular enclosure of one bank. The vernacular house is not illustrated on this map.

Figure 04: OS County Series Antrim Sheet 56 (part of) 1833

The ordnance survey maps all show the cashel bank to be unbroken, suggesting that the removal of a section of bank to the east was carried out later than 1925. However, the presence of ridge and furrow cultivation ridges within the cashel enclosure, probably dating to the early to mid-nineteenth-century, would indicate that this portion of bank may have been removed at this time to improve access to crops there and was not recorded on the OS maps.

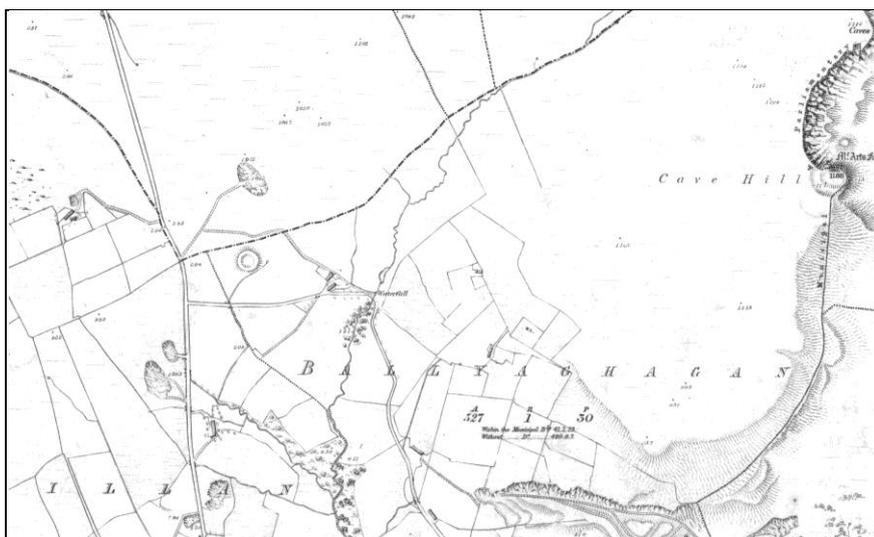
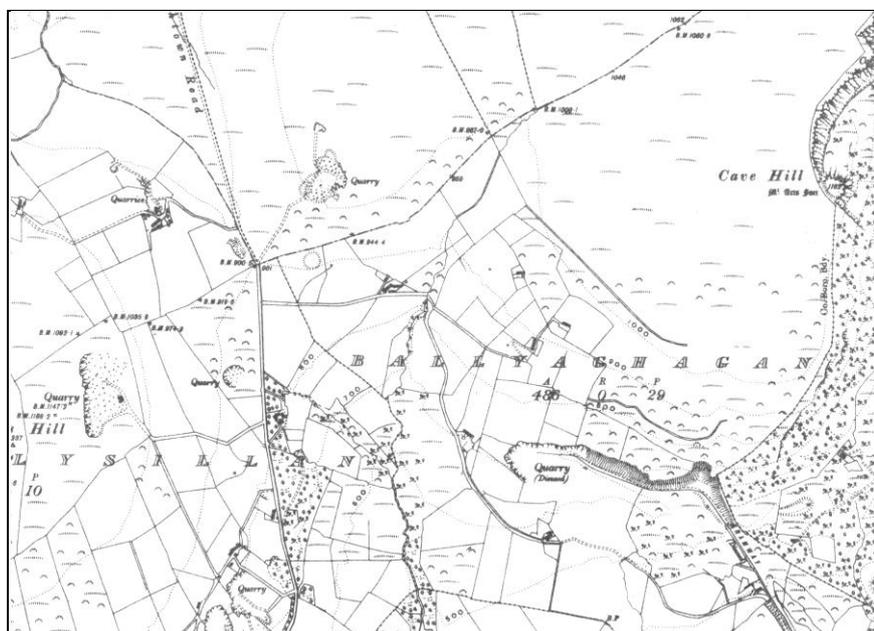
The cashel is also shown as a completely circular enclosure on the 1857 and 1925 revisions, but not annotated (figs 05 and 06). Again, there is no reference or illustration to the vernacular house.

Figure 05: OS County Series Antrim Sheet 56 (part of) 1857

Figure 06: OS County Series Antrim Sheet 56 (part of) 1925

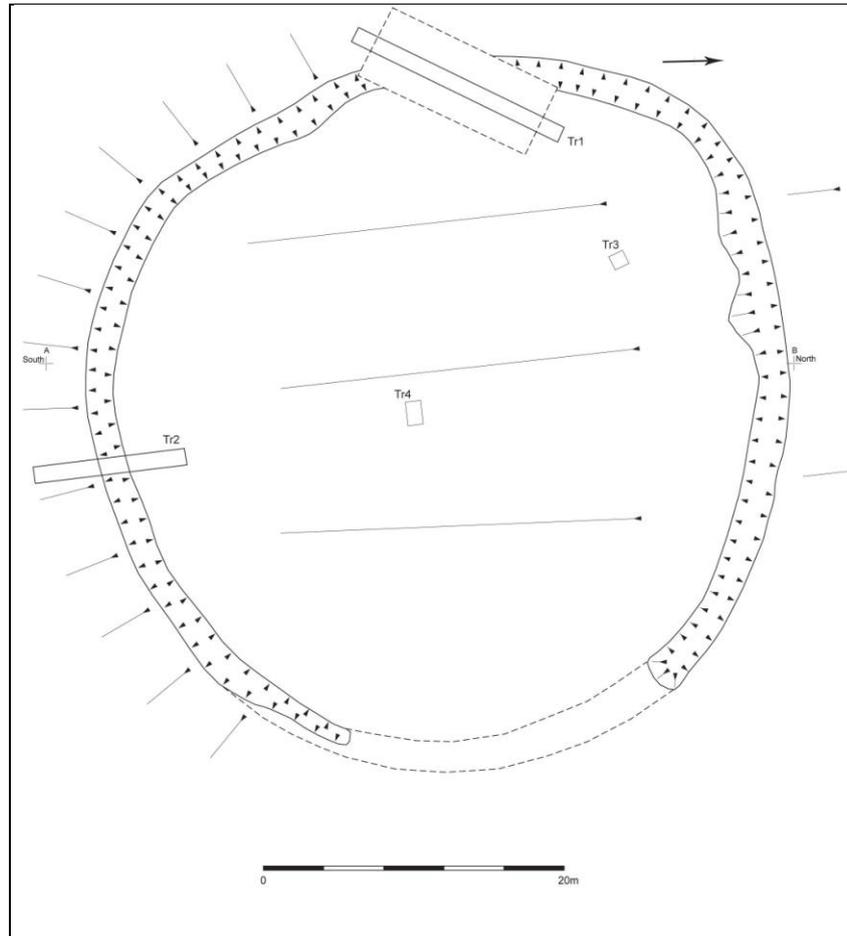
Figure 07: Plan of site, including excavation trenches

The UAS survey provided the first accurate plan of this site and included details of the cashel bank, vernacular house site and position of the excavation trenches for the 2011 excavations. It also provided a profile drawing of the site, in a north/south alignment, which captured the profiles of the cashel banks to the north and south of the monument.

The 2011 plan of Ballyaghagan Cashel confirms that the surrounding bank is roughly circular, with an interior diameter of 42m. A gap of 20m exists at the east and dumps of stones to the north and south of this gap probably represent the remains of the cashel wall that was removed at this point. The profile drawing indicated that there was little attempt made to level the interior of the cashel. Instead, it respected the gentle slope of the surrounding ground to the south-east, although a build-up of soil internally at the south might indicate that the external ground surface here was excavated and placed inside the bank to enhance the appearance of the cashel wall in this area. The bank was found to be constructed of earth, with a stone revetment to the external face. There was no evidence of a surrounding ditch. A geophysical resistivity survey of the interior of the cashel enclosure was carried out by CAF immediately prior to the 2011 excavations. The results indicated the presence of several anomalies within the enclosure, but two test trenches failed to identify any archaeological features.

The UAS plan accurately confirmed the position of the vernacular house over the cashel wall and detailed the excavation trenches and other features across the enclosure on an overall site plan. It is clear from initial analysis of the information so far obtained that the Ballyaghagan Cashel site is within an area of significant archaeological activity, stretching back into prehistory, with visible features relating to the early medieval and plantation periods and later activity in the form of large areas of ridge and furrow cultivation.

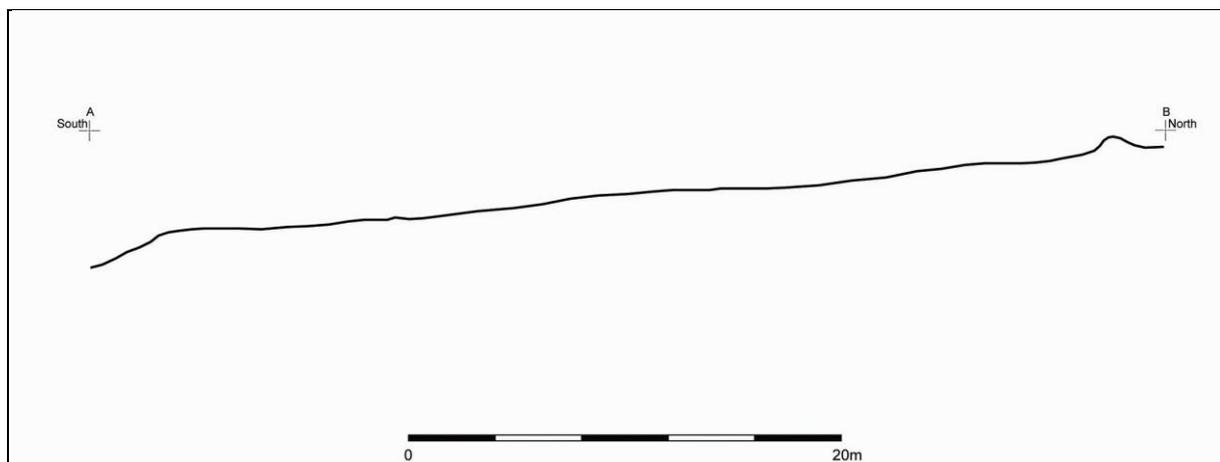
Figure 08: North/south profile of site

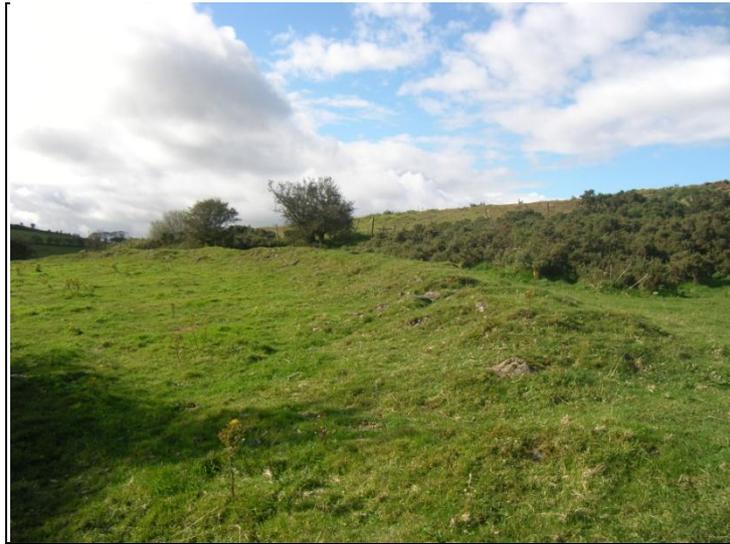
Figure 09: View of north bank of cashel, looking north-west

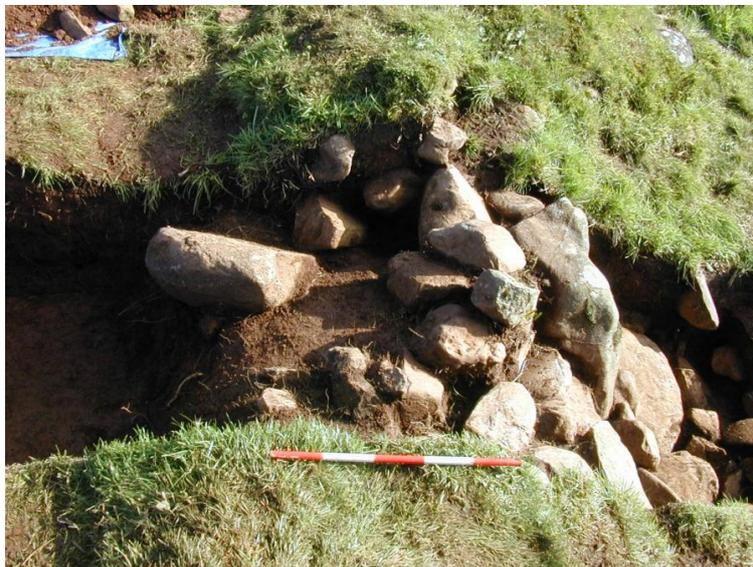
Figure 10: View of part of southern cashel wall during excavation, looking east [scale 0.5m]

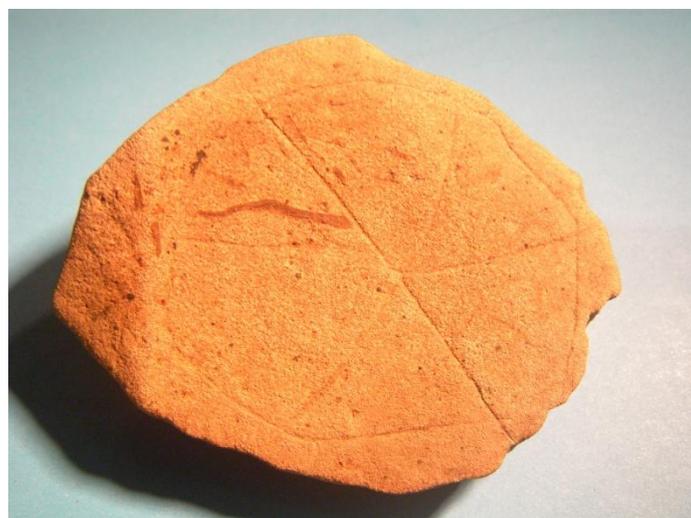
Figure 14: Inscribed stone recovered from vernacular house

Also recovered from the excavation at the vernacular house was an inscribed stone (fig. 14). Preliminary analysis suggests this is of red sandstone, with a segment pattern inscribed on both faces.
