ULSTER ARCHAEOLOGICAL SOCIETY

Survey Report: No. 45

**Survey of Vernacular House at Ballyaghagan,
County Antrim
UAS/11/09**

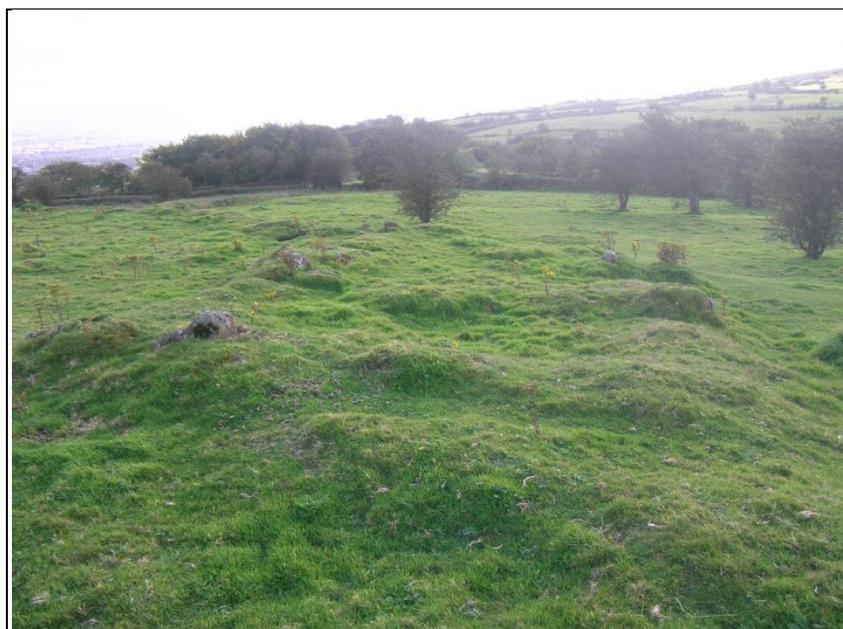
Figure 03: View of vernacular house remains, looking south-west

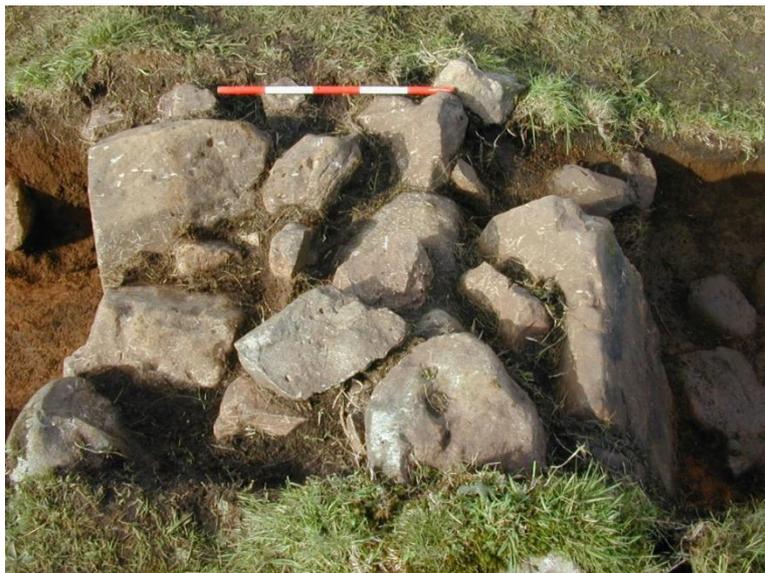
During the excavation, it was found that the original dwelling consisted of a single room, some 9m in length by 6m in width externally (7m by 4m internally). The gables and walls were constructed of large sub-angular boulders of basalt. No evidence of mortar was found, suggesting that clay was employed for bonding the stones. To the north of the original dwelling, a crudely-built extension had been added, 4m in length by 6m in width externally (2.5m by 4m internally). This appeared to be largely constructed of turves and was probably a lean-to storage area. The excavation did not uncover any significant deposits of collapsed masonry and there are two possible reasons for this. Either the dwelling had been constructed of a stone foundation and lower courses, upon which a sod or timber wall had been constructed, or more likely it had been of stone construction throughout and when the dwelling had fallen out of use, the larger stones were removed and re-used in nearby features, such as the enclosure to the south, or to line the drainage ditch that runs across the field.

Figure 13: North gable of vernacular house, looking west [scale 0.5m]

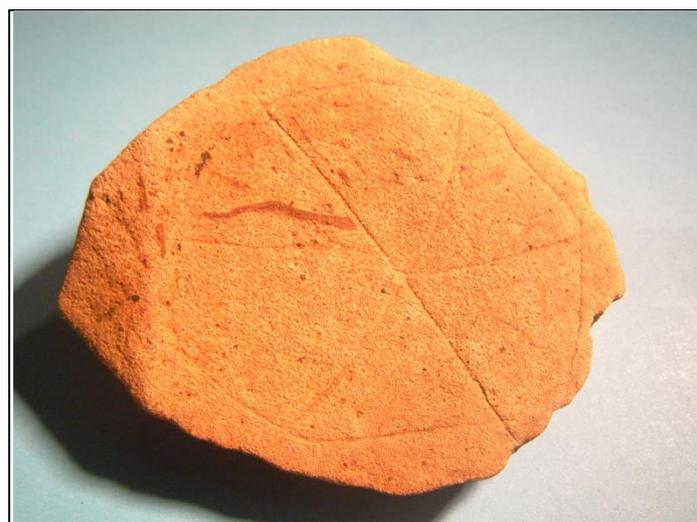
Figure 15: Inscribed stone recovered from vernacular house

Also recovered from the excavation at the vernacular house was an inscribed stone (fig. 14). Preliminary analysis suggests this is of red sandstone, with a segment pattern inscribed on both faces. Preliminary examination of some of the pottery sherds recovered during the excavation point to a mid-seventeenth-century date for the vernacular house. An artist's impression of the vernacular house was commissioned by the Belfast Hills Partnership, based on the findings of the excavation in 2011. This shows the relationship between the vernacular house and the remains of the earlier cashel bank over which it partially sits. The illustration also shows the original single-room dwelling with lean-to extension to the north. While the remains of a hearth at the southern gable were found during the excavation, there was no evidence for a chimney stack and this is reflected in the illustration. It is assumed that smoke would have simply filtered out through the thatched roof, probably making it very smoky inside on many occasions.

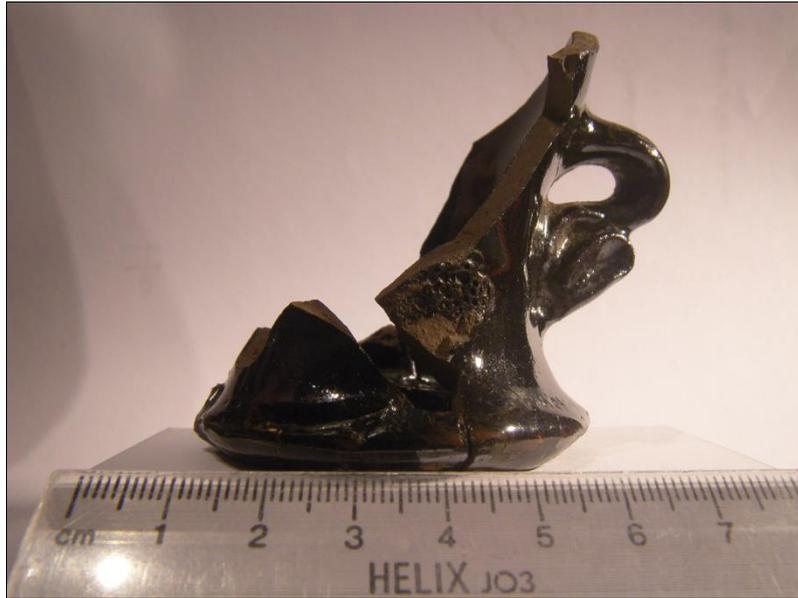
Figure 16: Two fragments of possible seventeenth-century *loving cup*

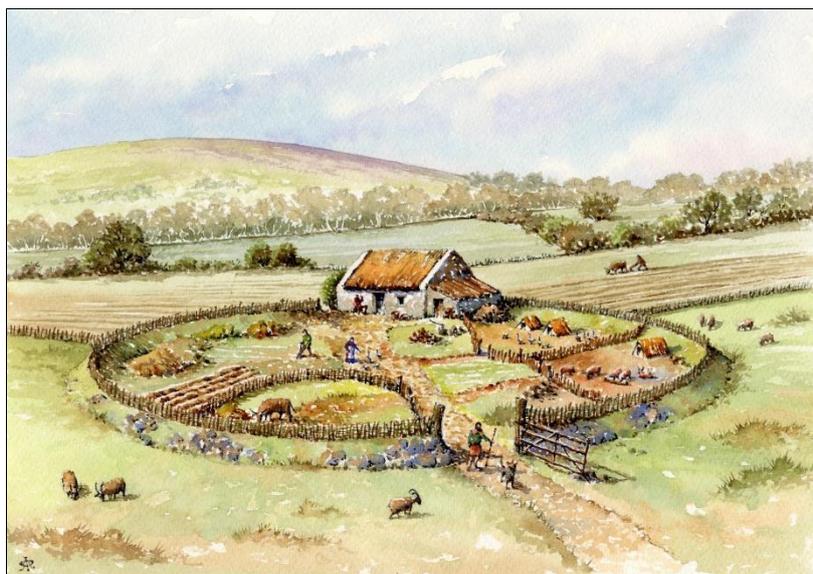
Figure 17: Artistic impression of vernacular house *Philip Armstrong*
