Survey Report: No. 3

**Survey of Summit Cairn, Divis Mountain, County Antrim
UAS/06/03**

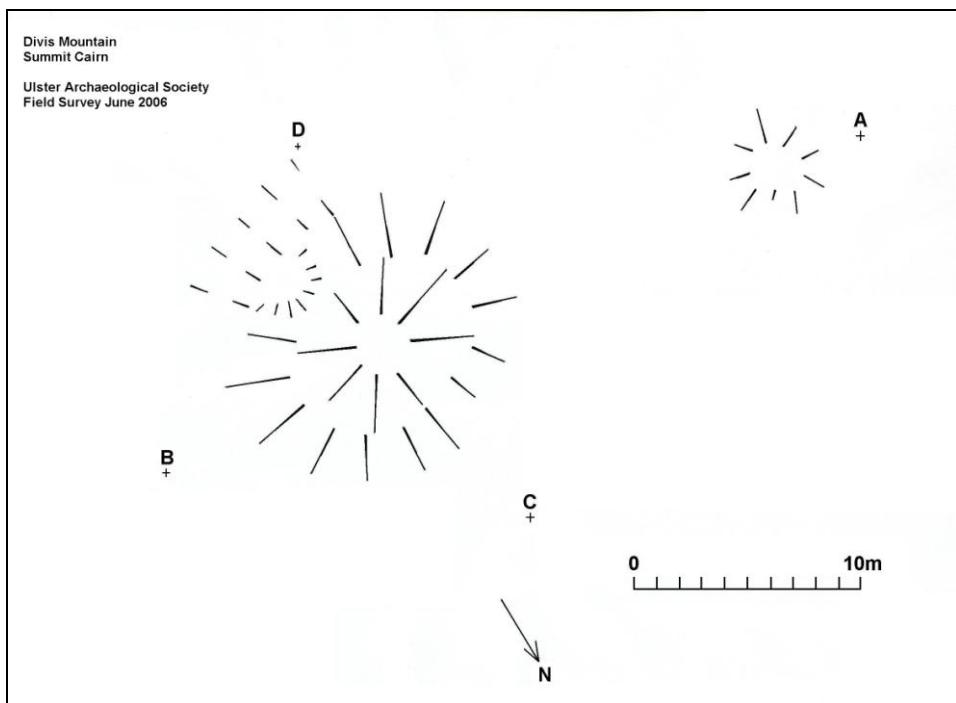
Figure 4: Plan of Summit Cairn, Divis Mountain

Sketch plans at 1:200 scale were completed on site by recording these measurements on drafting film secured to a plane table and the data obtained was also recorded on a field notebook for subsequent reference. Field plans were later transferred to a computer-based format for printing.

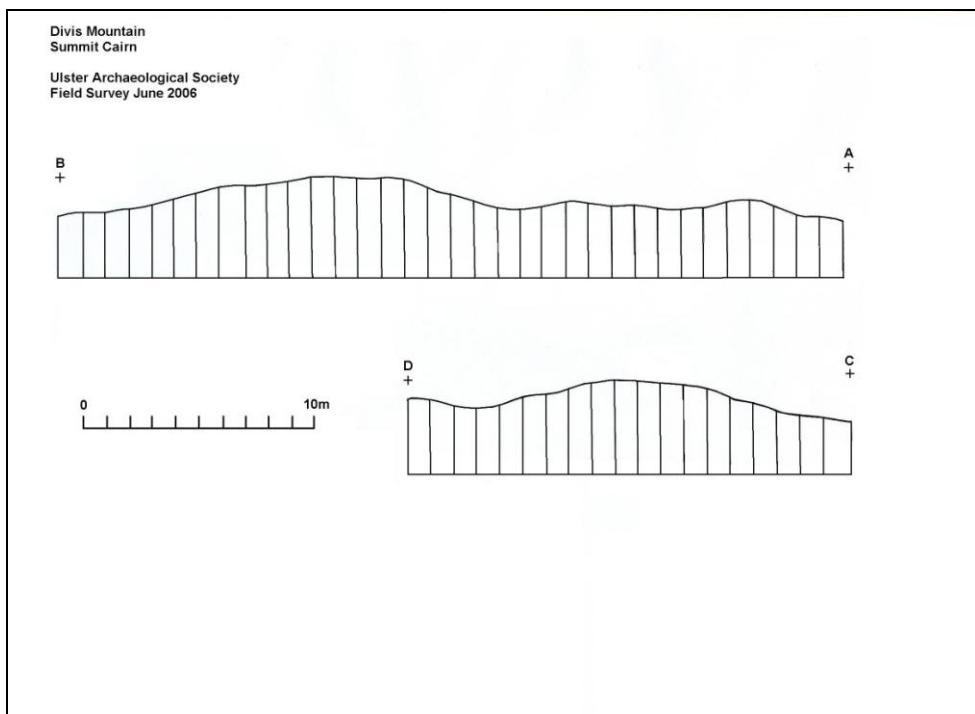
Figure 5: Profiles of Summit Cairn, Divis Mountain

Aerial photography (figure 7 above) revealed a sub-circular ditch and bank surrounding the cairn itself and at least one smaller cairn was visible to the west. These features were confirmed on profiles A-B and C-D. The smaller mound was found to be approximately 5.4 metres in diameter, with a maximum height of 1.2 metres. The survey of the main mound indicated a semi-circular depression of approximately 3.6 metres in diameter on the southern edge of the cairn and this could be the result of the past removal of some cairn material or an attempt to gain access to and loot the interior.

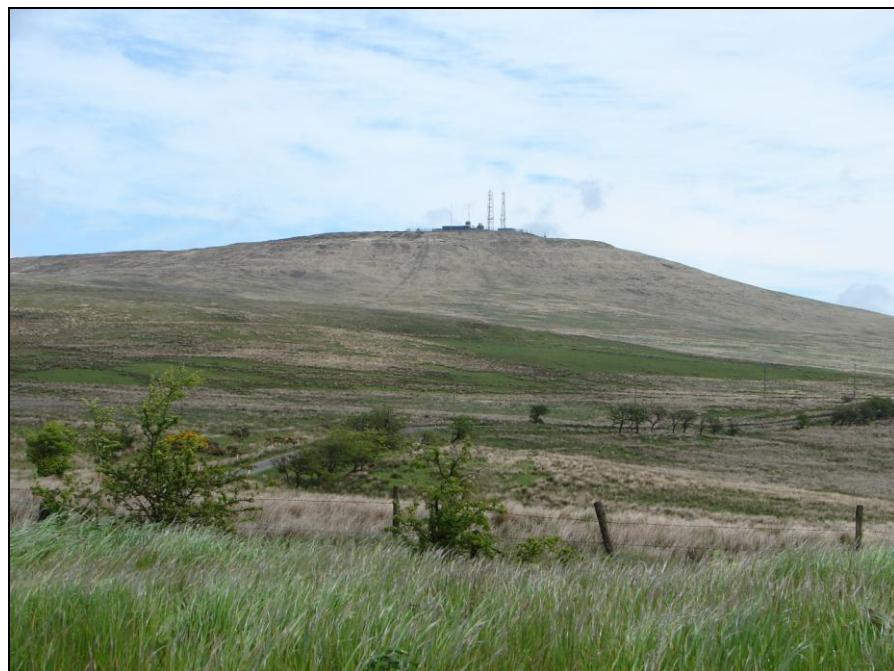
Figure 6: Divis Mountain, looking north

This monument sits close to the summit of Divis Mountain at altitude of 460 metres above sea level. It is one of a number of monuments in this area and

a rich and varied archaeological landscape reveals evidence for life and death rituals on the mountain particularly in prehistory. At least four Bronze Age burial cairns are now known along with the site of an earlier megalithic tomb. Prehistoric hut sites survive along with two curious stone walled enclosures, one of which may be early Christian period in date.
 (National Trust 2005, 1).

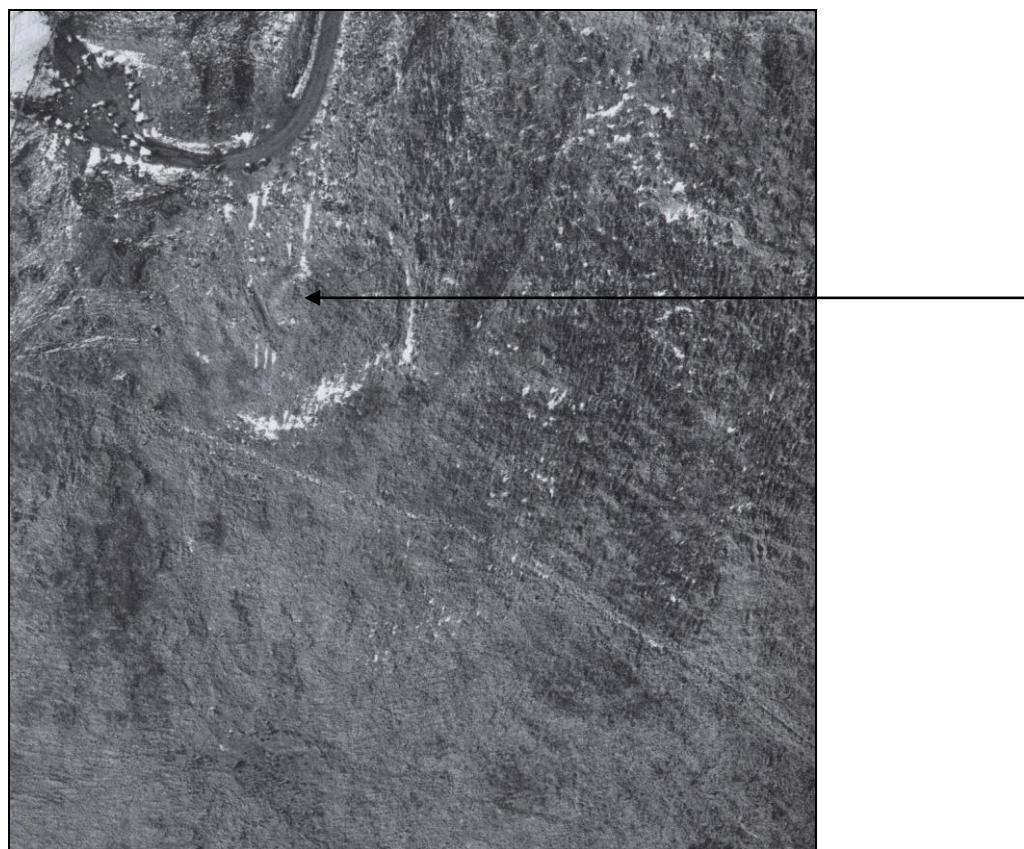
Figure 7: Aerial photograph with cairn indicated. *Crown Copyright*

The regular shape of the mound, combined with the evidence for a surrounding circular enclosure, seems to militate against the cairn being a dump of building materials and point to a prehistoric origin. This may only be confirmed by further archaeological examination.

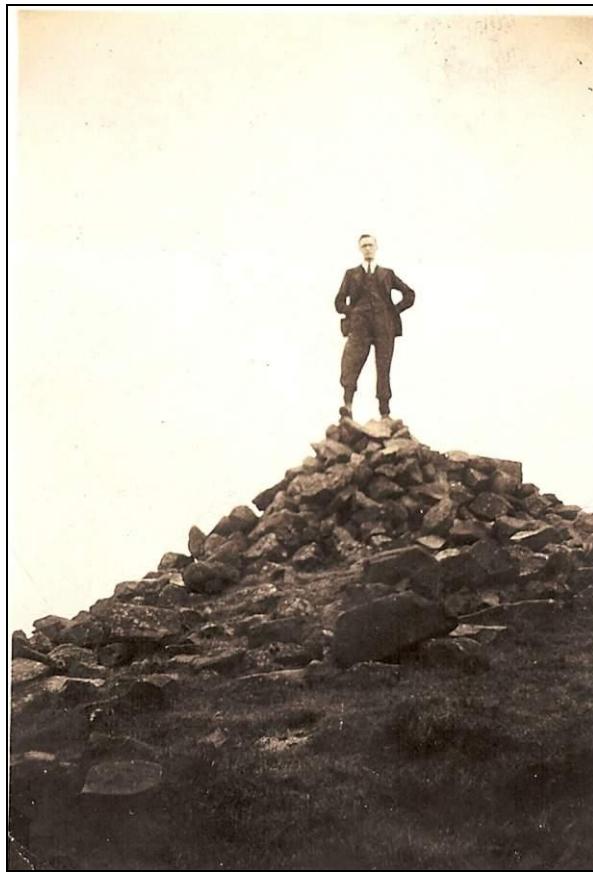
Figure 8: Divis Mountain, original summit cairn, *William Dunlop*

Little is known about the original cairn that was situated on the summit of Divis Mountain. However, one of the members of the UAS Survey Group (William Dunlop) kindly donated a photograph of his brother, Jim, standing on the cairn on 5 May 1940. This is the only known photograph of the cairn and must have been taken shortly before its destruction (figure 8 below).
