ULSTER ARCHAEOLOGICAL SOCIETY

Survey Report: No. 27

**Patterson's Spade Mill
UAS/10/05**

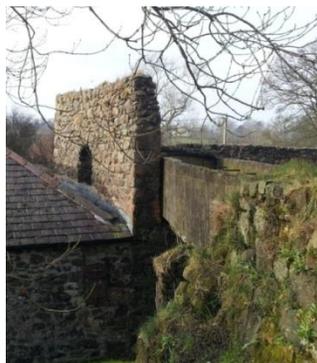
Fig 6. View of South wall of the Corn Mill with arched window –
- the flume is seen passing through the building. (GT –I1900, 1)

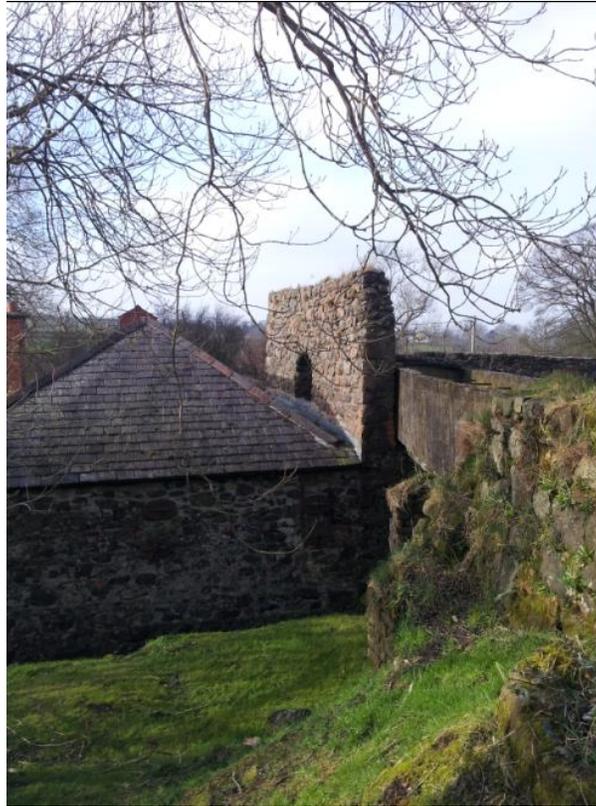
Fig 10. Single story roofed Paper Mill Machine Room facing east with remains of south wall of Rag Store and Engine Room (GT-I1900, 2)

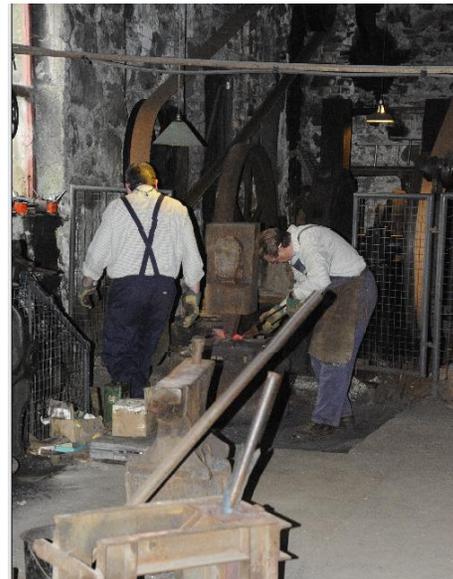
Fig 14. Tilt Hammer in operation at Patterson's Spade Mill (DSC6653)

The Tilt Hammer operation was timed and seen to operate at 2 stokes per second or 120 stokes per minute. By counting the teeth on the bevelled gears and drive belt wheel diameters an average speed of 260 rpm was recorded for the Leffel Double Turbine Water Wheel drive shaft.

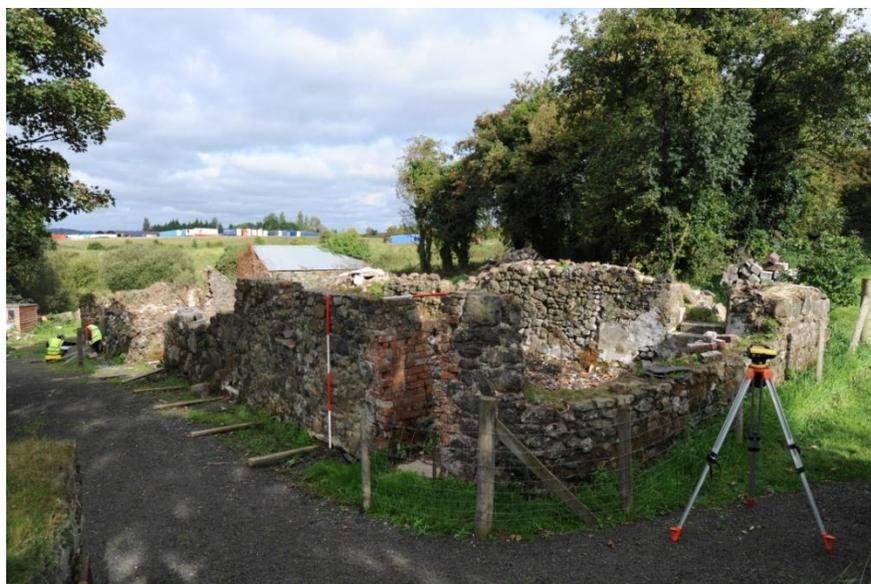
Fig. 24. Ruins of cottages viewed from the south (DSC 6947)

A stand alone house – 4d in fig. 23 above, was also added during that period. This is the slated roof building which has been restored in recent years and shown in the background in fig. 24.,
