# **ULSTER ARCHAEOLOGICAL SOCIETY**

Supplement to Survey Report: No. 4

Survey of St Mary's Church, Ballaghanery Upper, County Down UAS/06/04

# **GRAVEYARD SURVEY**

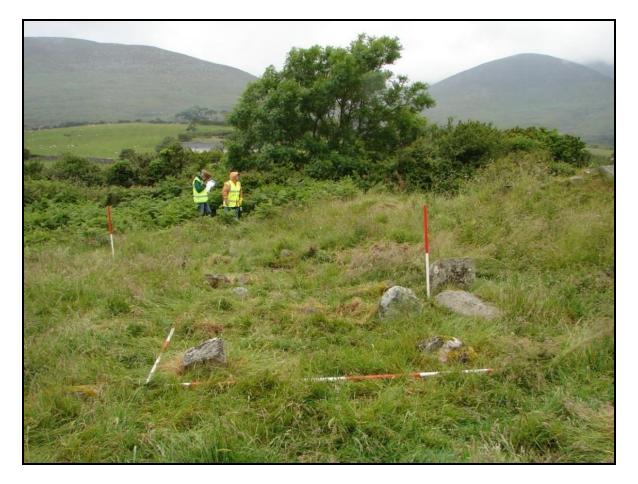
Figure 2: UAS Survey of grave markers, looking west

A number of small granite boulders were observed during the survey, principally on the southern side of the monument. These were interpreted as grave markers, although some may be structural remains from the church building. All were recorded using the Memorial Recording Form suggested by Harold Mytum and the results tabulated below (2000, 80). All visible grave markers were recorded, but more may be present along the western boundary of the site, which was not surveyed due to the presence of impenetrable bushes.

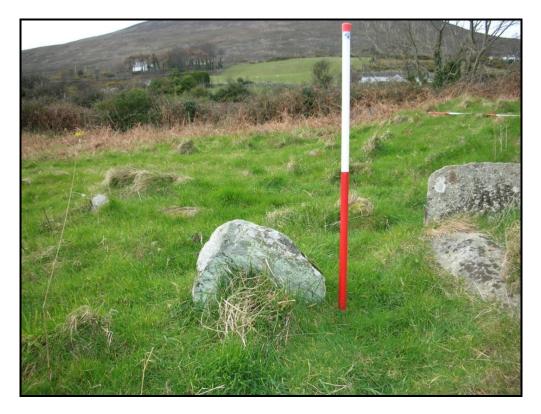
Figure 5: Grave markers, looking south-west

Of the forty-eight grave markers surveyed, half (50%) were identified as being composed of granite, a rock abundant in this area. Of the remainder that could be identified in the field, 21 were of slate (43.8%) and 3 (6.25%) were of sandstone. Co-incidentally, all these rock types were represented in the reconstructed arch of the adjacent church building.

The orientation of twenty-eight of the grave markers could be positively determined and of these, 22 (79%) were oriented east/west, seeming to confirm that these markers were not placed randomly, but instead complied with traditional Christian burial practices. This would further reinforce the view that that the majority of these boulders are indeed grave markers.

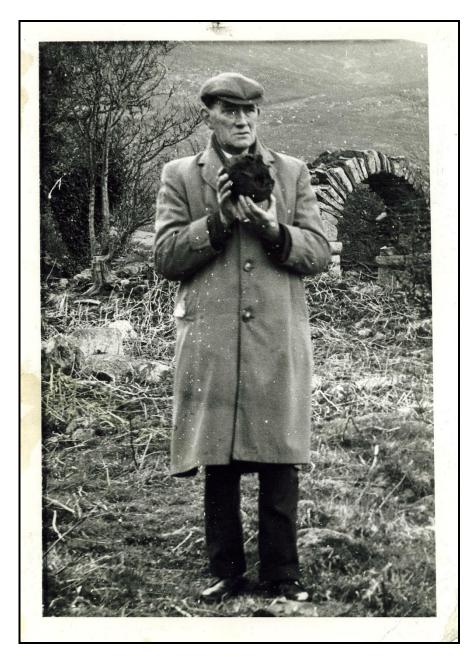
Figure 8: Skull found in the Chancel, c. 1965, Northern Ireland Environment Agency

Interestingly, the NIEA have on file a photograph (figure 8 below) of a skull, purported to have been found by Mr Fitzpatrick in the Chancel in about 1965 (NIEA, SMR DOW 049:012).
