ULSTER ARCHAEOLOGICAL SOCIETY

Survey Report: No. 1

**Survey of Forthill Rath, Creevyloughgare,
Saintfield, County Down
UAS/06/01**

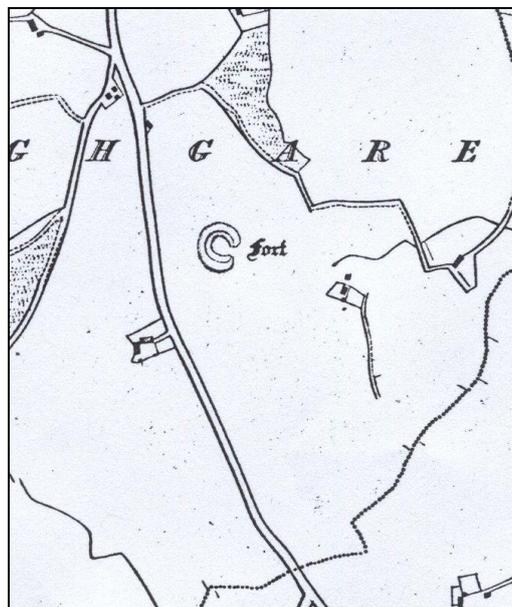
Figure 2: Ordnance Survey, First Edition, 1835 (scale 6" to 1 mile)

Forthill rath was previously recorded by the Ordnance Survey of Ireland, which subsequently became the Ordnance Survey of Northern Ireland. The first cartographic survey was carried out in 1832, when a clear break in the bank was recorded at the south-east.

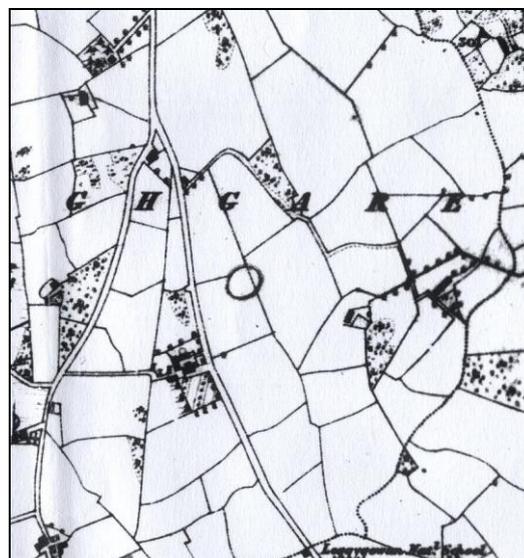
Figure 3: Ordnance Survey, Second Edition, 1859 (scale 6" to 1 mile)

The site was again recorded on the Second Edition map in 1859, by which time no gap was evident in the earthworks.

However there is an indication of an anomaly in the circularity of the enclosure on the western side that was also observed during the 2006 survey, suggesting that the original survey had been accurately undertaken. Further and possibly more significantly, a field boundary is shown transecting the monument in a north-north west, south-south east alignment. This boundary correlates well with the present line of truncation of the monument on the eastern side.

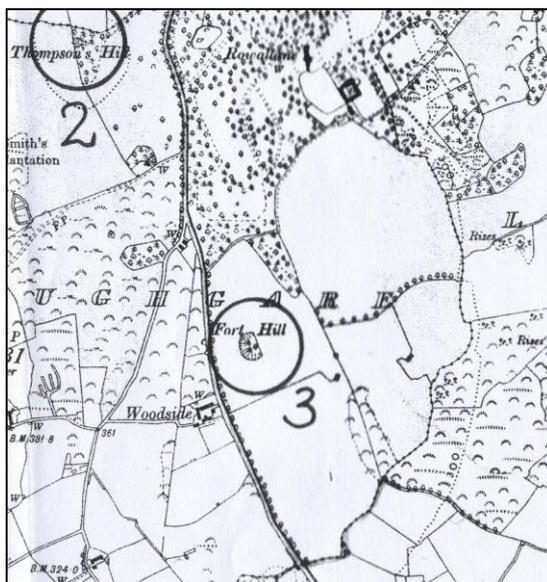
Figure 4: Ordnance Survey, Third Edition, 1932 (scale 6" to 1 mile)

By the time of the Third Edition map of 1932, the plan of the rath had clearly been modified in that a section of the eastern bank has been removed to the east of the 1859 field boundary. The truncated plan of the monument is very similar to that recorded during the 2006 survey.

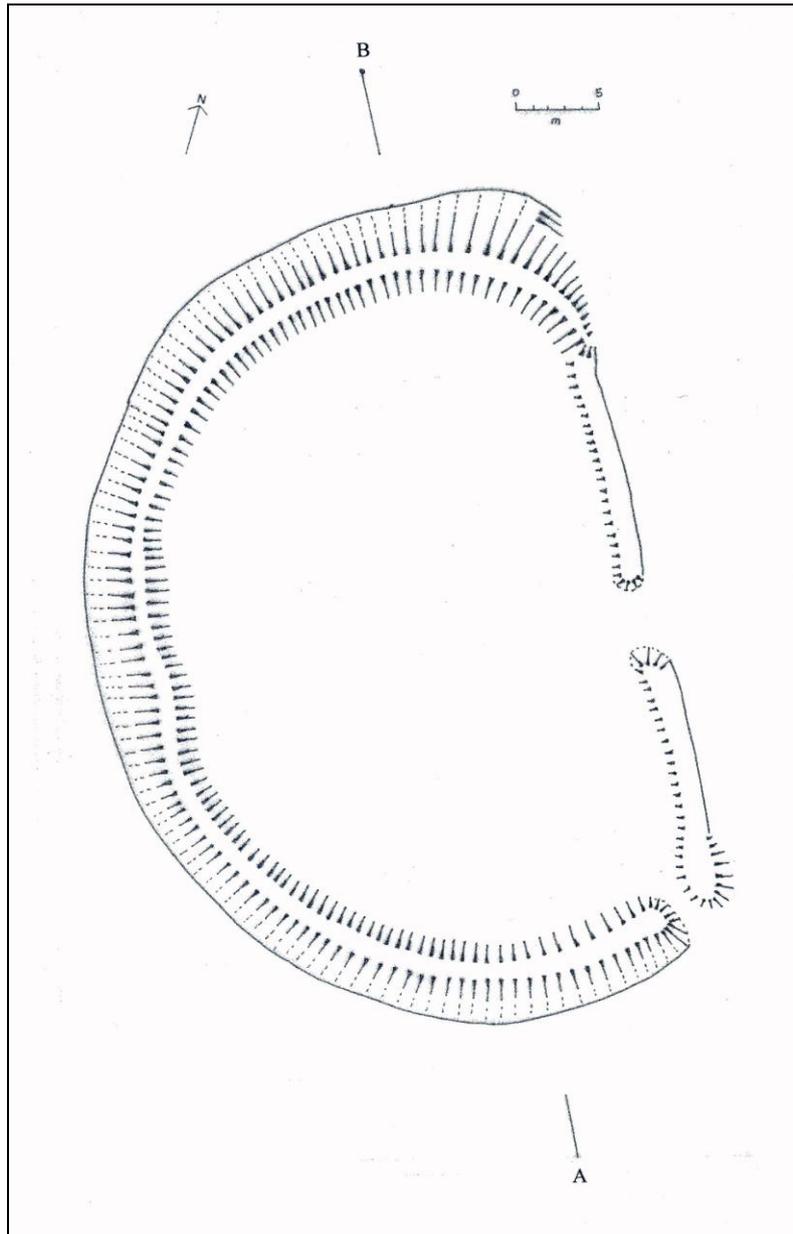
Figure 5: plan of Forthill Rath

Sketch plans at 1:200 scale were completed on site by recording these measurements on drafting film secured to a plane table and backing up the data on a field notebook for subsequent reference. Field plans were later transferred to a computer-based format for printing.

The internal diameter of Forthill rath is 38.5m at its widest point (north-west to south-east) and 26m from the interior of the eastern bank to the modern entrance (south-west to north-east). The internal dimensions of this rath place it among the larger examples so far recorded (Edwards 1990, 14). In addition to this entrance, a smaller opening has been created by the collapse of earth and stone where the bank terminates at the south-east.

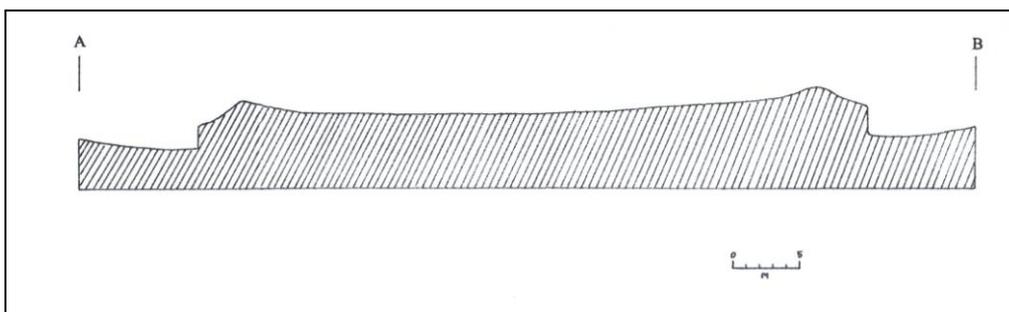
Figure 6: Profile A-B of Forthill Rath

Analysis of the profile diagram (figure 1 above) indicates that the hilltop has been extensively modified to enhance the appearance of the monument. This seems likely to have taken place when the monument was truncated, at some time between 1859 and 1932 and a number of other features confirm efforts to landscape the monument. These include the provision of stone revetments around the exterior circumference of the bank (see illustration 3).

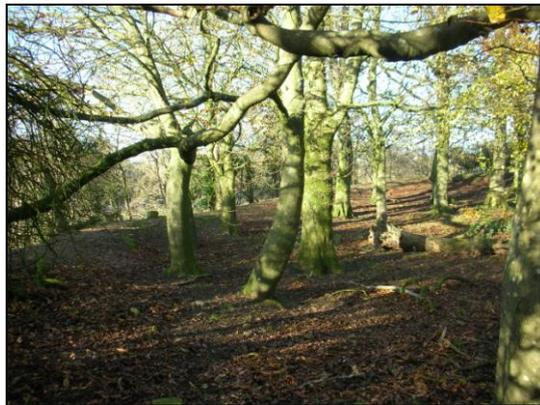
Illustration 4: Artificial copse inside monument

In addition, four regularly-spaced ash trees were planted along the interior of the eastern side and other deciduous trees, such as sycamore and beech, planted within the circumference of the bank to create an artificial copse (see illustration 4). There is no visible evidence to indicate the presence of a souterrain.

The monument is not protected from access by grazing animals and is therefore liable to damage from this source. The National Trust may therefore wish to consider restricting animal access to the site by the provision of a suitable fence. Further, trees present within the interior of the monument are of substantial size and are liable to damage the site by root activity. The National Trust may wish to consider restricting the further spread of such trees and regularly pruning those that are already there.
