Survey Report: No. 7

Survey of Scheduled Rath:- DOW 009:011

Lisnabreeny Townland, Castlereagh, Belfast

UAS/07/01

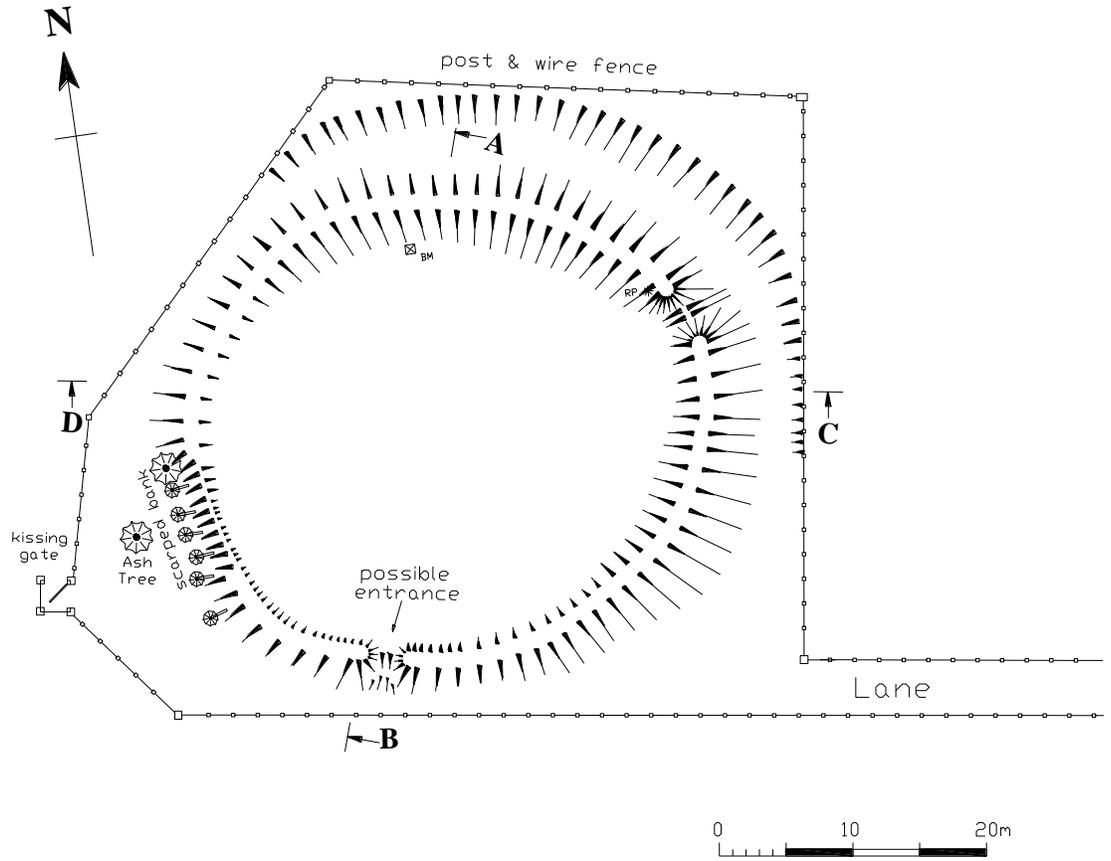
Figure 5. Plan view of Lisnabreeny Rath

Referring to the plan drawing in Figure 5 it can be seen that the rath was laid down in an almost true circle albeit with a bulge on the east side of the structure. The mean interior diameter of the enclosure was found to be 33m. Considering Stout (1997, 15) in which he states that in the midlands of Ireland 'Ringforts with enclosed areas between 20m and 44m account for 84% of all surviving sites', and that 'Comparable ranges of internal measurements have been found elsewhere in Ireland', then the Lisnabreeny rath could be taken as being of average size. The plan view shows two notable breaks in the bank, one at the south end which may have been the original entrance and a more pronounced opening at north-north-east which is thought to have been more recent. In Figure 6, the Profile A-B (north to south) shows the platform to have an incline of 1 in 20 from south to north and that the Profile C-D (east to west) is essentially horizontal.

A 10 metre scarping of the ditch wall is evident on the west side of the bank as shown in the plan view in Figure 5 with the ash tree referred to above located in the ditch at this point. A main limb of this ash tree has come away and fallen across the ditch which, with a build-up of bank debris and moss, gives rise to water logging of the ditch from west to north-north-east. A raised section of the ditch floor at the north-north-east break in the bank adds further to this problem.

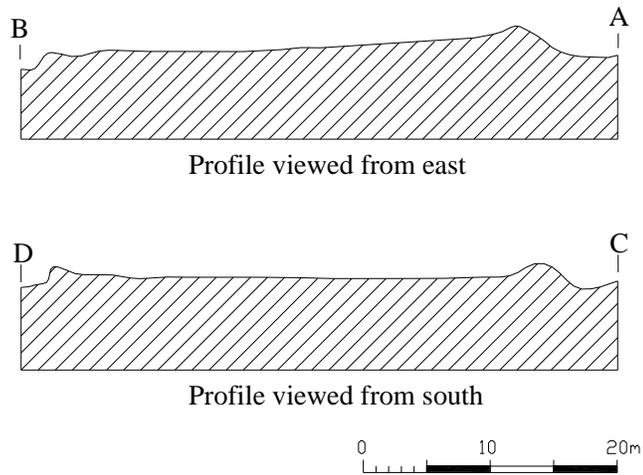
Figure 6. Profiles A-B and C-D of rath

to the highest point of the site which was on the top of the bank at a north-north-east location. Using a field mapping compass the azimuth zero for the level was set to magnetic north with azimuth 90° being due east. A Bench Mark was set at a point close to north on the inner slope of the bank. Four sets of measurements were taken to produce the plan drawing, these were, rath bank inner, top of rath bank (inner), ditch inner, and ditch outer. A number of cross check measurements were taken of the rath bank top outer edge. The plan view taken from the data is shown in Figure 5. An additional two set of measurements were taken diagonally roughly north-south and east-west to produce the rath profiles as shown in Figure 6. All Survey results were recorded in a Site Log Book.

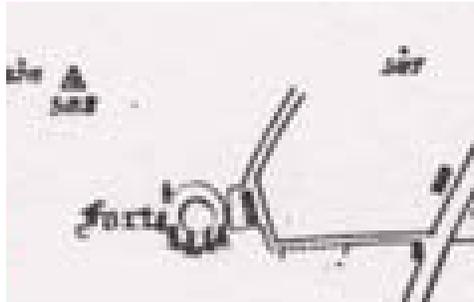
Figure 7. Rath DOW 009:011 in 6" 1834 Ordnance Survey

Today mature ash, sycamore, beech and a single oak are established in the bank and ditch in an arc north-east to east to south with tree plantation encircling the remainder of the rath being mainly low level hawthorn. There is a single ash tree in the ditch and one in the bank at west-south-west. This is contrary to the tree position shown in the original 6" Ordnance Survey of 1834 when significant conifers were shown to be positioned in an arc north to west to south-east and nothing around the rest of the site. See Figure 7.

It was observed that the enclosure bank is much reduced in height spanning the circumference from north to west to south-east coincident with the position of the conifers that occupied that area in the original Ordnance Survey of 1834 as shown in Figure 7. Whether or not there was an alteration in the bank when these larger trees were replaced with arboreal planting of mainly hawthorn trees in that section is, at present, unknown.

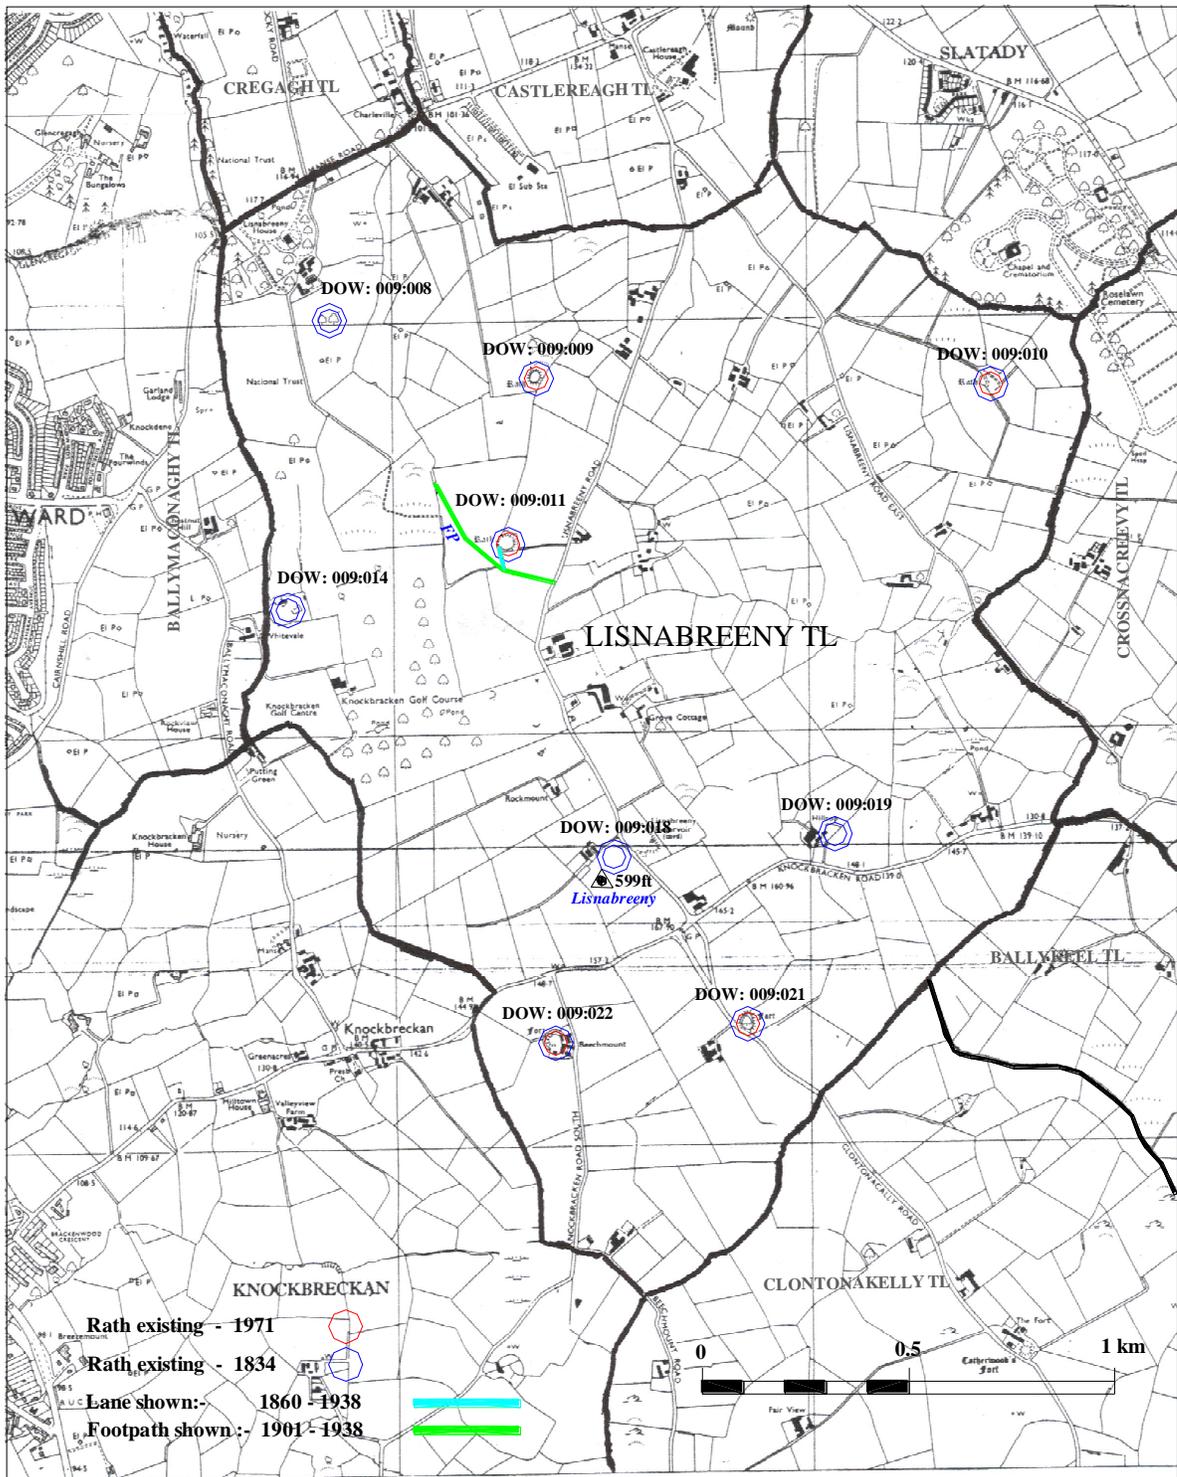
Figure 8. Location of Raths in Lisnabreeny Townland

The cartographic evidence shows that whereas in the 1834 Ordnance Survey map there was a total of nine raths recorded in the Lisnabreeny Townland, by the time of the 1971 Ordnance Survey this had fallen to five. Today there only three that are recognizable on the ground as raths. These are DOW:009:010, DOW:009:021 and this scheduled rath DOW:009:011.

Figure 8 shows the location of the 9 raths known to exist in townland of Lisnabreeny when the 1st Ordnance Survey 6" County Maps were issued in 1834 and also highlights the 5 raths which survived until the 25" Irish Grid 1st Edition Ordnance Survey of this area was issued in 1971.
