ULSTER ARCHAEOLOGICAL SOCIETY

Survey Report: No. 34

**Survey of World War II Pillbox, Murlough, County Down
UAS/11/07**

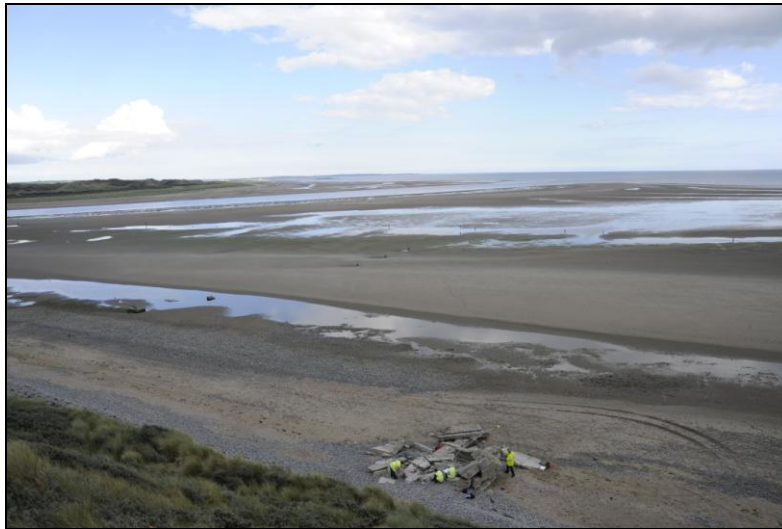
Figure 2: The beach at Murlough, with view of Pillbox ruins, looking east

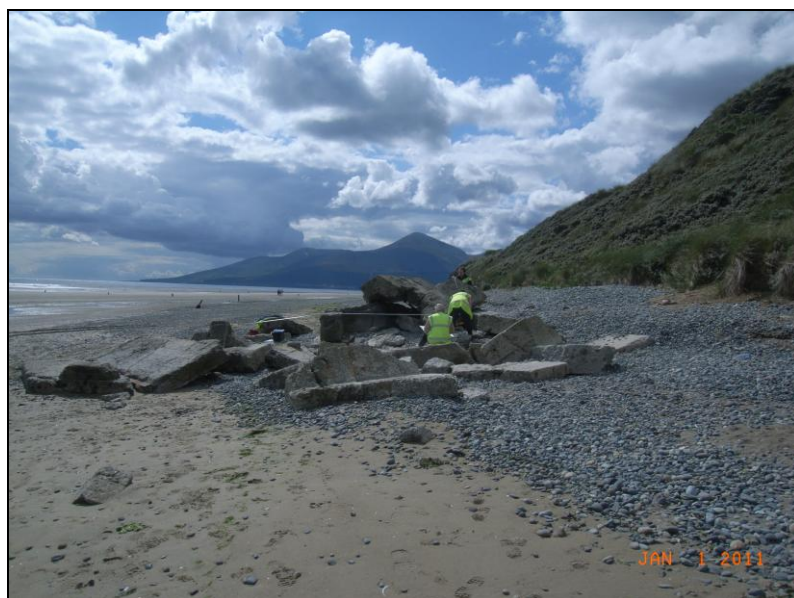
Figure 7: View of Pillbox remains, with Mourne Mountains to the south

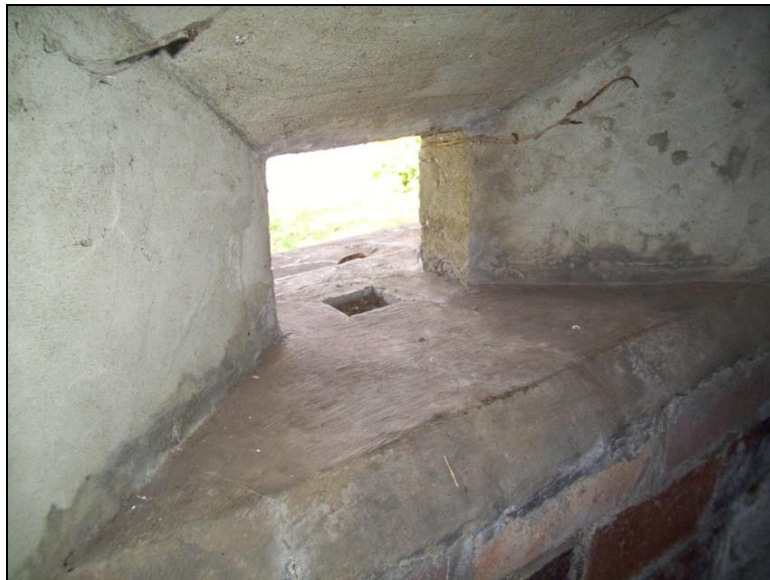
Figure 15: Inside a Type 22 Pillbox in Elstead, Surrey, complete with concrete loopole tables (Pillbox Study Group)

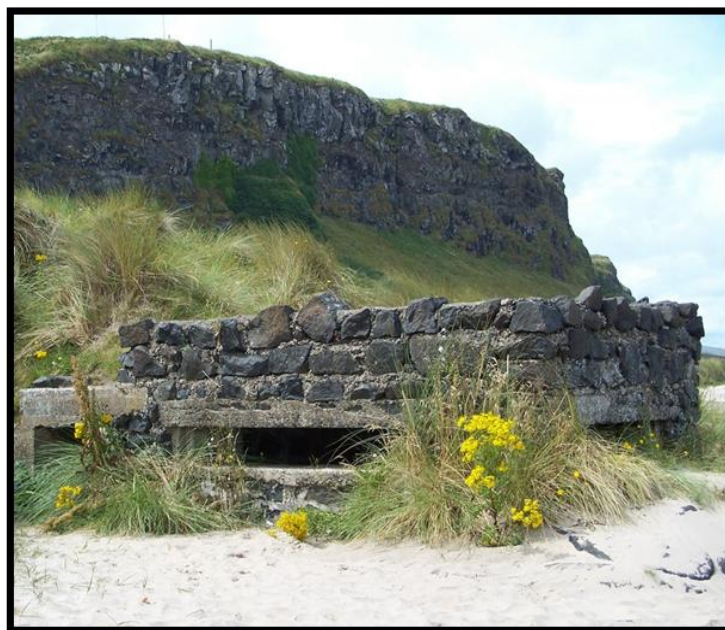
Figure 18: Downhill Pillbox, with basalt blocks as additional camouflage

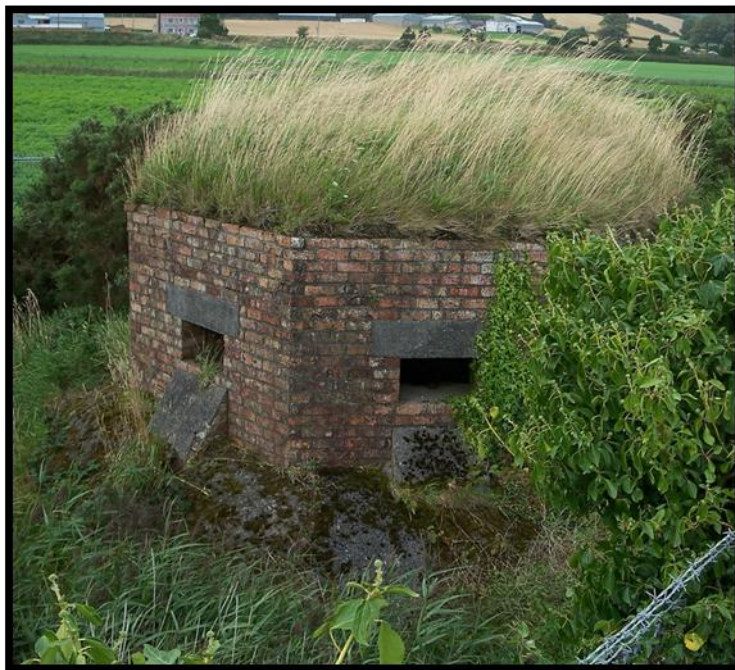
Figure 20: Comber Pillbox

The Pillbox at Comber is located on the shore of Strangford Lough and has been sited to afford excellent views of the lough. The grass roof provides interesting and effective camouflage.

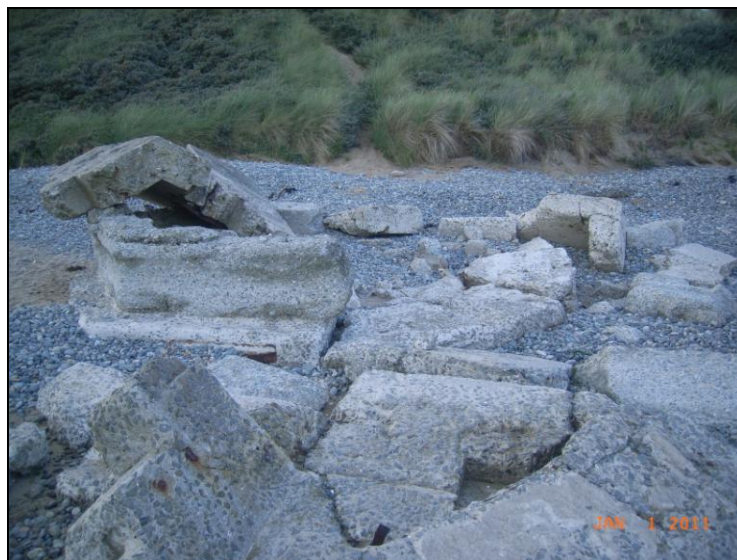
The remains of this Pillbox, which lie on the beach at the southern end of the sand dunes, are spread over an area of approximately 11m east/west and 12m north/south. There are about twenty-five visible fragments above the level of the sand and it is possible that more may be buried. These fragments of concrete range in size from 4m in length by 3m in width and 0.3m in depth to 0.5m in length by 0.4m in width and 0.3m in depth.

Figure 24: Scattered fragments of Murlough WWII Pillbox

This Pillbox at Murlough is comprehensively damaged, with every wall section shattered and its roof lying inverted to the south, strongly suggesting that it was destroyed by explosives. This was most likely carried out by the military during the recent civil disturbances in Northern Ireland, to prevent its use by terrorists to attack the nearby Ballykinler Army Camp, which lies to the east.

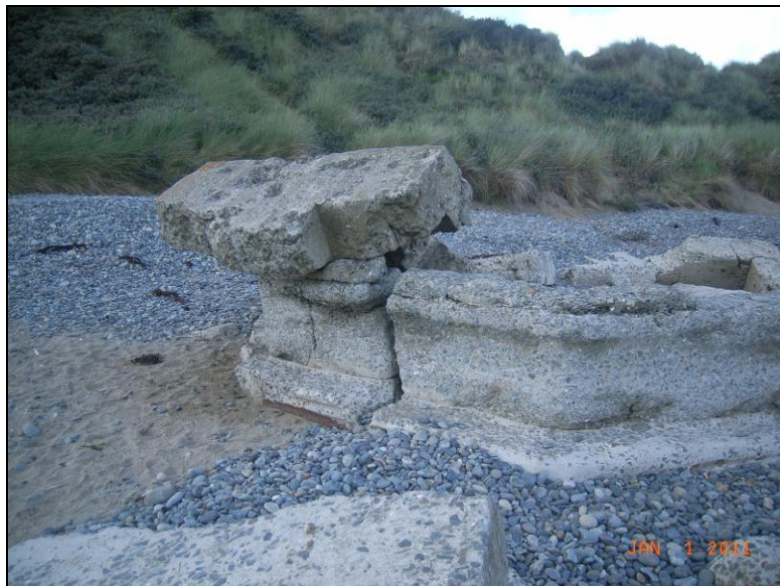
Figure 25: Elements of Pillbox still in situ

To the north-west of the debris field, some elements of the Pillbox remain relatively undisturbed, as evident above. From this we can tell it was hexagonal in shape and its internal width measures about 4m, with walls between 30cm and 40cm thick. The visible remains are 0.75m maximum height above the level of the sand. From the scattered remains it appears that it was constructed in sections, with a strip foundation at its base, constructed from corrugated iron shuttering, into which concrete was poured. The lower wall on top of the base has a shaped moulding at the upper external face and the upper wall measures about 2m in height. Finally, the concrete roof, some 0.3m thick, is set in place, giving an overall height of approximately 3.35m.

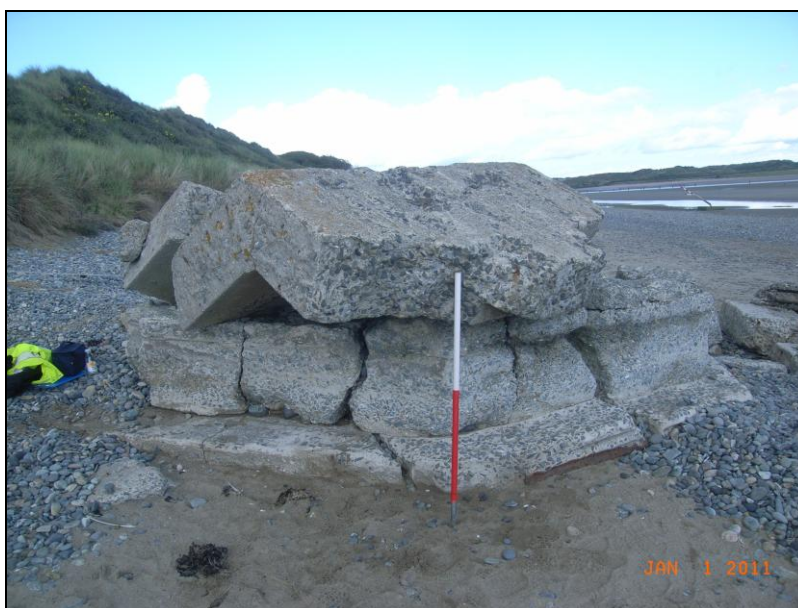
Figure 26: Evidence for sectional construction

The roof appears to be cast in three sections, supported by what appears to be re-used metal rails, perhaps from railway lines. Its overall external measurement is approximately 5.5m in diameter. Although the entrance to the Pillbox is not visible, it seems likely that it would be at the rear of the structure and facing the sand dunes. It is important to remember that over the years the sand dunes have been eroded to the north, leaving the Pillbox further out on the beach.

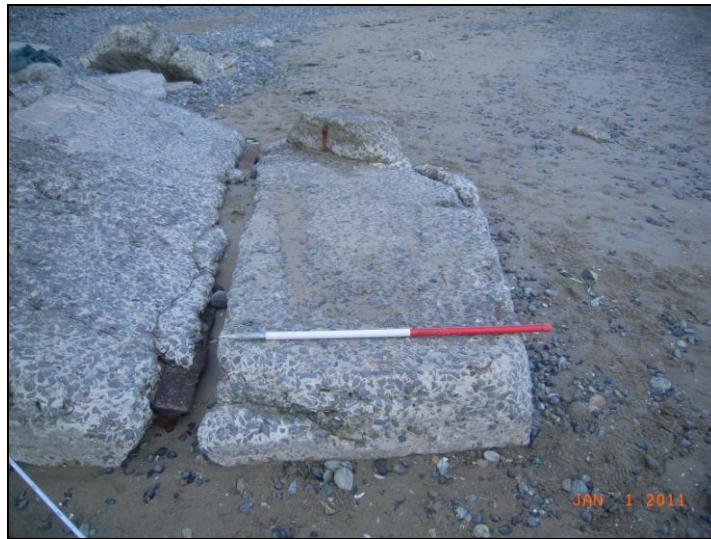
Figure 27: Metal rails used as roof supports

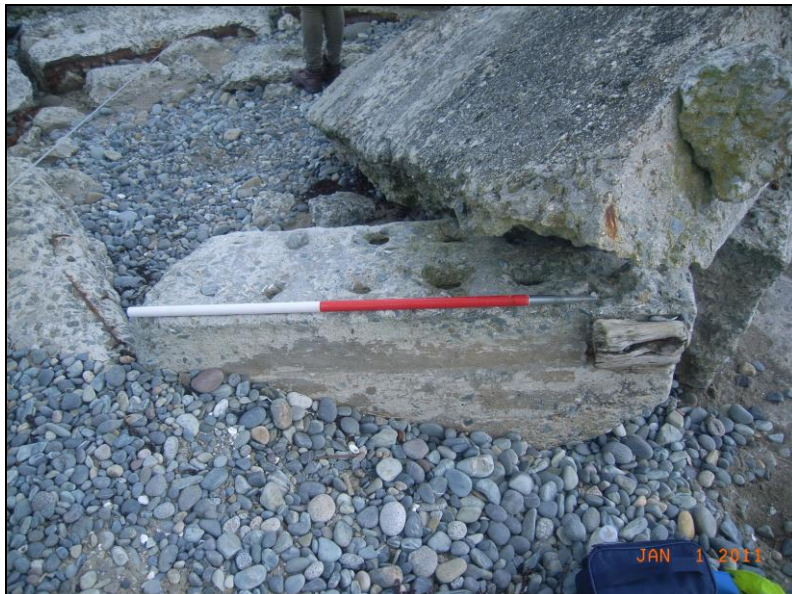
The upper face of several sections of the lower wall display evidence of regularly placed sockets and also stone pegs, some of which are still in situ. These were obviously used to provide a secure joint.

Figure 28: Ten regularly placed sockets with some stone pegs still in situ

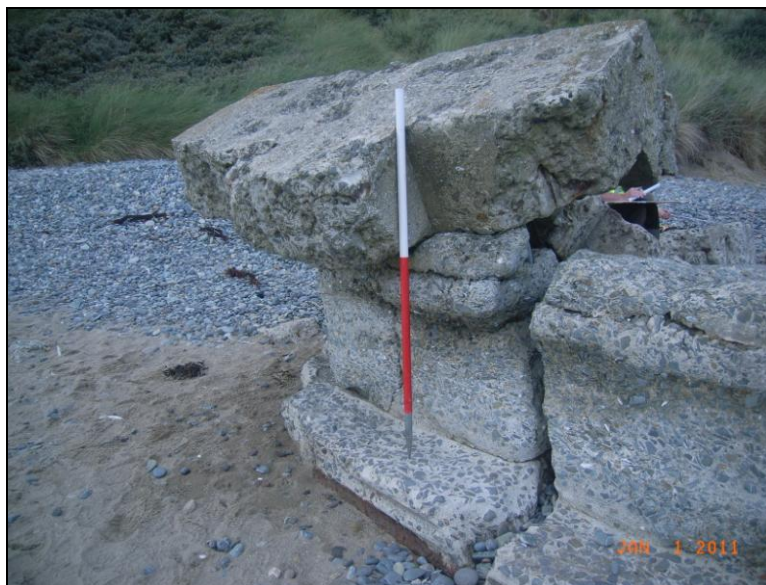
Elements of gun loopholes are visible from some fragments of the upper wall of the Pillbox.

Figure 29: Indent of partial gun loophole

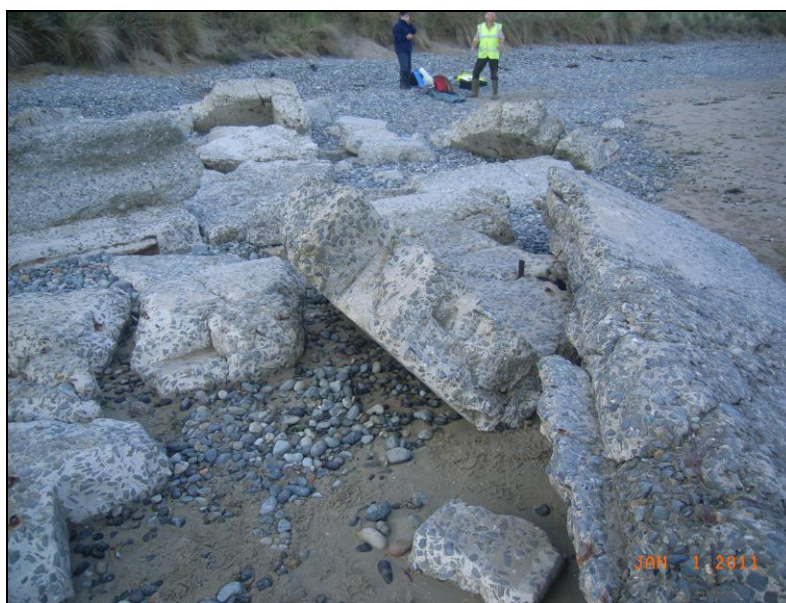
The entire structure is constructed of angular stones, which vary from 3cm to 6cm in diameter and were set into a concrete matrix. Some evidence exists for the use of corrugated iron shuttering in constructing its foundations. However, the presence of angular stones and not beach-rolled pebbles in the fabric of the other structural components indicates that these were not constructed on the beach, but were transported to the site and erected, using a pre-fabricated design.

Figure 30: Angular stones set into concrete matrix

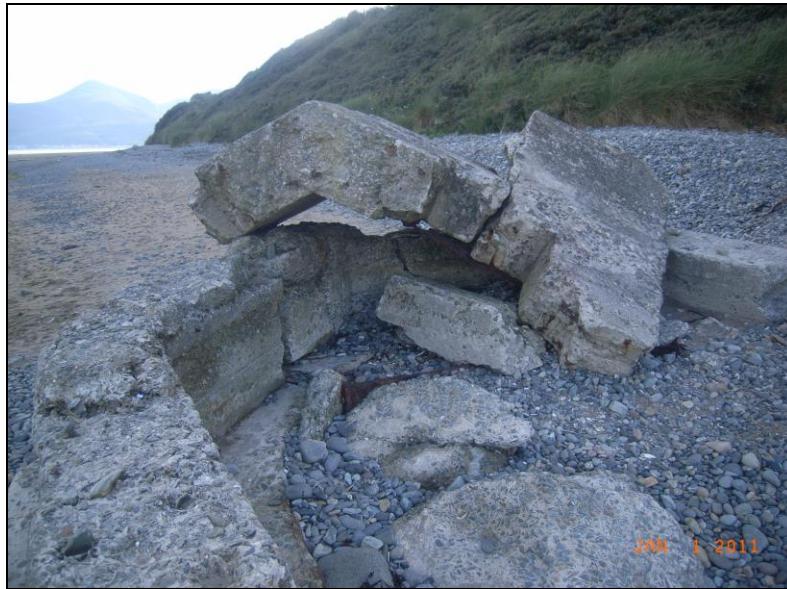
Within the remains of the Pillbox were a number of iron items, some partially buried in the debris. It is difficult to determine accurately their function.

Figure 31: Iron/metal items within the Pillbox structure
