ULSTER
ARCHÆOLOGICAL
SOCIETY

Survey Report

Reference: Survey Report No. 37

**Survey of Island Taggart
Strangford Lough,
County Down**

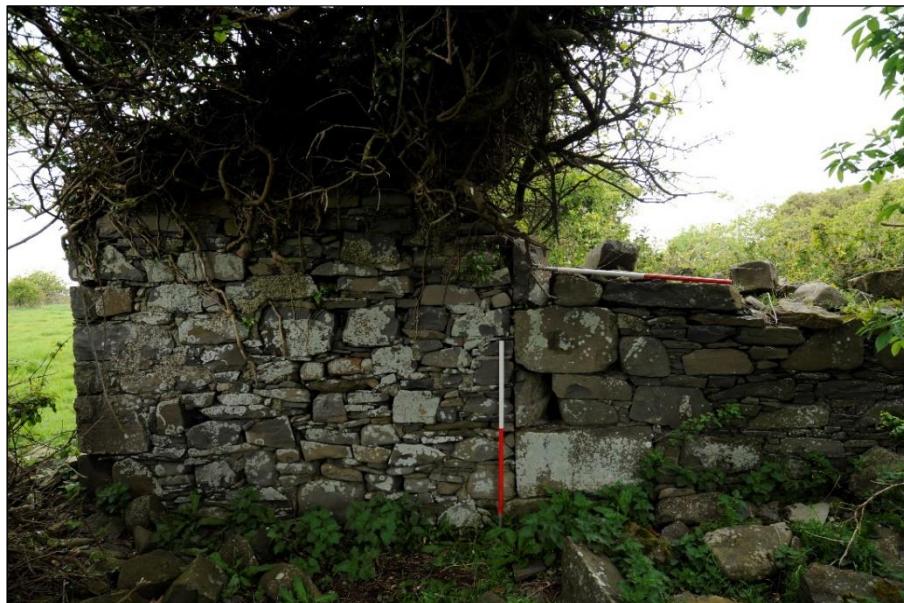
Plate 01: Southern corner of Site 1 (Vernacular building)

This site is currently designated NTSMR 132071 by the National Trust and is thought to date from the late eighteenth century or early nineteenth century. Grid reference J 53499 54950. The site is currently classified as an outbuilding and consists of an arrangement of partially-collapsed walls. It is approximately 14.6m in length (ne/sw) and 5.8m in width (nw/se). The northern and eastern corners of the building were in a bad state of repair, having largely collapsed. The northern corner is only 0.1m in height, whereas the eastern corner stands at 0.65m in height. The western end of the structure is markedly more intact, with the west and south corners standing at a height of 2.8, and 2.25m respectively. The walls are approximately 0.50m in width. There is a doorway on the NW section wall, it is 0.9m wide and positioned 1.8m from the western corner of the building. There is another stone building (NTSMR 132072) located approximately 25m to the north, however this was not surveyed on the day.

The vernacular structure at site 1 has been interpreted as a 'kelp processing building' or 'store'. As soda is highly soluble it was essential that the kelp was stored in a dry environment to prevent the deterioration (McErlean et al. 2002). Although the Island Taggart kelp store seems to have been modified at a later date, it was a substantial stone built structure, which probably had an originally had a slate roof. Its location close to the kelp drying racks (Site 2) would have made the drying, burning and storing process more efficient, and its location, close to one of the islands mooring points, would have facilitated the transport of the product to the mainland.

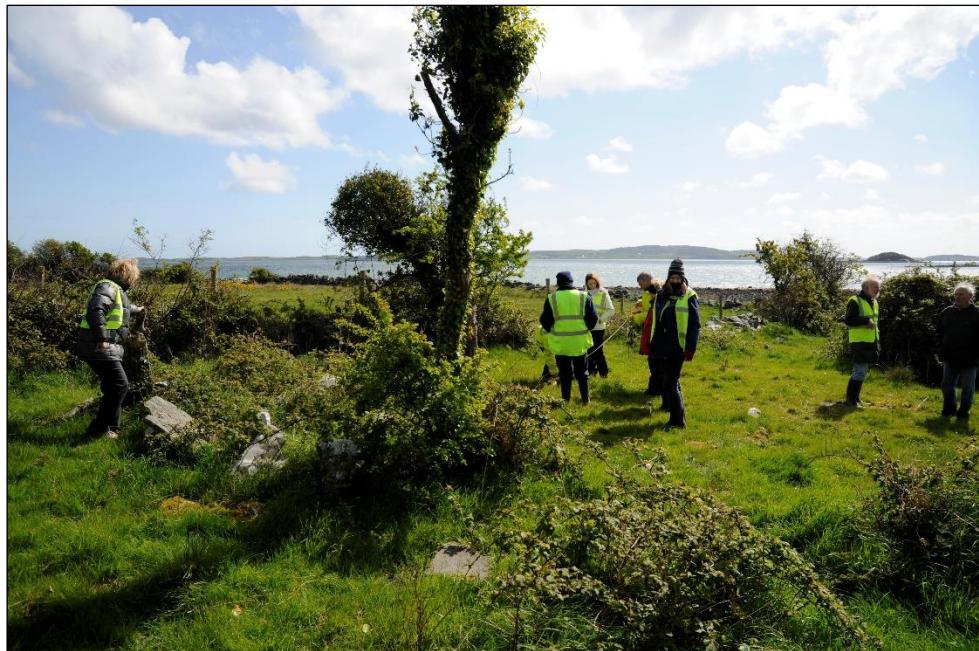
Plate 02: Surveying of kelp drying racks

This site is currently designated NTSMR 132070 by the National Trust and is thought to date from the late eighteenth century or early nineteenth century. Grid reference J 53511 54933. The site is immediately to the south-west of the ruins of a vernacular building (Site 1 above). The site consists of a series of stone uprights and is currently classified as kelp drying racks. While their function has not been positively confirmed, it would be reasonable to attribute their use as racks for drying kelp before further processing.

The kelp drying racks are located close to the building interpreted as the 'kelp processing building' (Site 1). One of the stages in kelp production was to dry the seaweed to make it more combustible and to stop it from rotting. The seaweed was spread out along the shoreline, often over low stone walls or 'racks' to dry naturally in the sun and wind and then stacked in preparation to be burnt (McErlean et al. 2002).

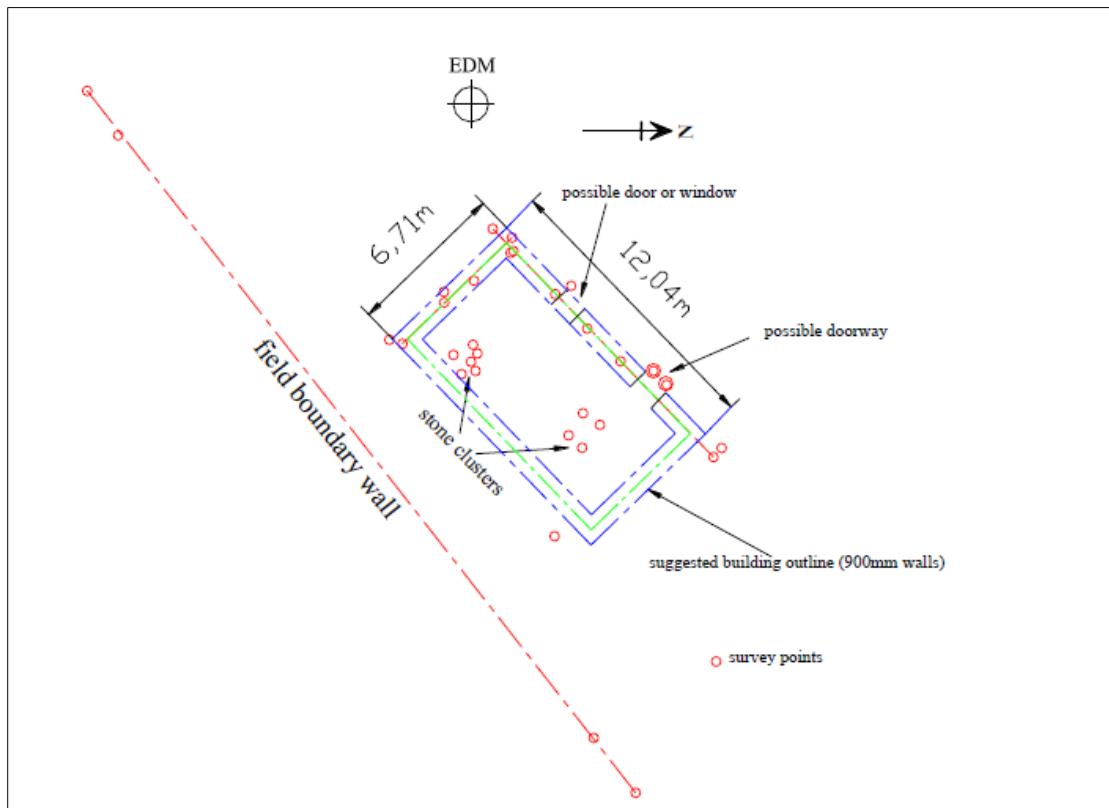
Figure 09: Plan of Site 3

The site is currently designated NTSMR 133027 by the National Trust and has been described as a kelp store. The site is on the southern end of the island, and consists of a rectangular building which measures 12.04m in length (sw/ne) and 6.71m in width (se/nw). The walls are approximately 0.8m in width and are largely collapsed. There is an entrance along the NW section of wall, it is approximately 1m wide and positioned 3.2m from the NE corner of the

building. There are two cluster of stones in the interior of the building, however these may just be associated with the collapse of the building. A small kelp kiln (NTSMR 132084) is located to the south-west of the structure, however it was not surveyed.

The OS 6" County Series maps from OS6-3-24-1(1833) to the present do not show the Rectangular enclosure but do indicate the position of the Kiln some 40 metres uphill from the enclosure. Given the remoteness of the location and the presence of a Kiln nearby it would be reasonable to assume that they were linked with the Rectangular Enclosure being a Kelp Store or a Worker's Cottage or a pair of single room attached cottages. The purpose and use of the Rectangular Enclosure predated 1833 since if it had stood at any height even without a roof it would have been shown in at least outline form. Had it had a roof it would most certainly have been shown shaded to represent a habitable or usable building especially in the Griffith Valuation map of 1859. There appears to be no Ordnance Survey for Island Taggart. Killyleagh has a memoir in Co. Down - DN17 but Island Taggart is not included.

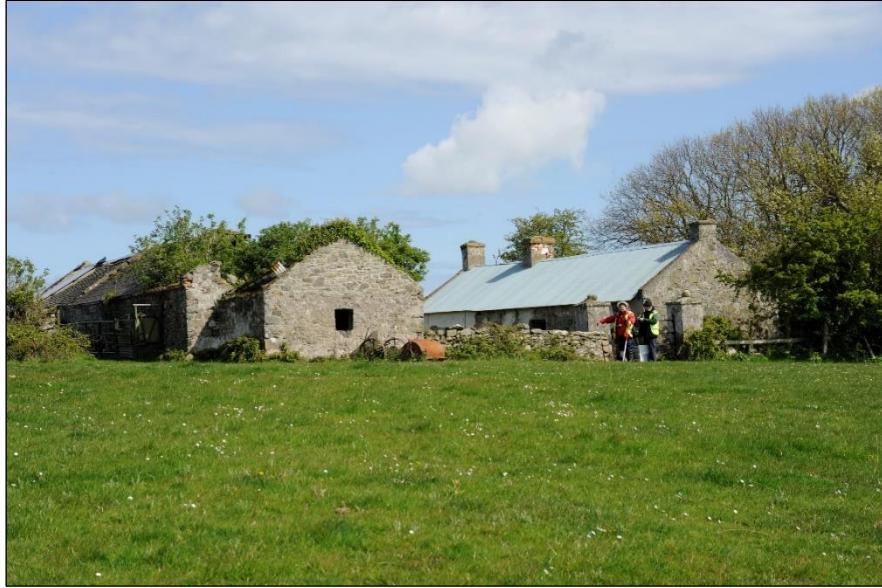
Plate 03: Farm enclosure, looking south-east

This site is a farmyard which incorporates two buildings – NTSMR 132066, a house and NTSMR 132067 an outbuilding. The buildings are located opposite each other. The House measures 14.2m in length and 5.6m in width with a ‘lean-to’ at the eastern end which is 3.6m in length. There are 2 chimneys, one at either end of the structure. The outbuilding is 13.6m in length and 5.4m in width and incorporates a 3.5m x 4.6m outshot to the western end of the structure. There is a window in the west end of the structure which is 0.6m in width. The enclosing yard measures 19.5 m x 37.8m and has an entrance which is 2.5m in width. The western and northern walls of the yard are abutted to the outbuilding. There is also a substantial garden, a well, another outbuilding and a horse walk which have been assigned NTSMR numbers.

The enclosure, a farmyard with a house and outbuildings, is present in the first edition map indicating that there has been a dwelling there since at least 1835 and probably before this. Census data indicates that in 1821, there were 3 houses occupied on the island with a total of 23 inhabitants, this seems to be when the island population was at its peak. By 1851 there are

only 6 inhabitants, on the island, all occupying the one house. This decline is hardly surprising given the mass depopulation in Ireland in the mid-19th century due to famine and emigration. Although derelict, the buildings in the enclosure are in relatively good condition, suggesting that this was the main house on the island, that was occupied for the longest. The last resident to leave the island was Mr David (Davey) Calvert who left the island in 1967, it is reasonable to presume he occupied Site 4.

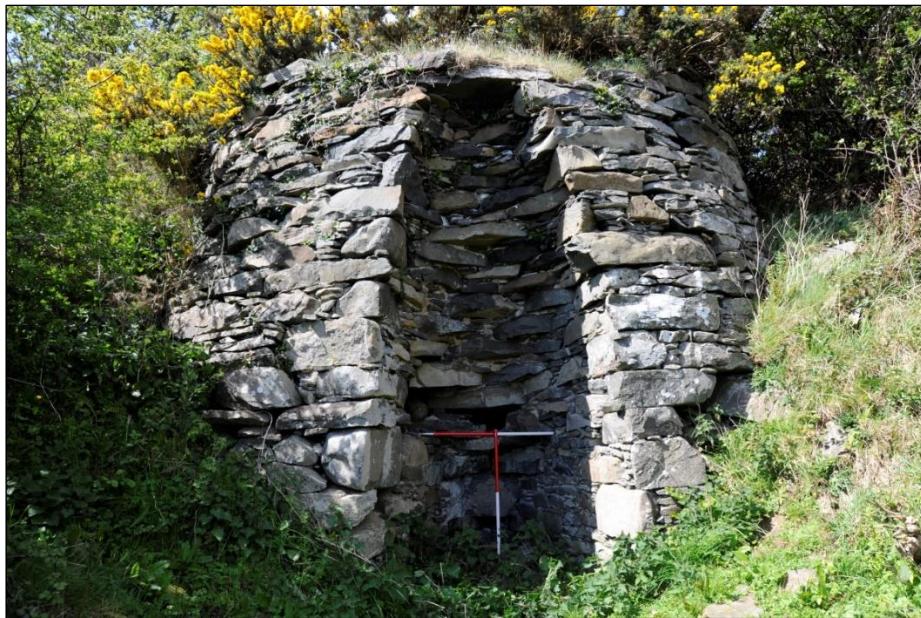
Plate 05: Dry-stone 'kelp kiln' feature

This site is currently designated NTSMR 132080 by the National Trust and is thought to date from the late eighteenth century or early nineteenth century. Grid reference J 53464 54816. It is currently classified as a kelp kiln, but is very different to other kelp kilns in the Strangford area. The feature has been constructed against a west-facing natural bank, which probably forms part of a raised beach. The feature is constructed of angular un-mortared stones and is exposed on the western side. The remainder of the structure is obscured by vegetation and it was not possible to determine if it was built into the hillside, or was free-standing. It is approximately 4m in height and 4m in width, tapering to 3m at the top and 2m at the base. It is sub-circular at the western side. At the west, a well-constructed flue-like feature was visible, approximately 1.5m in width at the base, tapering to approximately 0.75m at the top. There was no evidence of heat damage to the interior of this feature and no soot-blackening was visible. Due to time constraints, this site was not planned during the survey but a photographic record was taken.

Due to time constraints, this site was not planned during the survey but a photographic record was taken. This has previously been described as a kelp kiln, and although a flue-like feature was noted, the open fronted design questions its functionality as a kiln.

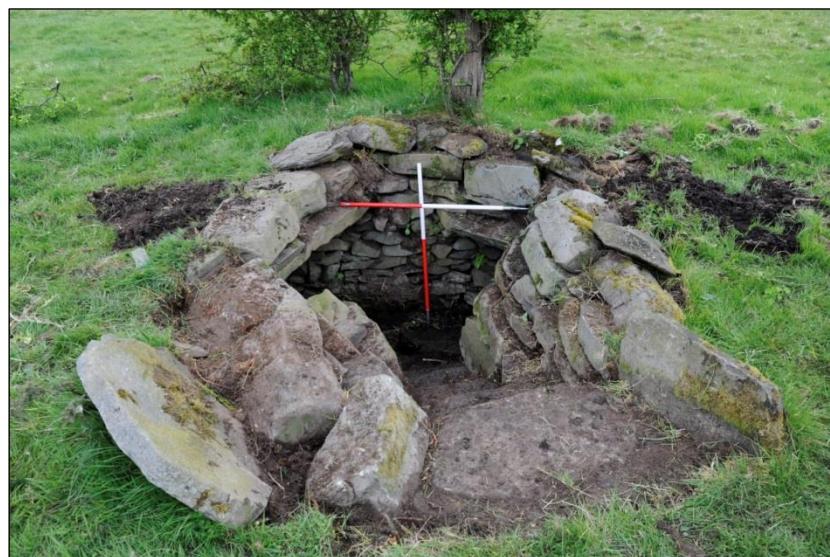
Plate 06: View of Well A, looking west

A substantial dry-stone constructed well (NT132079) was observed in a field to the north of the island, approximately 100m from farm building NT132071. A series of well-constructed stone steps provides access to the water source, which is protected but not totally enclosed by stone corbelling. Other stone slabs were observed in and around the well, suggesting that the stone corbelling may once have enclosed the well, possibly with an access door to prevent animals entering and damaging the structure. Due to time constraints, this site was not planned during the survey but a photographic record was taken.

Due to time constraints, these sites were not planned during the survey but a photographic record was taken. Fresh water wells would have been a vital resource to support the community living on the island.

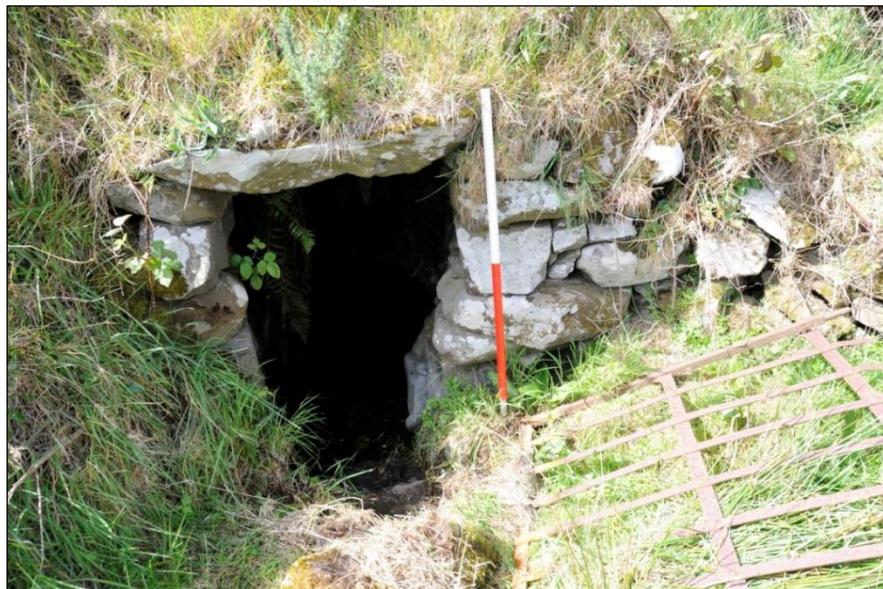
Plate 07: View of Well B

Another well (NT132078) was located to in the middle of the island, beside the farm Site 4, the enclosure incorporating NTSMR 132066, a house and NTSMR 132067. This was found to be of dry stone construction, with a stone slab above and a covering of sods. Access from ground level was by a series of stone steps and an entrance doorway, 1m in height and 0.5m in width, which probably held a door to prevent animal access. The structure is currently protected by a metal grille. Due to time constraints, this site was not planned during the survey but a photographic record was taken.

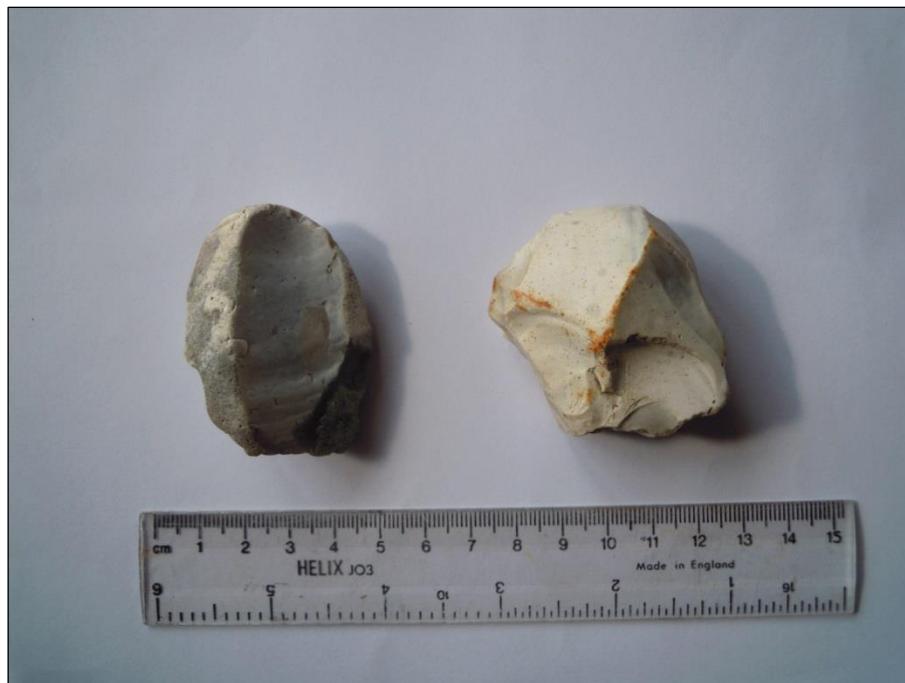
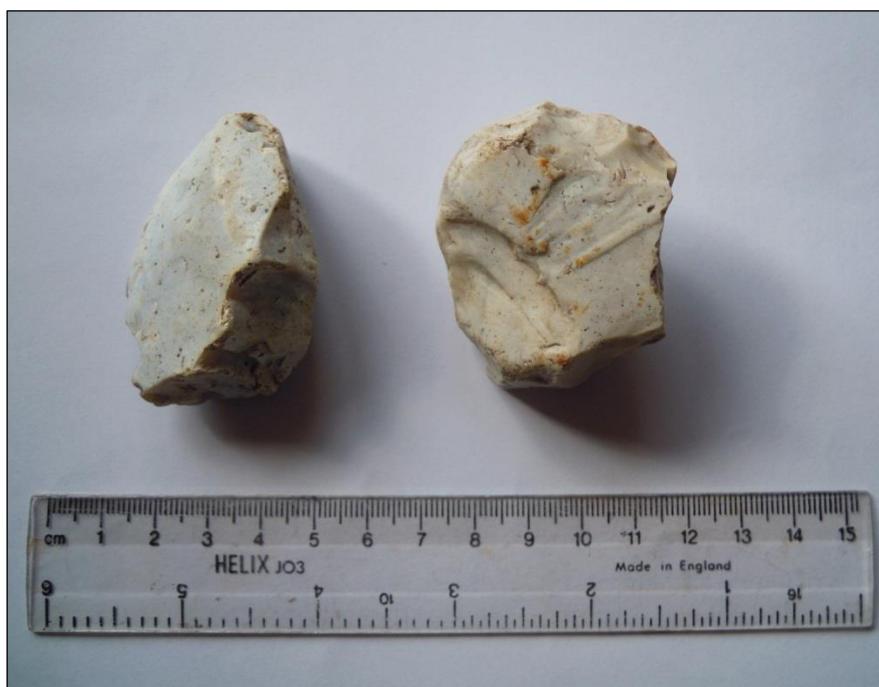
Plate 08: Mesolithic flint flakes, dorsal surfaces

While traversing a beach on the west of the island, two worked flint flakes were observed by Janna McDonald, one of the members of the UAS Survey Group. The findspot was recorded at grid reference J 5350 5450. The flakes were later identified by Brian Sloan of the Centre for Archaeological Fieldwork at Queen's University as dating to between 5,500 BC and 4,500 BC, in the later Mesolithic.

Mesolithic flints have previously been found at Island Taggart (NISMIR DOW 024:034 and NTSMR 132081) Irish Grid Reference J 3533 3542. Evidence of Mesolithic activity has been recorded at many locations around Strangford Lough, with the raised beaches of the Lough a rich source of Mesolithic material. Many sites consist of scatters of flint flakes or shell middens and much of this material has been preserved at the Ulster Museum, Belfast and the National Museum in Dublin (ASNI 1966, 69). Perhaps the best recorded is at Rough Island, some 16 km to the north of Island Taggart (Movius *et al.* 1940). The Ulster Archaeological Society Survey Group also found Mesolithic material at Ballygarvan, Kircubbin during a survey and surface artefact collection in April 2012 (Welsh 2012).
