ULSTER
ARCHÆOLOGICAL
SOCIETY

Survey Report

Reference: **Survey Report No. 37**

**Survey of Island Taggart
Strangford Lough,
County Down**

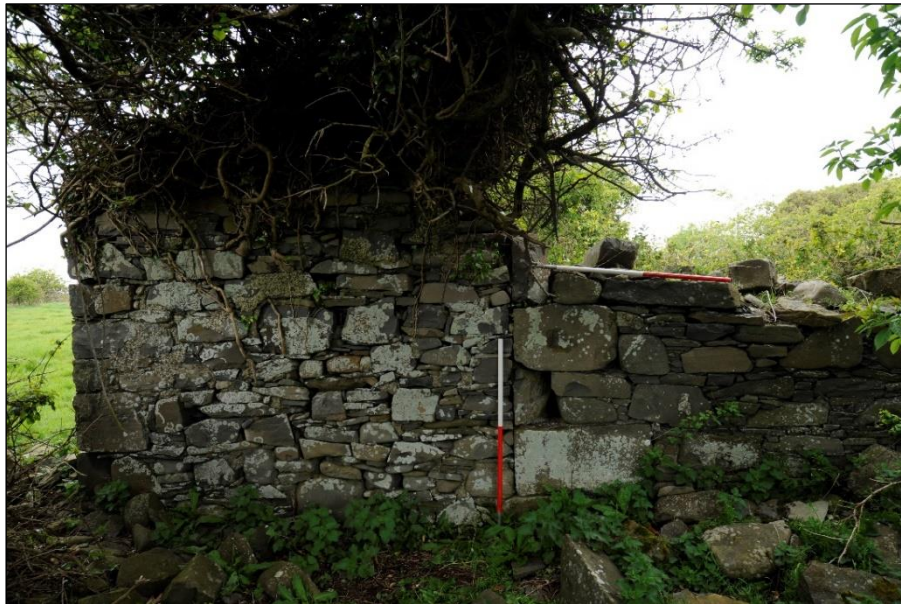
Plate 01: Southern corner of Site 1 (Vernacular building)

This site is currently designated NTSMR 132071 by the National Trust and is thought to date from the late eighteenth century or early nineteenth century. Grid reference J 53499 54950. The site is currently classified as an outbuilding and consists of an arrangement of partially-collapsed walls. It is approximately 14.6m in length (ne/sw) and 5.8m in width (nw/se). The northern and eastern corners of the building were in a bad state of repair, having largely collapsed. The northern corner is only 0.1m in height, whereas the eastern corner stands at 0.65m in height. The western end of the structure is markedly more intact, with the west and south corners standing at a height of 2.8, and 2.25m respectively. The walls are approximately 0.50m in width. There is a doorway on the NW section wall, it is 0.9m wide and positioned 1.8m from the western corner of the building. There is another stone building (NTSMR 132072) located approximately 25m to the north, however this was not surveyed on the day.

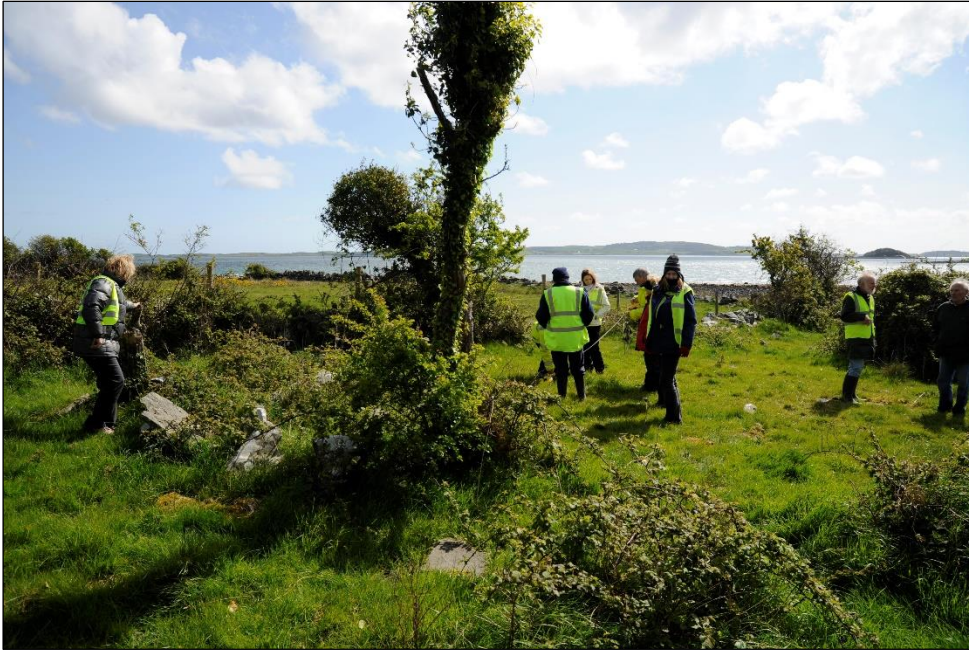
Plate 02: Surveying of kelp drying racks

This site is currently designated NTSMR 132070 by the National Trust and is thought to date from the late eighteenth century or early nineteenth century. Grid reference J 53511 54933. The site is immediately to the south-west of the ruins of a vernacular building (Site 1 above). The site consists of a series of stone uprights and is currently classified as kelp drying racks. While their function has not been positively confirmed, it would be reasonable to attribute their use as racks for drying kelp before further processing.

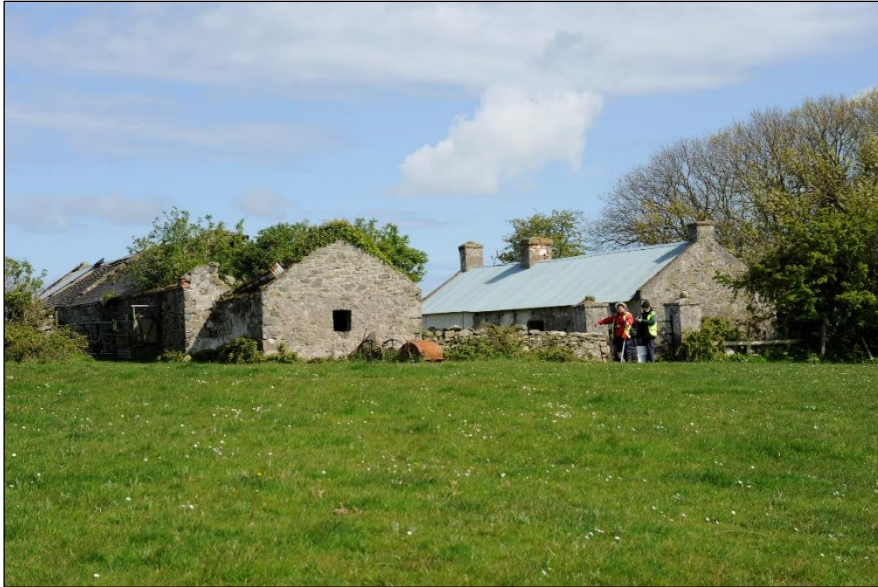
Plate 03: Farm enclosure, looking south-east

This site is a farmyard which incorporates two buildings – NTSMR 132066, a house and NTSMR 132067 an outbuilding. The buildings are located opposite each other. The House measures 14.2m in length and 5.6m in width with a ‘lean-to’ at the eastern end which is 3.6m in length. There are 2 chimneys, one at either end of the structure. The outbuilding is 13.6m in length and 5.4m in width and incorporates a 3.5m x 4.6m outshot to the western end of the structure. There is a window in the west end of the structure which is 0.6m in width. The enclosing yard measures 19.5 m x 37.8m and has an entrance which is 2.5m in width. The western and northern walls of the yard are abutted to the outbuilding. There is also a substantial garden, a well, another outbuilding and a horse walk which have been assigned NTSMR numbers.

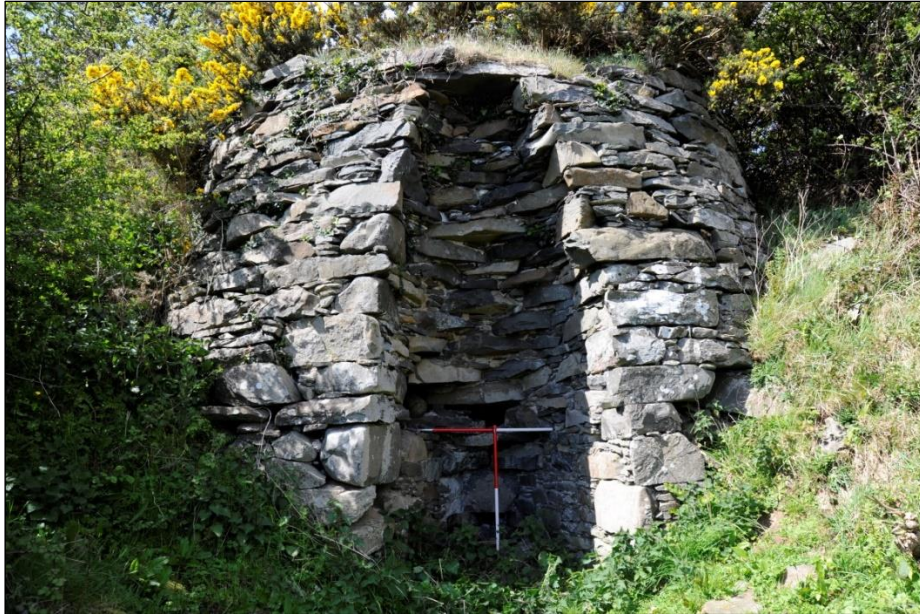
Plate 05: Dry-stone 'kelp kiln' feature

This site is currently designated NTSMR 132080 by the National Trust and is thought to date from the late eighteenth century or early nineteenth century. Grid reference J 53464 54816. It is currently classified as a kelp kiln, but is very different to other kelp kilns in the Strangford area. The feature has been constructed against a west-facing natural bank, which probably forms part of a raised beach. The feature is constructed of angular un-mortared stones and is exposed on the western side. The remainder of the structure is obscured by vegetation and it was not possible to determine if it was built into the hillside, or was free-standing. It is approximately 4m in height and 4m in width, tapering to 3m at the top and 2m at the base. It is sub-circular at the western side. At the west, a well-constructed flue-like feature was visible, approximately 1.5m in width at the base, tapering to approximately 0.75m at the top. There was no evidence of heat damage to the interior of this feature and no soot-blackening was visible. Due to time constraints, this site was not planned during the survey but a photographic record was taken.

Due to time constraints, this site was not planned during the survey but a photographic record was taken. This has previously been described as a kelp kiln, and although a flue-like featured was noted, the open fronted design questions its functionality as a kiln.

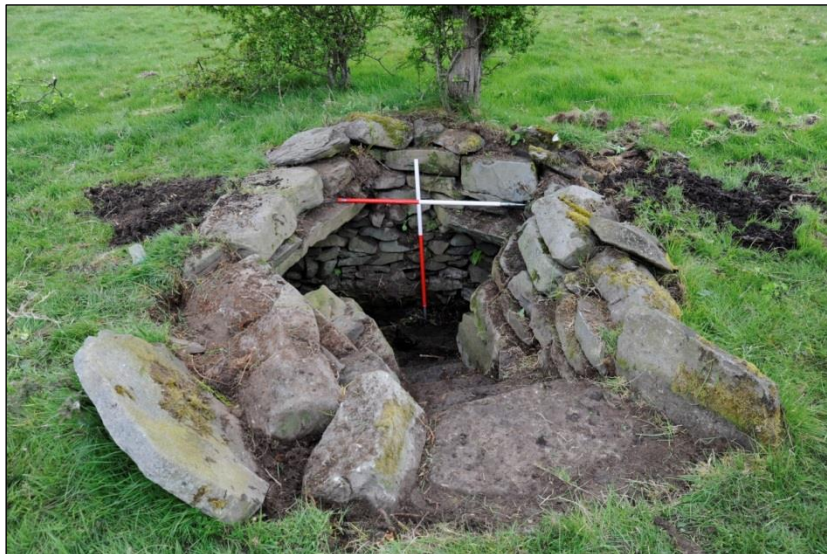
Plate 06: View of Well A, looking west

A substantial dry-stone constructed well (NT132079) was observed in a field to the north of the island, approximately 100m from farm building NT132071. A series of well-constructed stone steps provides access to the water source, which is protected but not totally enclosed by stone corbelling. Other stone slabs were observed in and around the well, suggesting that the stone corbelling may once have enclosed the well, possibly with an access door to prevent animals entering and damaging the structure. Due to time constraints, this site was not planned during the survey but a photographic record was taken.

Due to time constraints, these sites were not planned during the survey but a photographic record was taken. Fresh water wells would have been a vital resource to support the community living on the island.

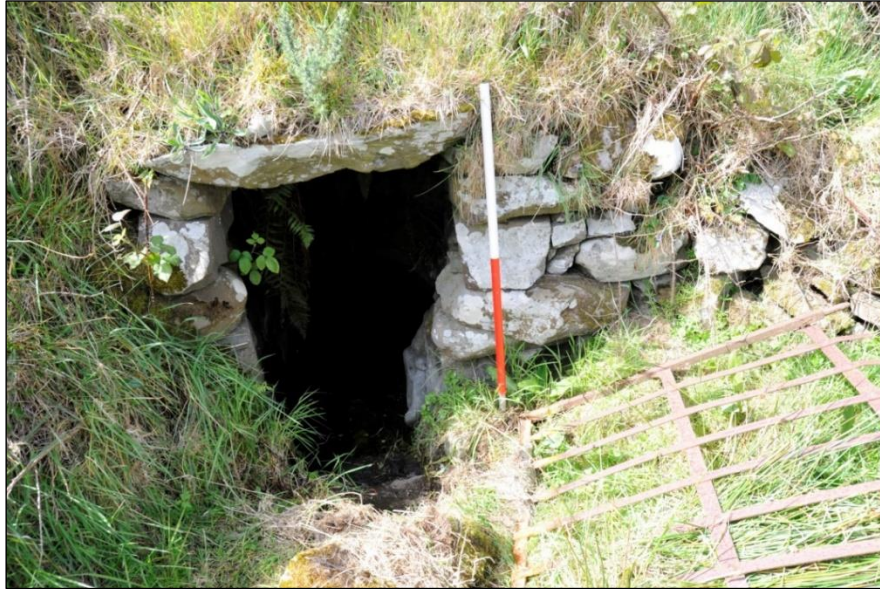
Plate 07: View of Well B

Another well (NT132078) was located to in the middle of the island, beside the farm Site 4, the enclosure incorporating NTSMR 132066, a house and NTSMR 132067. This was found to be of dry stone construction, with a stone slab above and a covering of sods. Access from ground level was by a series of stone steps and an entrance doorway, 1m in height and 0.5m in width, which probably held a door to prevent animal access. The structure is currently protected by a metal grille. Due to time constraints, this site was not planned during the survey but a photographic record was taken.

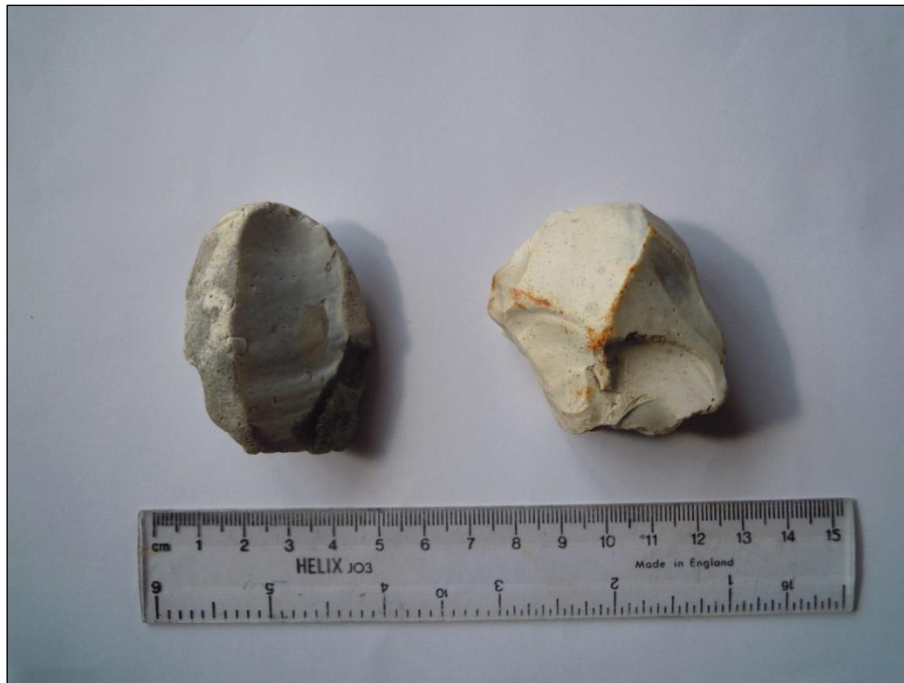
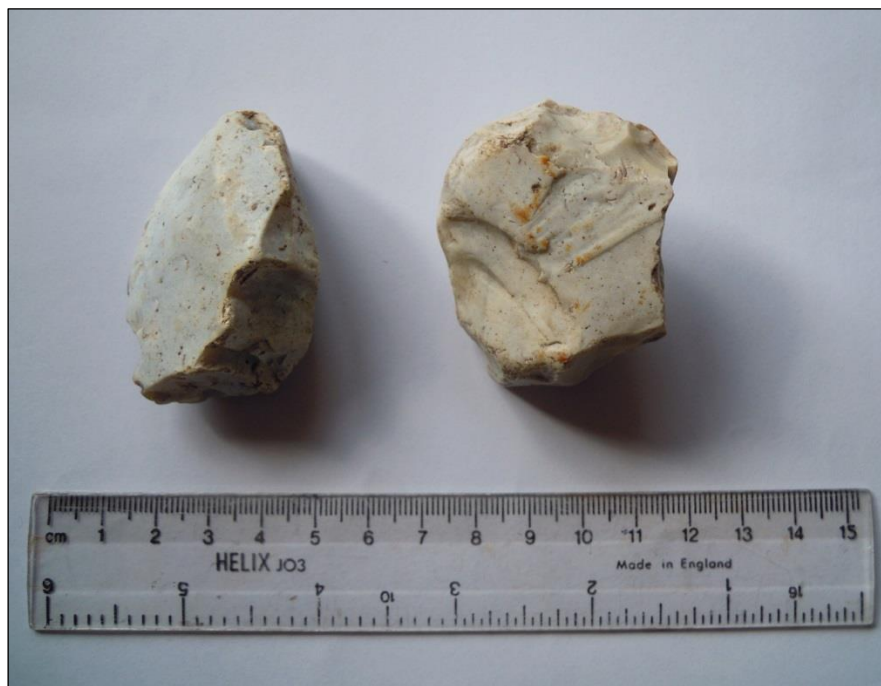
While traversing a beach on the west of the island, two worked flint flakes were observed by Janna McDonald, one of the members of the UAS Survey Group. The findspot was recorded at grid reference J 5350 5450. The flakes were later identified by Brian Sloan of the Centre for Archaeological Fieldwork at Queen's University as dating to between 5,500 BC and 4,500 BC, in the later Mesolithic.

Plate 08: Mesolithic flint flakes, dorsal surfaces

Plate 09: Mesolithic flint flakes, ventral surfaces

Mesolithic flints have previously been found at Island Taggart (NISMR DOW 024:034 and NTSMR 132081) Irish Grid Reference J 3533 3542. Evidence of Mesolithic activity has been recorded at many locations around Strangford Lough, with the raised beaches of the Lough a rich source of Mesolithic material. Many sites consist of scatters of flint flakes or shell middens and much of this material has been preserved at the Ulster Museum, Belfast and the National Museum in Dublin (ASNI 1966, 69). Perhaps the best recorded is at Rough Island, some 16 km to the north of Island Taggart (Movius *et al.* 1940). The Ulster Archaeological Society Survey Group also found Mesolithic material at Ballygarvan, Kircubbin during a survey and surface artefact collection in April 2012 (Welsh 2012).
