ULSTER
ARCHÆOLOGICAL
SOCIETY

Survey Report

Reference: **Survey Report No. 59**

**Windsor Garden
Castle Ward
County Down**

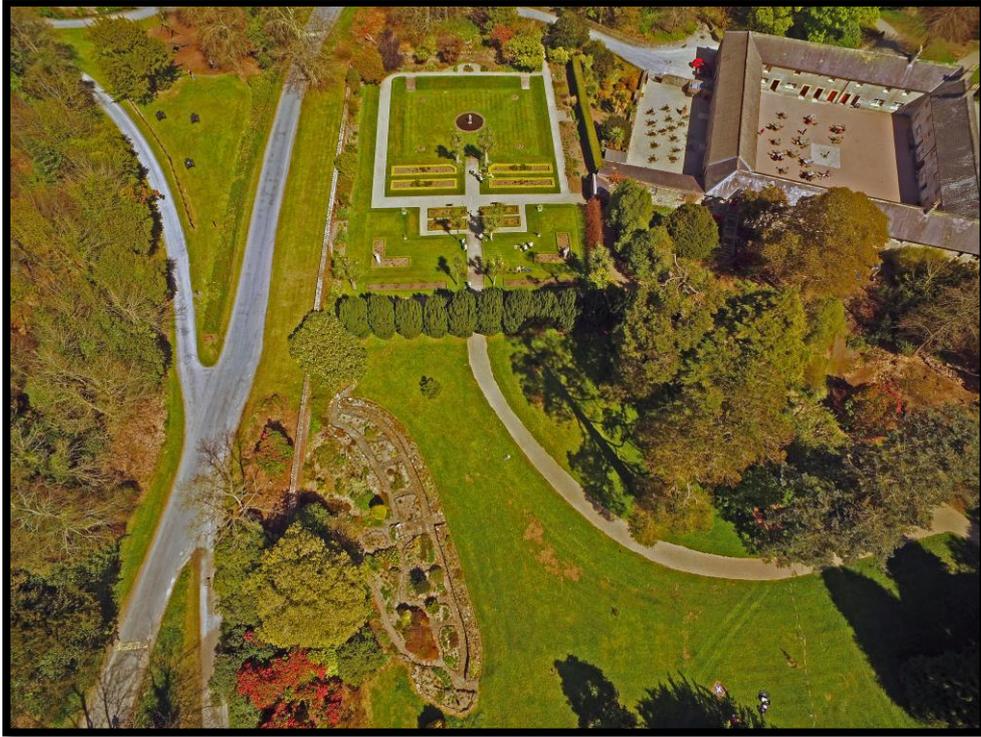
Figure 02: Aerial view of the Windsor Garden, looking north

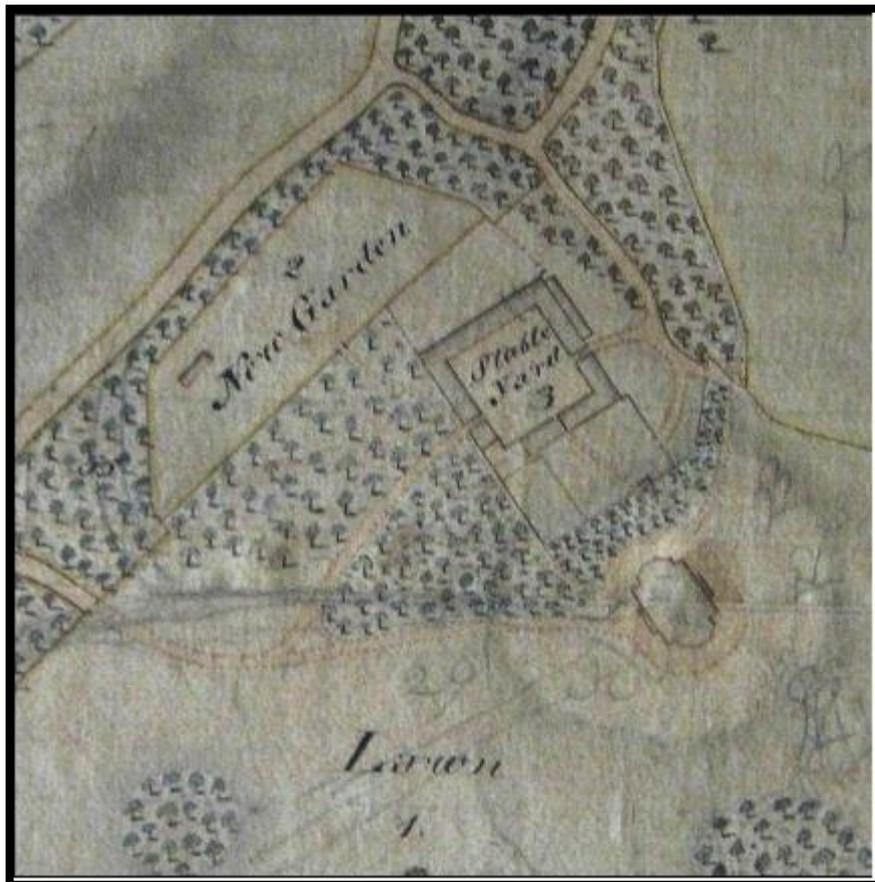
Figure 04: Estate map (part of) 1813, showing the 'New Garden'. *National Trust*

The precise date for the creation of the Windsor Garden is unclear, as by 1813 the walled enclosure was being referred to as the *new garden* (Fig. 4), in contrast to the old garden, which had surrounded the Queen Anne House. By 1834 rectangular beds and paths with terracing had been constructed, but 1864 highlights the garden when fully established. The focal point of the formal Windsor Garden was the elaborate parterre, with gem-stone like flower beds set in gravel, but enclosed by terraces. A 1902 article in *The Irish Farming World* (cited in Rutherford 2010, 58-59) explained that it was given this name, Windsor Garden, because of the design of the sunken parterre, which was based on one at Windsor Castle. Although the two locations do share a sunken parterre, the actual flower beds and paths are remarkably different. At Castle Ward four levels form three terraces, which lead to a rectangular sunken domain. Centrally located steps have been set into the steep-sided banks and provide access to the different levels. Brick and stone walls from the old garden enclose this area on two sides, while a line of Irish yew trees forms a third side.

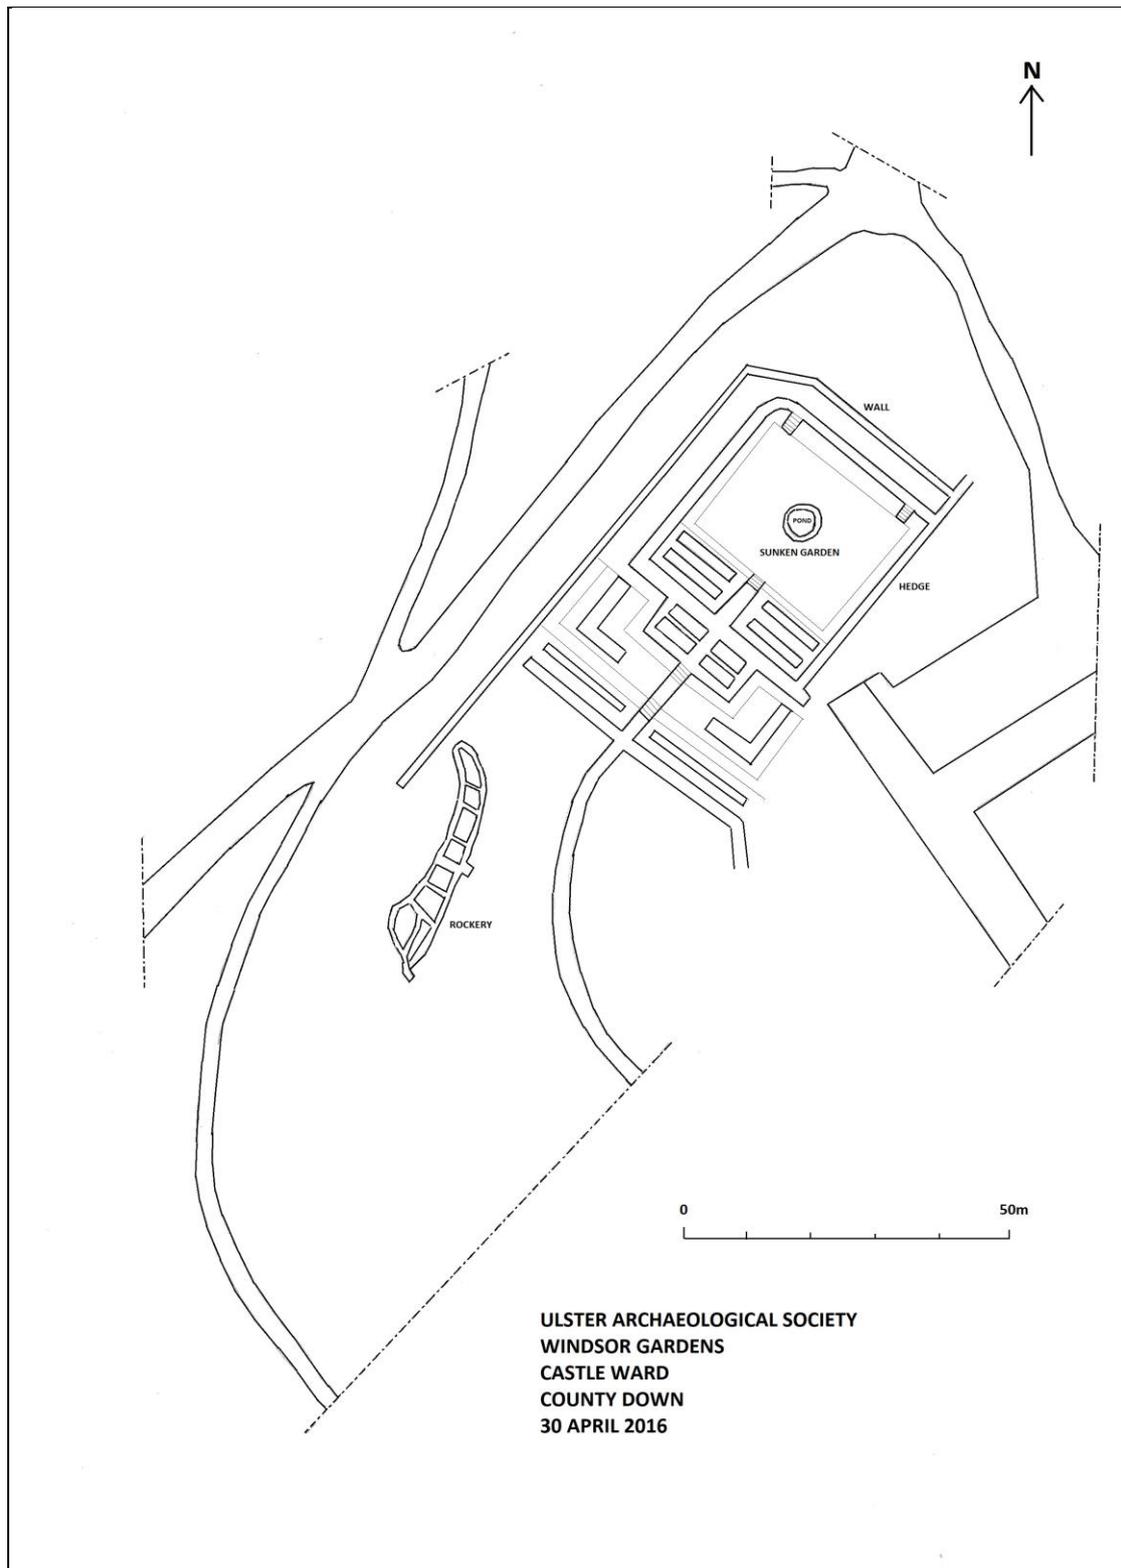
Figure 07: Plan of Windsor Garden

The Walled Garden is situated on four levels. On the north-west there is a substantial red brick wall, built with gently sloping courses and standing approximately 3m high. The base of the wall is comprised of rubble stone and the top of the wall is coped with unshaped local stone. This wall is supported by two buttresses: the northern buttress measures 1.4m wide by 0.95m projecting and by 2.8m high, while the southern buttress measures 1.3m wide by 0.9m projecting and by 3.5m high.

The lowest level of the garden is a rectangular grass lawn, with a circular pond with a stone statue of Neptune at its centre. The pond measures 4.96m in diameter and is edged with a double row of red brick. On the north-eastern bank of the Sunken Garden, there are two separate flights of steps, leading to a surrounding gravel path. On the south-eastern side of the garden there is a yew hedge, consisting of thirteen trees, which effectively closes the south-western side of the garden.

On level two there are four large and four small rectangular beds, each enclosed by a box hedge, which stands at 0.3m high. The flower beds are symmetrically designed on either side of the path leading from level one. A further flight of red-bricked steps connects levels two and three.

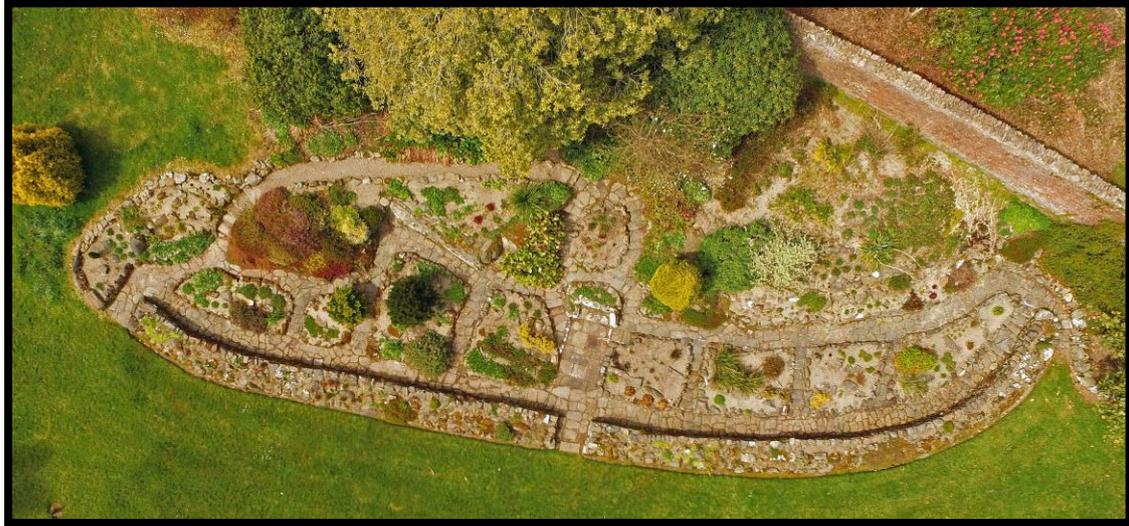
Figure 08: Aerial view of Rock Garden, looking west

The rockery is kidney-shaped in plan and rises gently from ground level in the gardens to meet the enclosing wall to the west. It is provided with a range of small paths from which to view the rock plants. It was sparsely planted at the time of the survey.

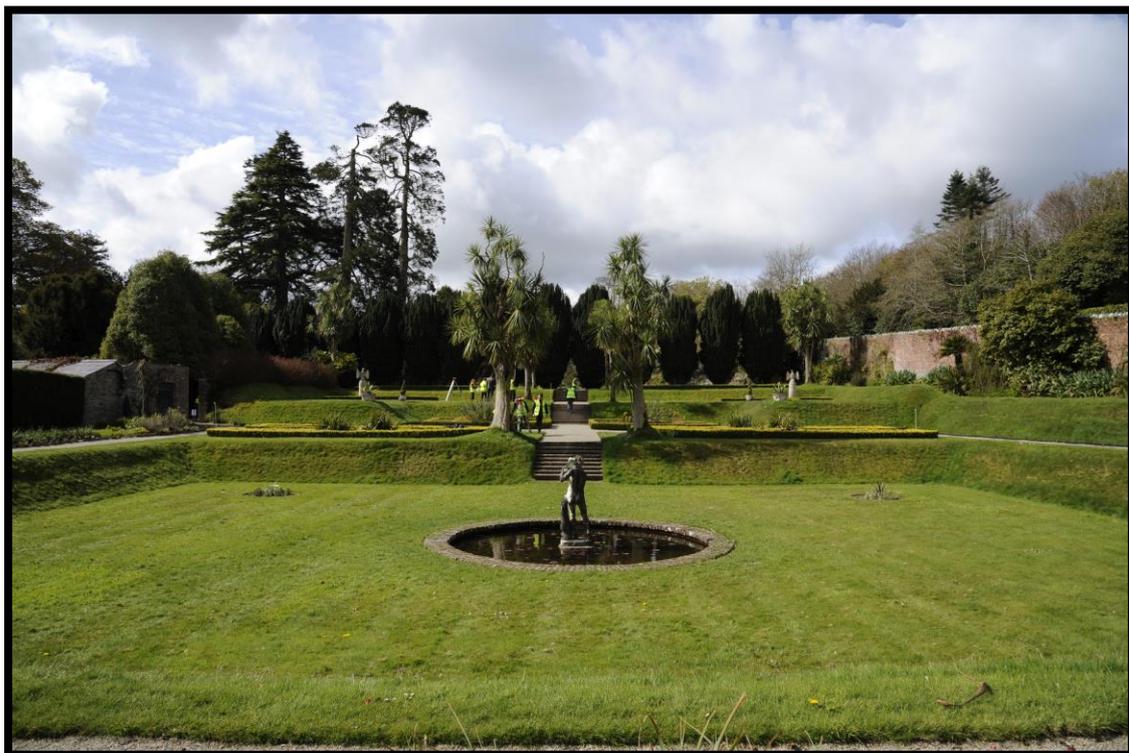
Figure 09: View of Sunken Garden and terraces, looking south-east

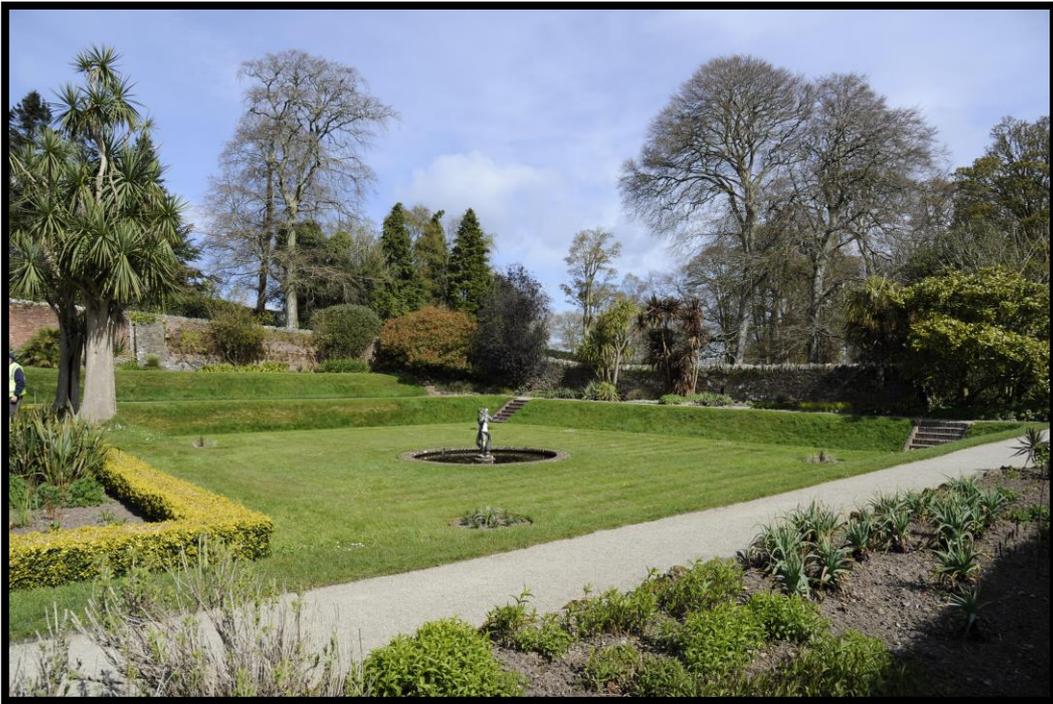
Figure 10: View of Sunken Garden and enclosing walls, looking north-west

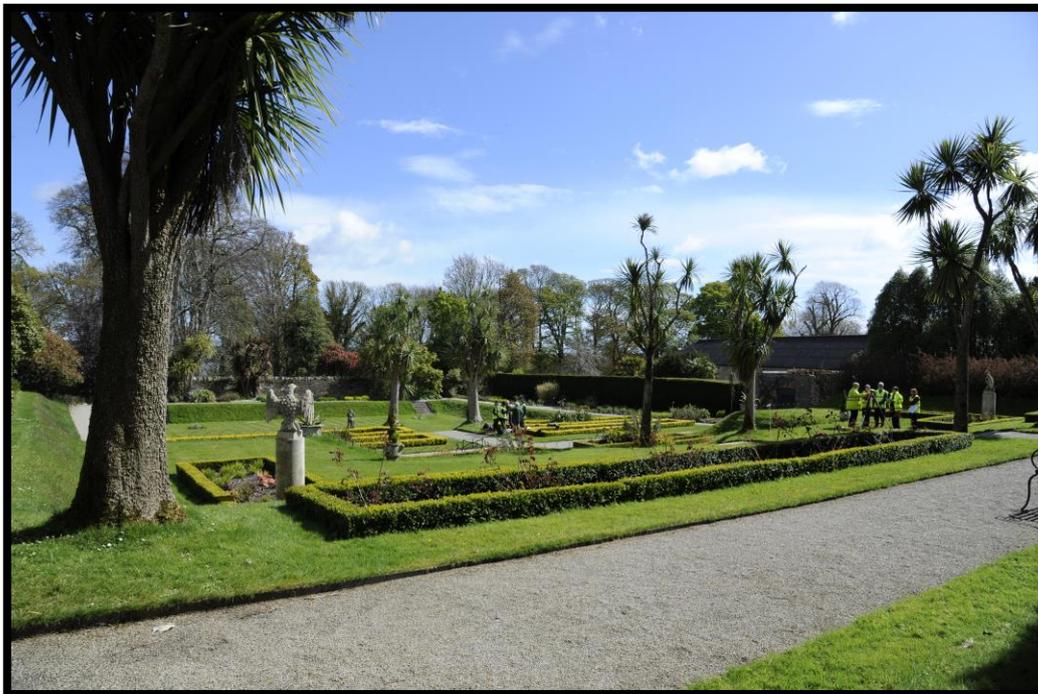
Figure 11: View of Sunken Garden and parterres, looking north-east

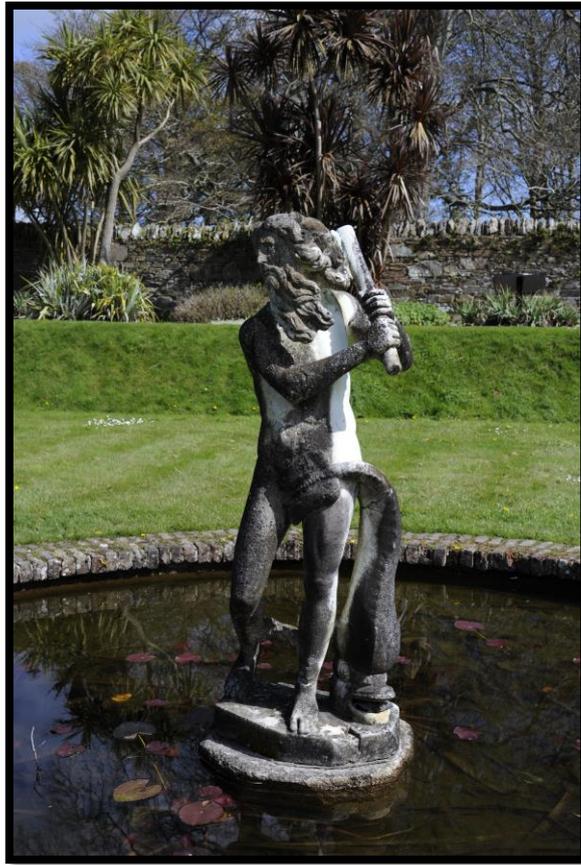
Figure 12: View of Portland stone statue of Neptune, looking north-east

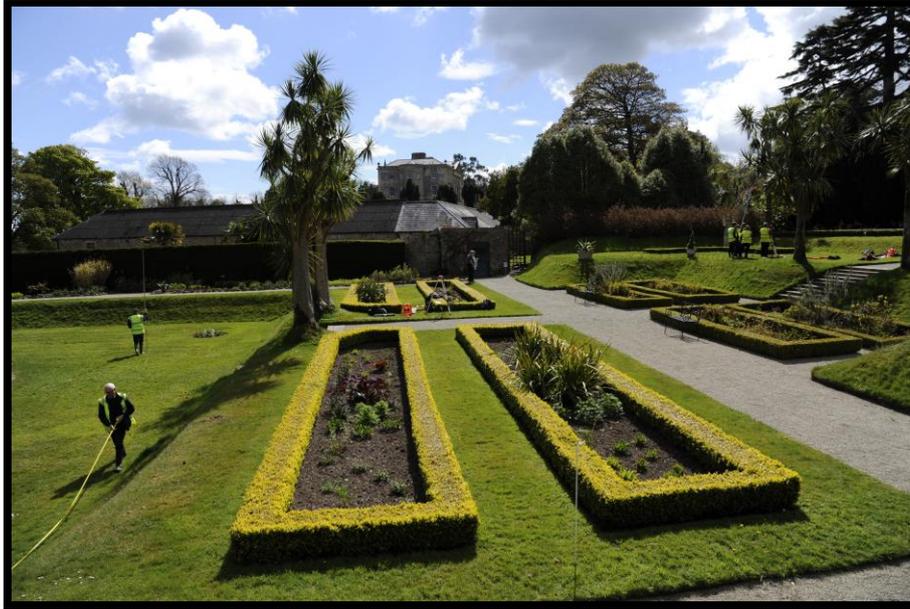
Fig. 13: View of parterres on the intermediate level, looking east

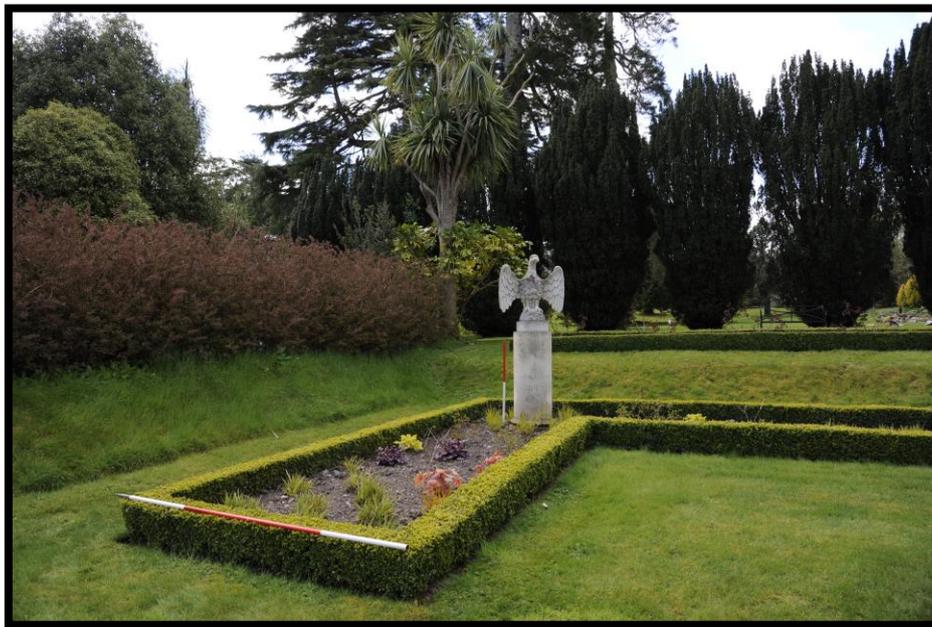
Level three consists of a grass lawn with two L-shaped flower beds, which are edged with box hedging. Each flower bed has a pillar centrally placed and topped dramatically with a Portland stone eagle, with wings outstretched.

Figure 14: View of Portland stone eagle, looking south-east

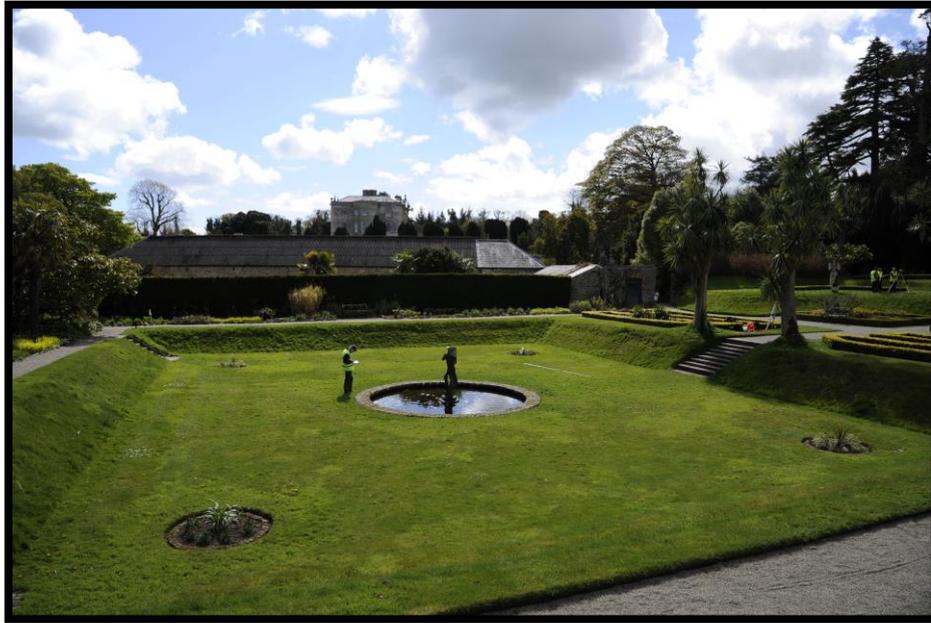
Fig.15: View of garden terraces, with Castle Ward House in the background

Close to the house, in the area occupied by the old Georgian kitchen garden, a formal Victorian terraced garden was generated, the focus of which was an ornate sunken parterre called the Windsor Garden. Subsequent developments were limited, but they did include the Rockery and the Pinetum.

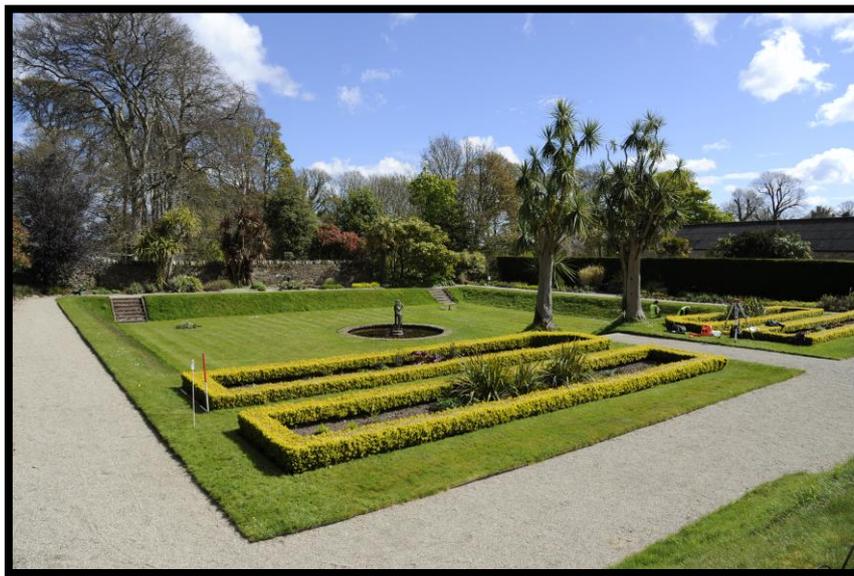
Fig.16: View of walkways and also steps into the Sunken Garden, looking north-east

Gravel paths are provided around the perimeter of the sunken garden and to access the remainder of the gardens. The gardens are contained within an area of approximately 75m north-west/south-east, by 130m north-east/south-west.

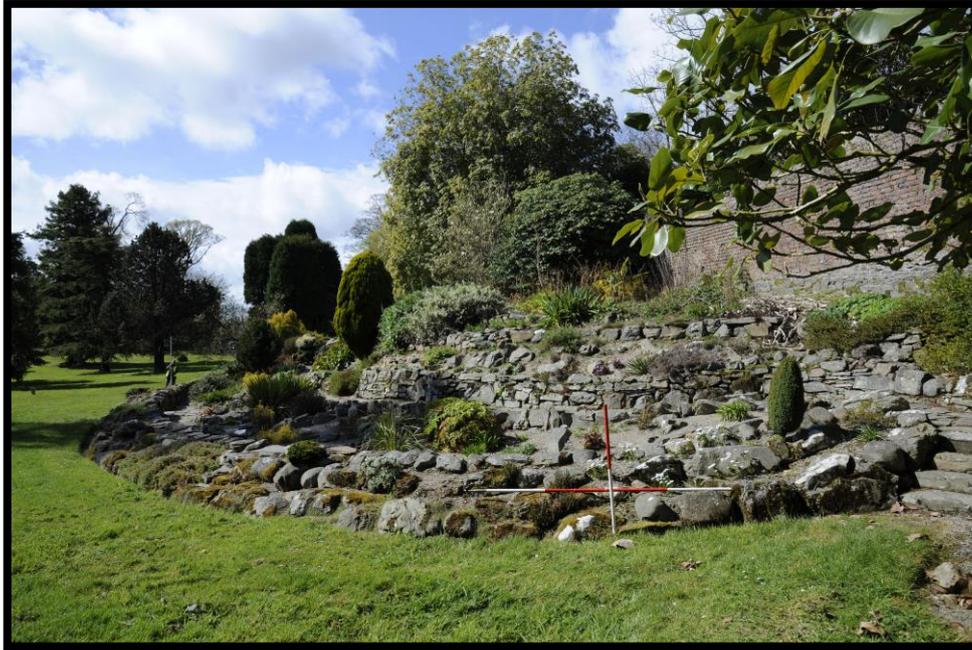
Fig.17: View of Rockery, looking south-west

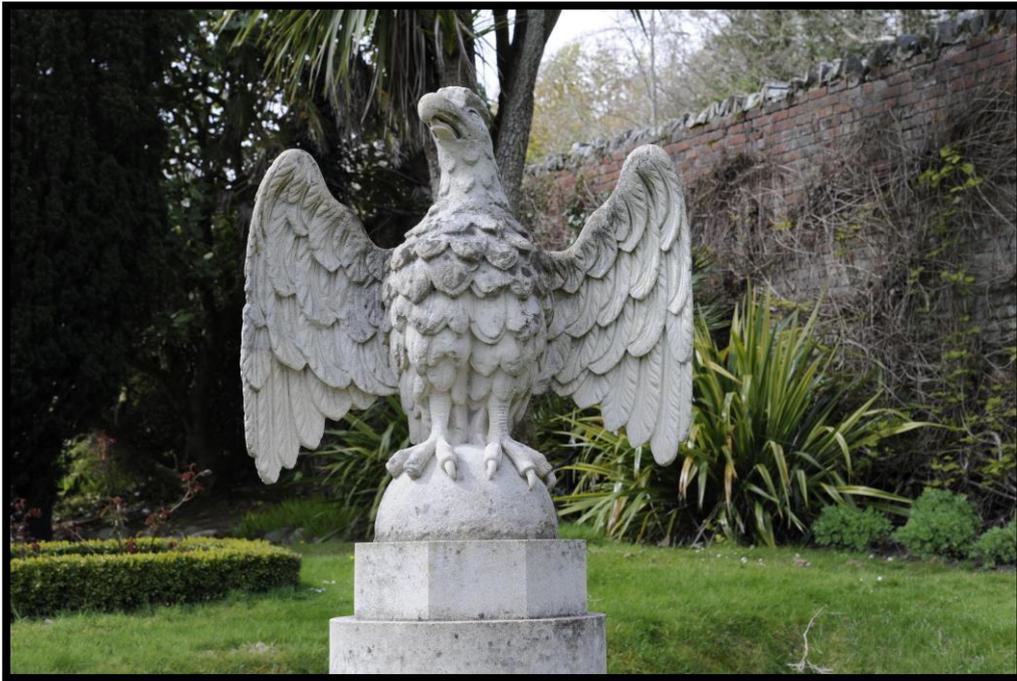
Fig.19: Close-up of the Portland stone eagle, following restoration

In 1858 stone sculpture, which included two planted urns and also two eagles, were sited on the terrace above the garden. These disappeared in the twentieth century, but fragments of the stone eagles were excavated in the vicinity and have been restored. They were replaced as recently as 2009. The urns were probably those now sited at the front entrance to Castle Ward House. The Castle Ward Windsor Garden has been recorded in the National Trust record as NT 131520 and is described thus:

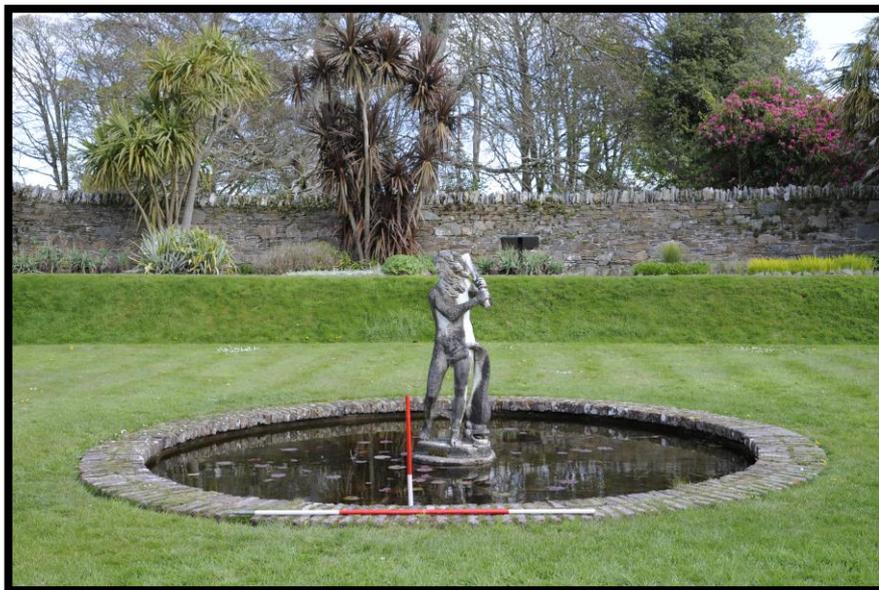
After the Great War, the Windsor garden was converted into a rose garden by the 6th Countess. In the 1970s the Trust rebuilt the steps in brick, turned the parterre area into a lawn and at the centre created a pond placing the figure of Neptune in the centre of the pond, which was originally acquired for Cothele, Cornwall, was transported to Castle Ward in the 1970s.

Fig. 20: View of the ornamental pond, with Neptune at its centre
