ULSTER
ARCHÆOLOGICAL
SOCIETY

Survey Report

Reference: **Survey Report No. 72**

**Redburn Garden
Redburn Country Park,
Holywood, Co. Down**

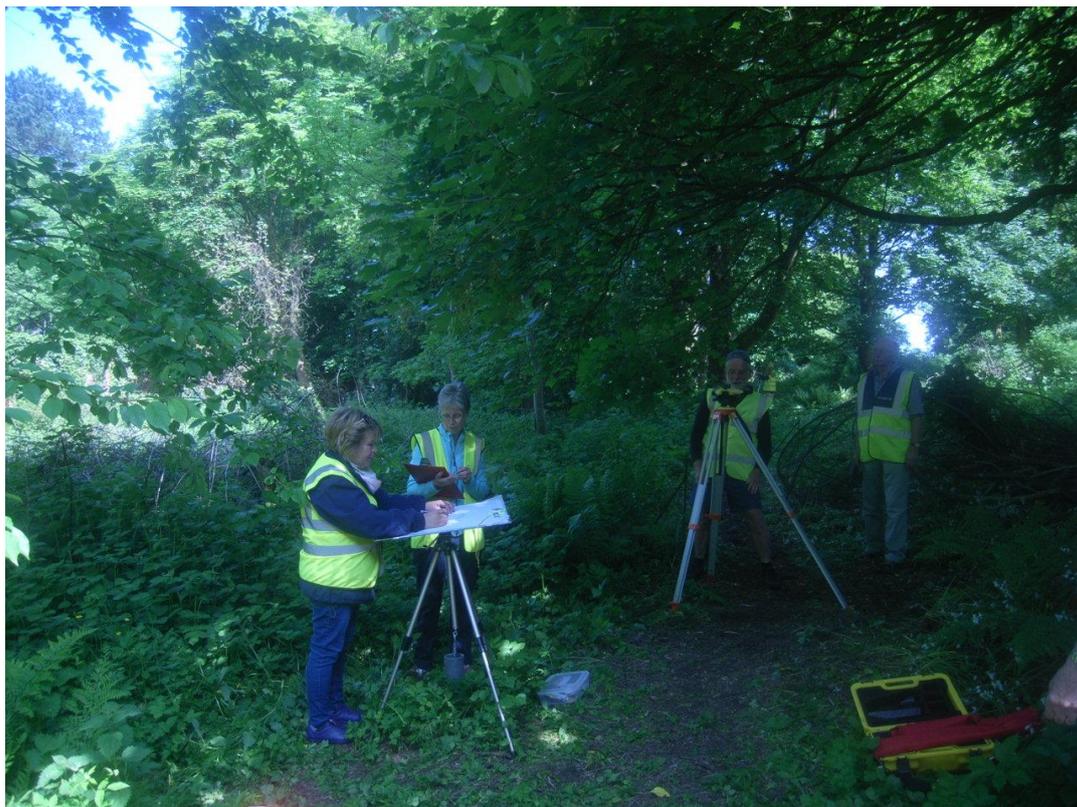
Figure 03. Survey team in the Garden.

The remains of what is thought to have been an arbour can be seen to the middle-right of the photograph, probably not in its original location.

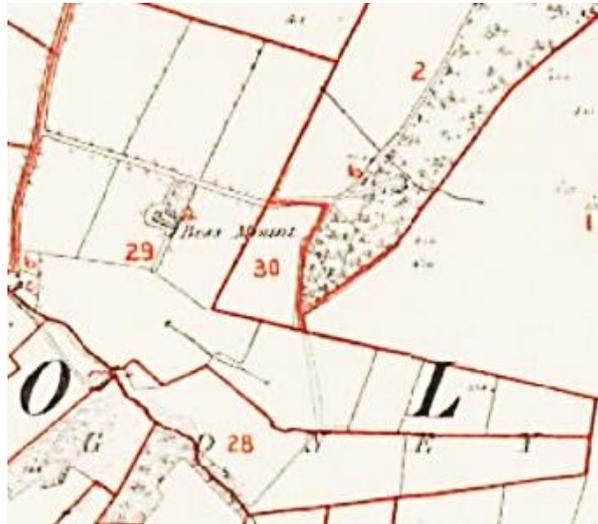
Figure 04. Griffith Primary Valuation of Ireland – 1862

The Griffith Valuation map of 1862 (see Fig. 04 above) shows a property called “Bess Mount” on the site subsequently occupied by Redburn House.

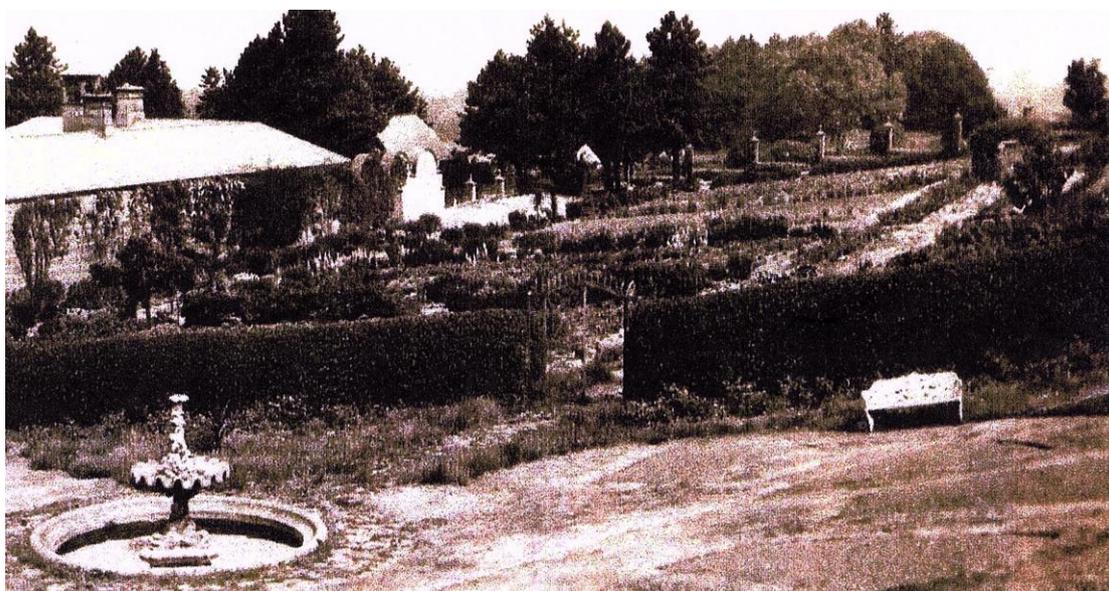
Figure 07. Early photograph of Garden and Stable Block.

Figures 07 and 08 are two early photographs showing the Garden and its position in relation to the House and Stable Block. No exact date could be found but using information given below in 2.4 they would not be earlier than about 1908/1910 – the boundary wall can be clearly seen in Figure 07. The photographs, and much more, can be found at the website www.dumville.org/photo-pages/redburn-house.html.

The conservatory opened into a garden area, containing a fountain (see Figs. 7 and 9). A gate, set in a low hedge, led into a rectangular area, probably a kitchen garden for growing flowers, fruit and vegetables. The “kitchen garden” is clearly depicted in the 1904 Ordnance Survey Map (Fig. 9) and the gate can be seen in the photograph (Fig. 7). The remains of the gate are still in situ (photograph Fig. 15). To the east of the “kitchen garden” there is an upward sloping area, perhaps less formal and with some shrubbery. During the survey steps which would have led up into this area were uncovered (see Fig. 16). The “kitchen garden” was later extended northwards, probably around 1910 (see 2.4 and Figs. 10 and 11). The heyday of this extended garden was probably from 1910 and well into the 1920’s. The photographs (Figs 7 and 8) are most likely from this period. Later, the eastern sloped area appears to have become more wooded (Fig. 12). Finally, when the House was abandoned just after World War II, nature took its course and the entire Garden area reverted to trees and shrubbery (Fig, 13).

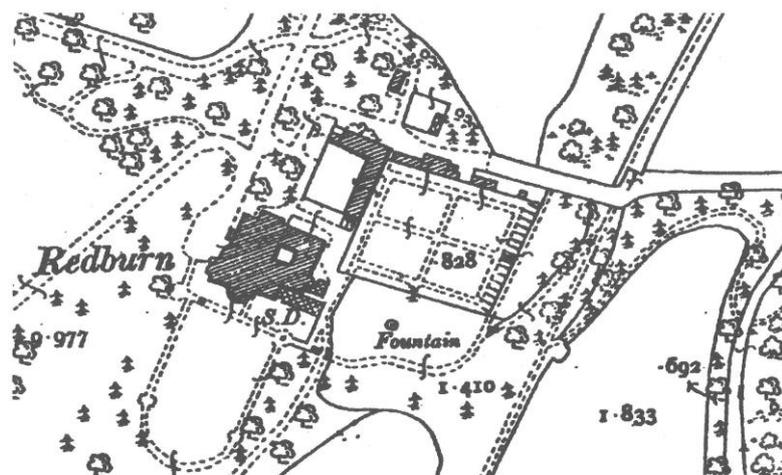
Figure 09. Redburn Ordnance Survey Map 1904.

These two maps show how the Garden was extended (to the north) between 1904 and 1921. The House and Stable Block are clearly visible in both. However, buildings, extending from the north east corner of the Stable Block in an easterly direction and seen in the 1904 Map, have been demolished to accommodate the garden extension. The extension includes a glassed area, seen hatched and north of the Stable Block (cf. hatched conservatory at the south corner of the House). The extension is enclosed by a boundary wall to the north and east. It is clearly seen in the old photograph (Fig. 07) and the northern section is still present today (Fig.02). Bricks used in the wall construction were manufactured by McGladery and Sons and post-date 1905 when press machinery was introduced into the brick-making process (communication George Rutherford 2018). The wall is a low one with a metal fence on top and between pillars. Terence Reeves-Smith (Historic Environment Division) suggested a date of around 1908-1910 for the wall (and Garden extension by implication) when visiting Redburn in April 2018 (communication from Robin Masefield). This date is consistent with the above information.

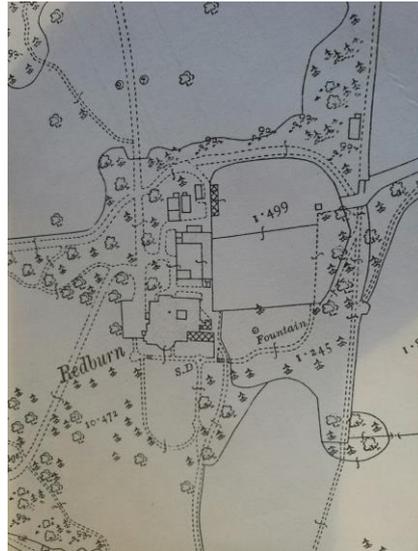
Figure 10. Redburn Ordnance Survey Map 1921.

The 1921 Map depicts a boundary (probably hedge) between the old Garden on its north side and the extension. This appears to have gone by 1932 (Fig. 11). By 1938 the eastern part of the garden, which is on an upward slope, is separated off (shown as 0.320 acres) and appears to be planted with trees/shrubs (Fig. 12).

These steps would have entered into the Fountain Garden, from around the conservatory at the south-east side of Redburn House (see Fig. 10).

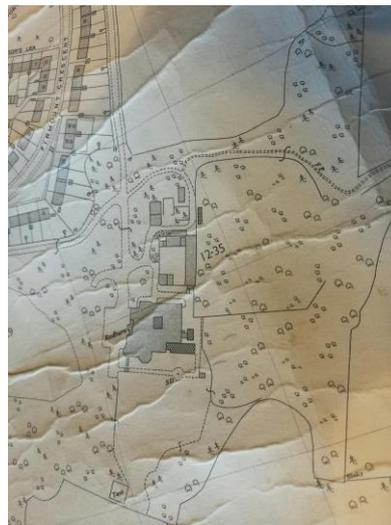
Figure 13. Redburn Ordnance Survey Map 1957.

By 1957 the Garden boundary is open on the eastern side and the whole area planted out in trees/shrubs (Fig. 13).

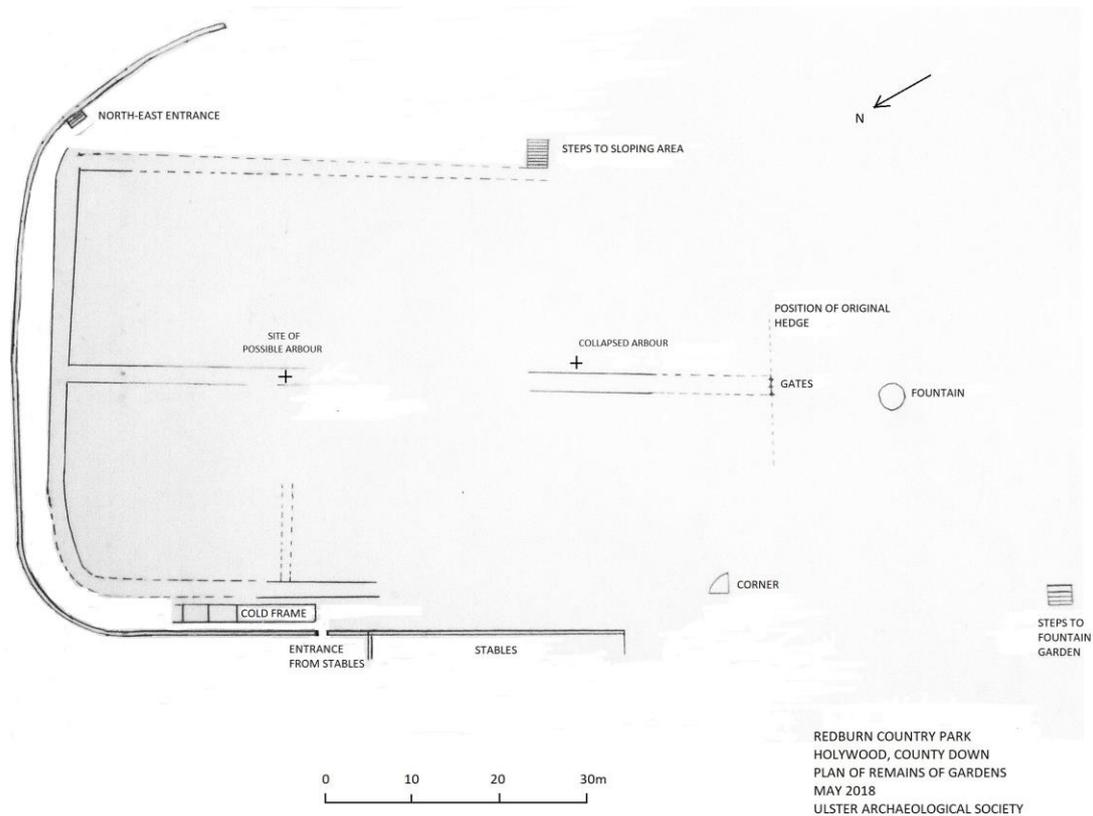
Figure 14. Redburn Garden Site Plan

The resultant Redburn Garden Site Plan is shown below (Fig. 14). As mentioned previously, the Garden is now considerably overgrown. Features which were clearly visible are depicted as solid lines in the plan, for example steps, paths where edging and/or paving could be seen. The dotted lines represent paths where only occasional bits of edging were identified and are "joined up" in the plan to suggest a possible line of path.

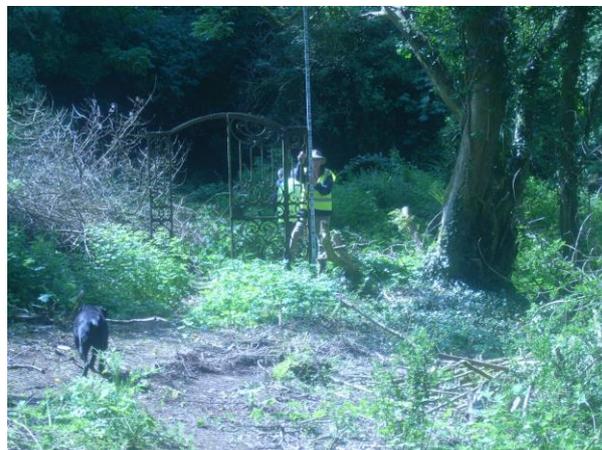
Figure 15. Remains of gate, looking south towards fountain.

Volunteer groups have already started to clear the Garden site. Various structures including steps, brick edging to paths etc were recorded and photographed for the Survey Report. The path edging, for example, is indicative of the features still waiting to be discovered. The remains of what is thought to have been an Arbour is of particular interest; it appears that enough survives to enable restoration. The gates near to the Fountain are also worthy of restoration.

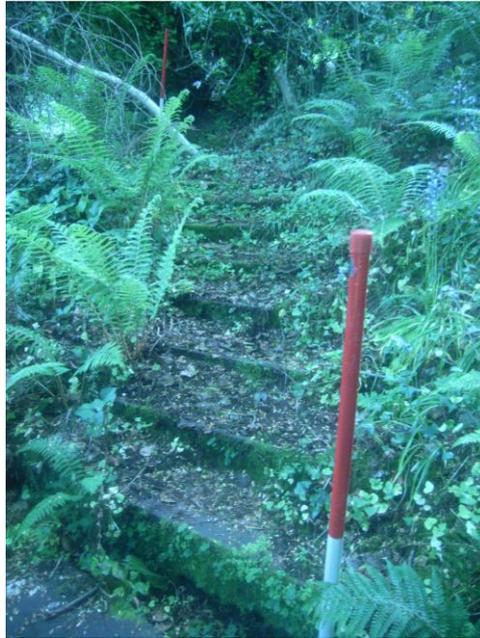
Figure 16. Steps leading into upward sloping area, looking east.

There were at least eleven steps. They were 215 cm wide, formed by 26 red bricks on edge. Treads were about 30 cm deep and risers were 11 cm high. These steps lead into a distinctly upwardly sloping part of the garden and are depicted in the site plan (Fig. 14). This part of the Garden, on the east side, can be seen in the Ordnance Survey Map 1938 as a separate, wooded area (Fig. 12).

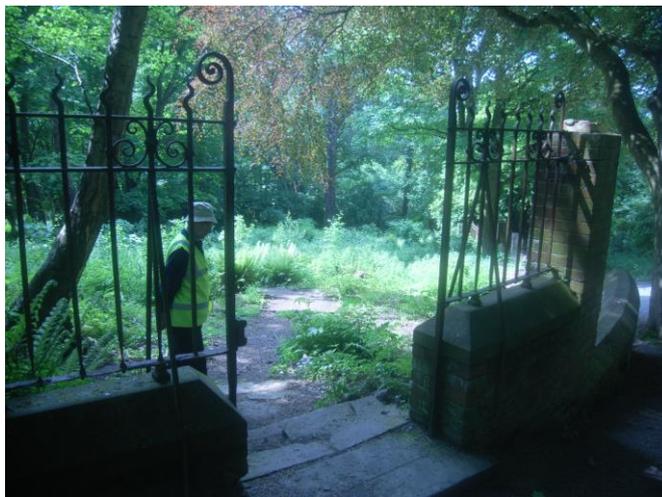
Figure 17. Top entrance at north-east corner of Garden, looking west into Garden.

Steps, leading down into the Garden, are also visible in this photograph.

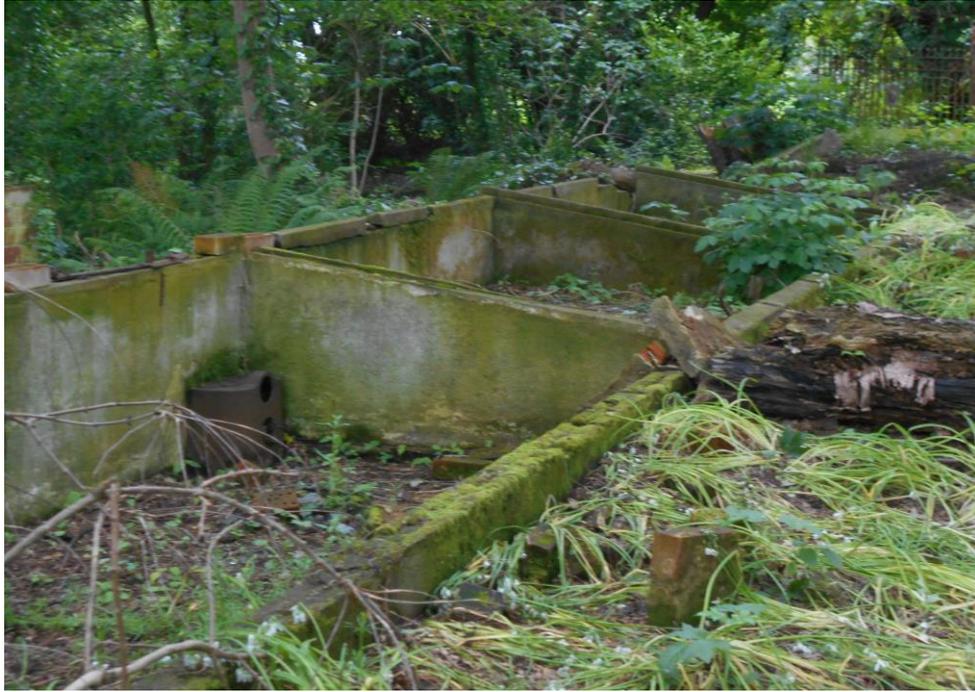
Figure 18. Cold Frame, looking north.

This Cold Frame is just visible in the old photograph (Fig.7) confirming that it was a low structure, with glass frames resting on the walls. Part of it could have been heated; the “iron box” shown in Fig. 18 above may have been part of a heating system.

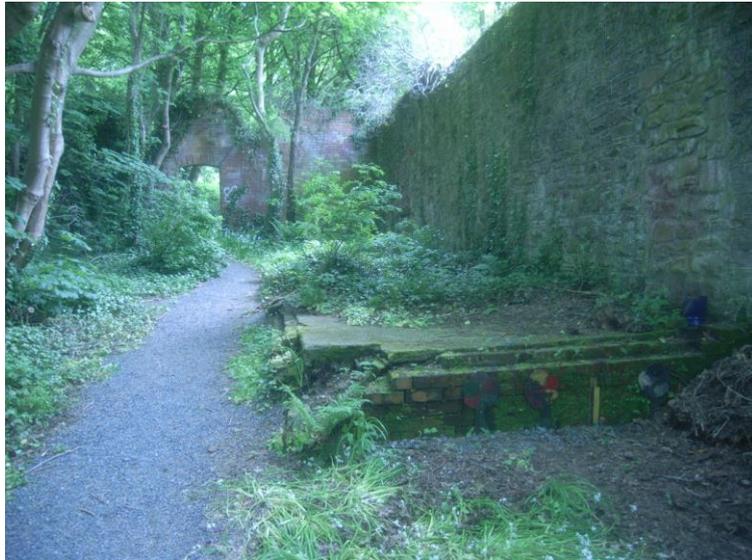
Figure 19. Garden Entrance from Stables, looking east.

The small arched doorway into the Garden is visible, with the Stable wall to the right of the photograph.

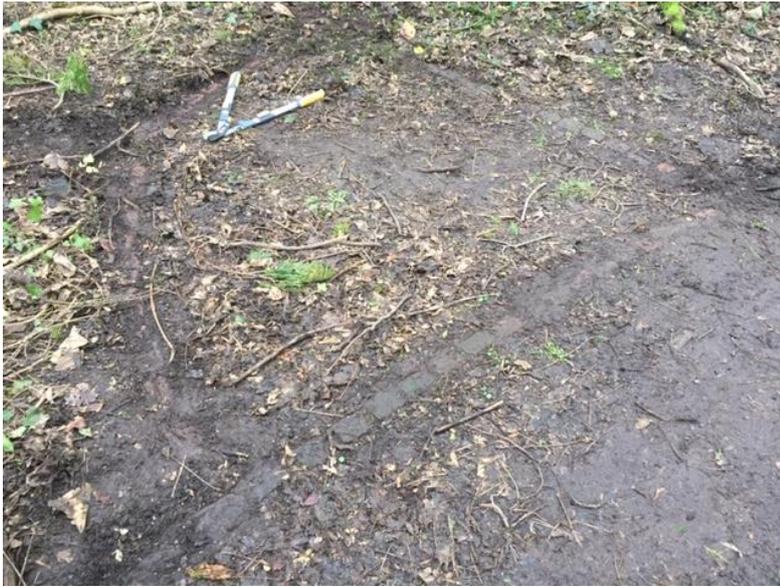
Figure 20. Corner, uncovered feature, looking east.

This is a brick-edged area, in the shape of a quadrant. It could be at a path corner, and is indicative of the features waiting to be uncovered.

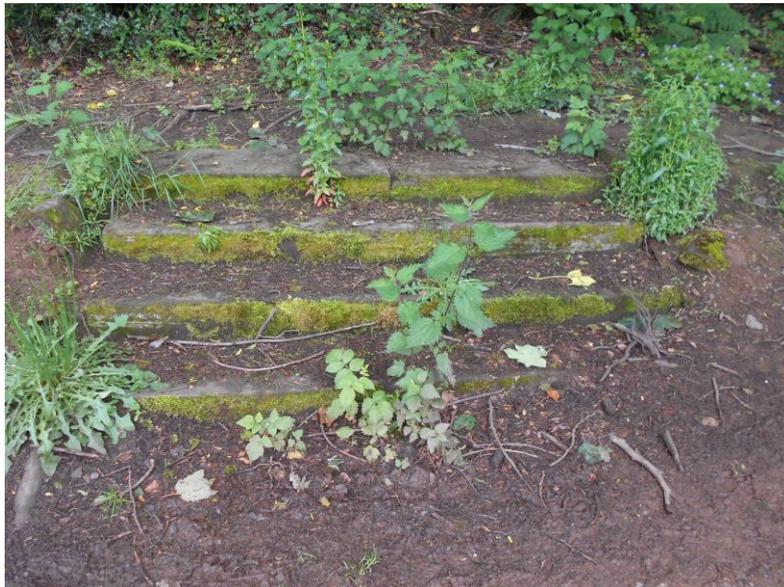
Figure 21. Steps to Fountain Garden, looking east.

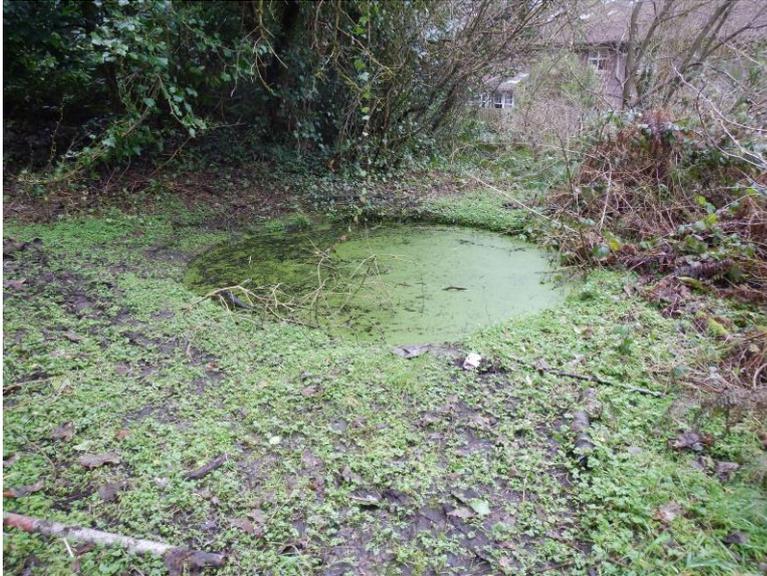
Figure 22. The Fountain, looking west.

The Care Home, built on the previous Redburn House site, can be seen in the background.

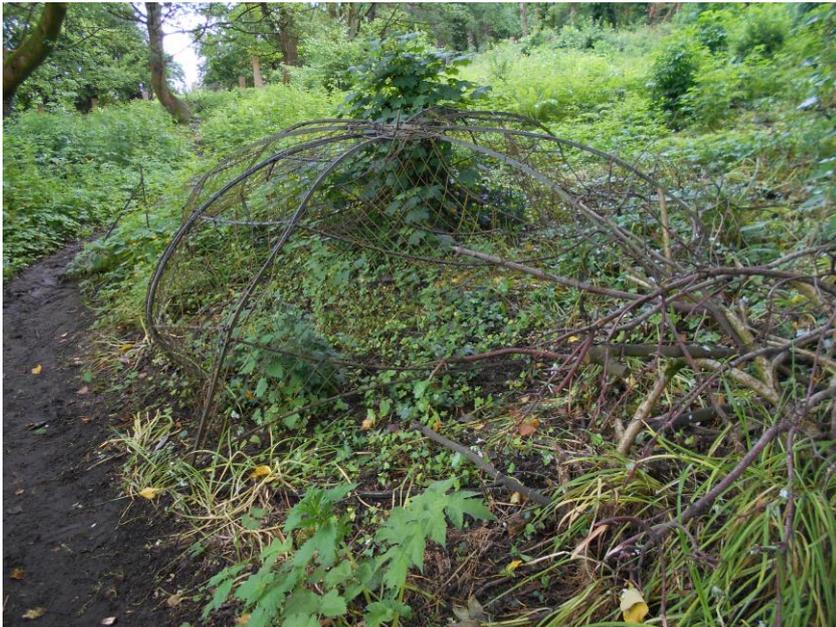
Figure 23. Collapsed Arbour, looking north-east.

This photograph shows the remains of a possible Arbour in its present location (see Site Plan Fig. 14 and Fig. 3). A closer examination revealed that most of the Arbour is still there, including the uprights.

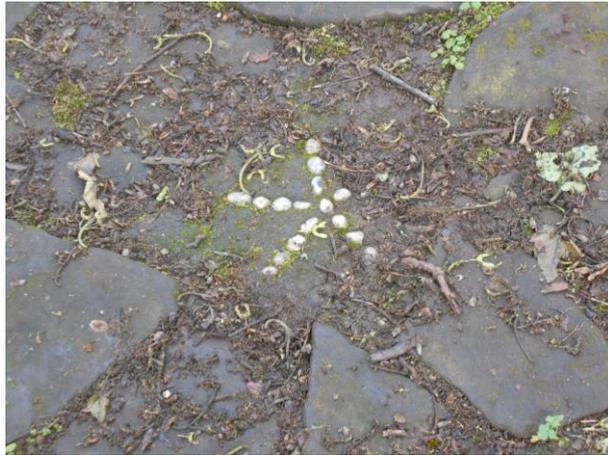
Figure 24. Possible Arbour site.

This “white star” is located in the exposed pathway at the point described as “Possible Arbour site” in the Site Plan (Fig.14). The Arbour is clearly visible in the old photographs (see Figs 7 and 8) and appears to be occupying the location shown in the Site Plan.
