ULSTER  
ARCHÆOLOGICAL  
SOCIETY

# Survey Report

Reference: **Survey Report No. 68**

**Survey of Revolving Summer  
House, Sea Plantation,  
Mount Stewart  
County Down**

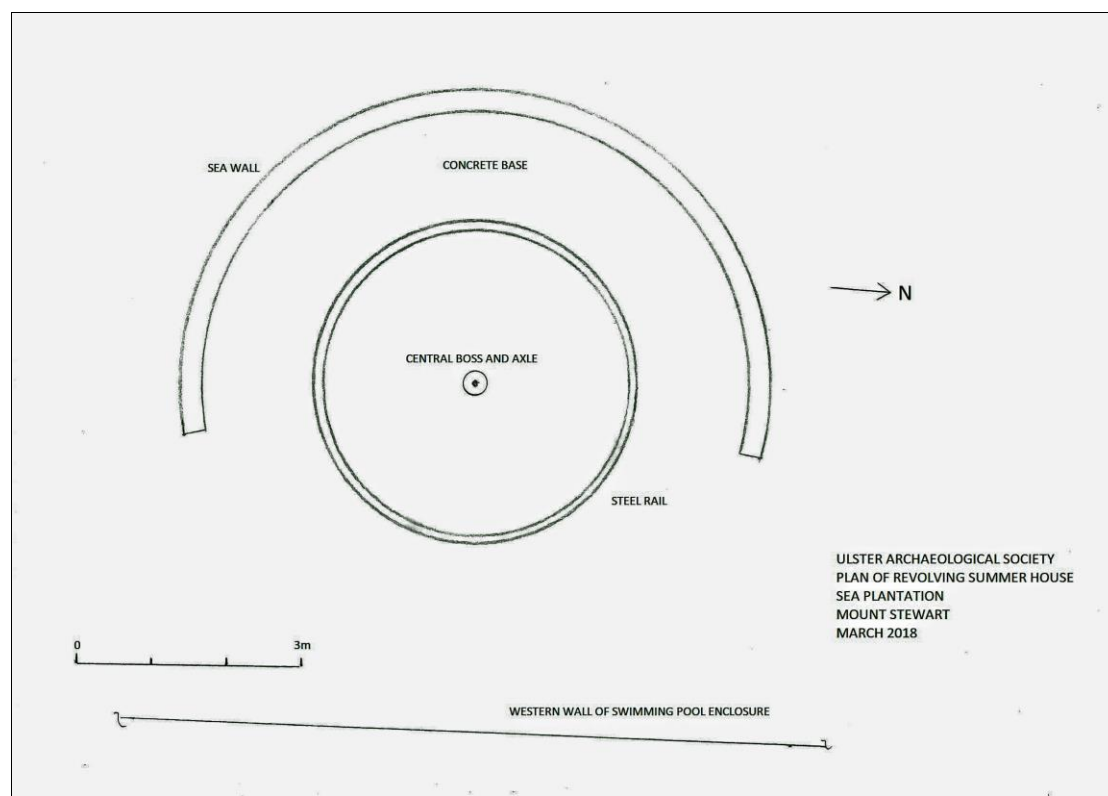
Figure 06: Plan of revolving summer house base

Plan drawings and elevations were completed, using data obtained from the field survey. Measurements were obtained by using the society's *Leica Sprinter 100* electronic measuring device. Sketch plans at 1:50 scale were completed on site by

recording these measurements on drafting film secured to a plane table and backing up the data on a field notebook for subsequent reference. Field plans were later transferred to a computer-based format for printing.

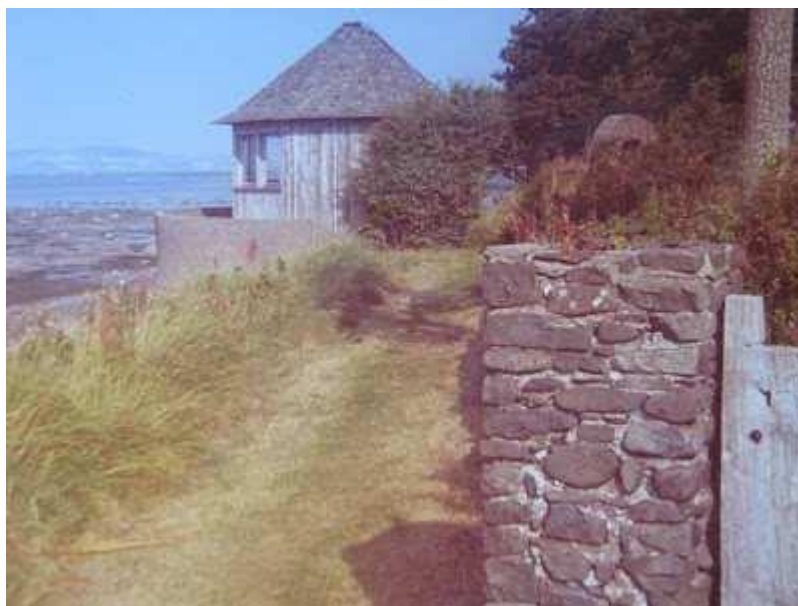
Figure 08: Revolving summer house and the wall protecting it from the sea. The wooden gate is the most westerly entrance, without an arch into the swimming pool enclosure. *National Trust*

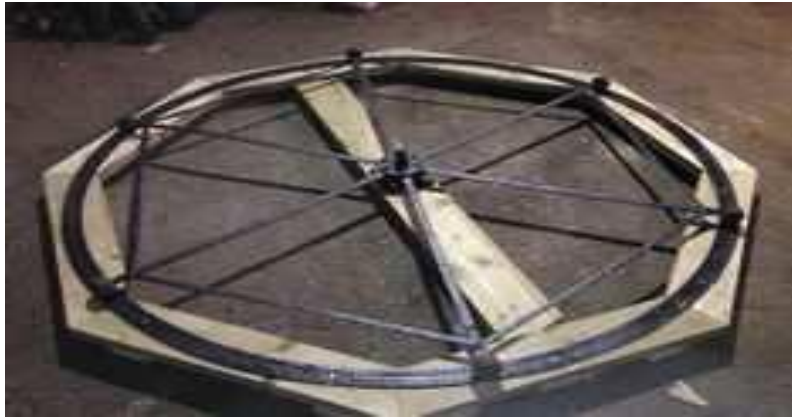
The wooden summer house was set on a chassis which ran on a circular metal rail, the chassis was six-sided, each corner had a wheel like a very large castor and a spoke connecting it to a central shaft or axle on which the bearing of the summer house turned. It was moved manually to follow the sun in this open location.

Figure 09: The chassis of a modern revolving summer house on which the wooden structure would be built. The original Mount Stewart one would have been very similar.

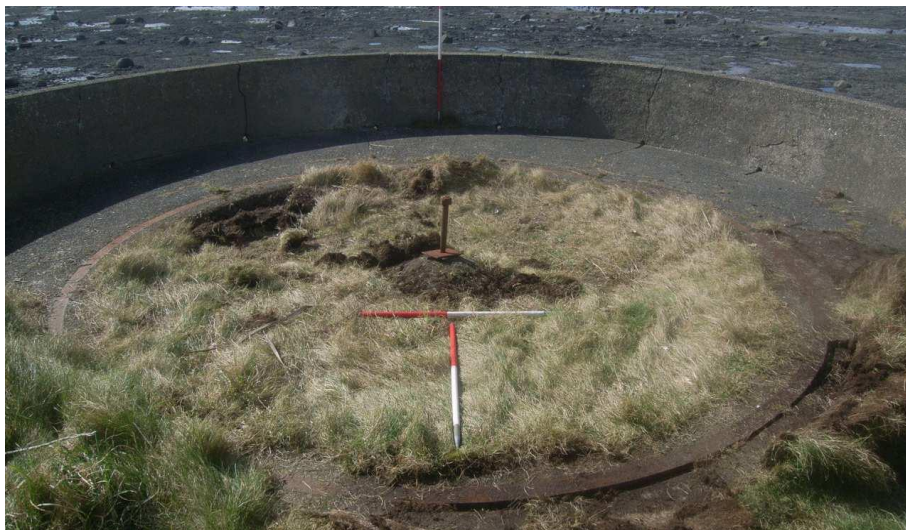
The circular platform structure of the revolving summer house is still in place.

Figure 10; The Mount Stewart summer house protective wall, circular platform, iron rail and central axle, looking west.

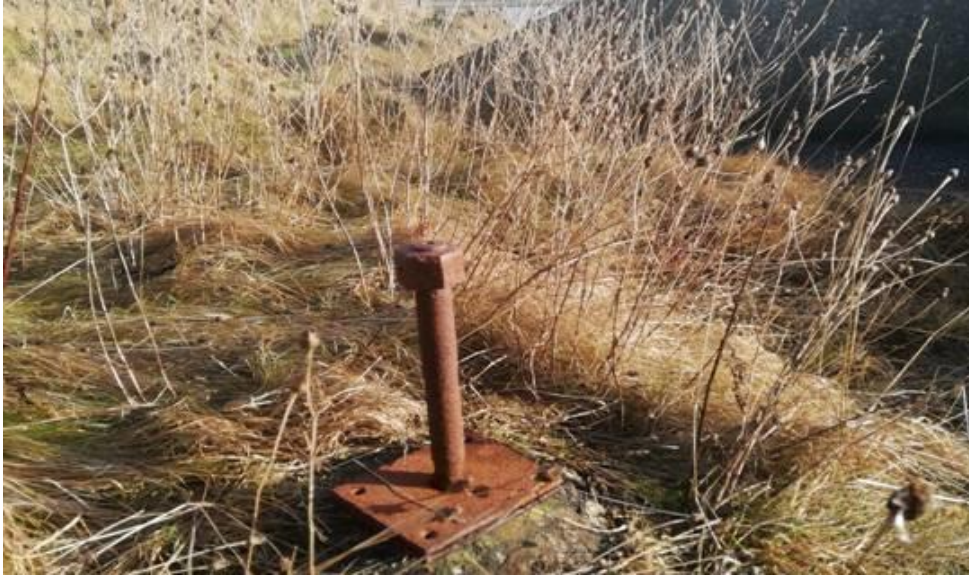
Figure 11: View of the central iron axle with a mounting plate

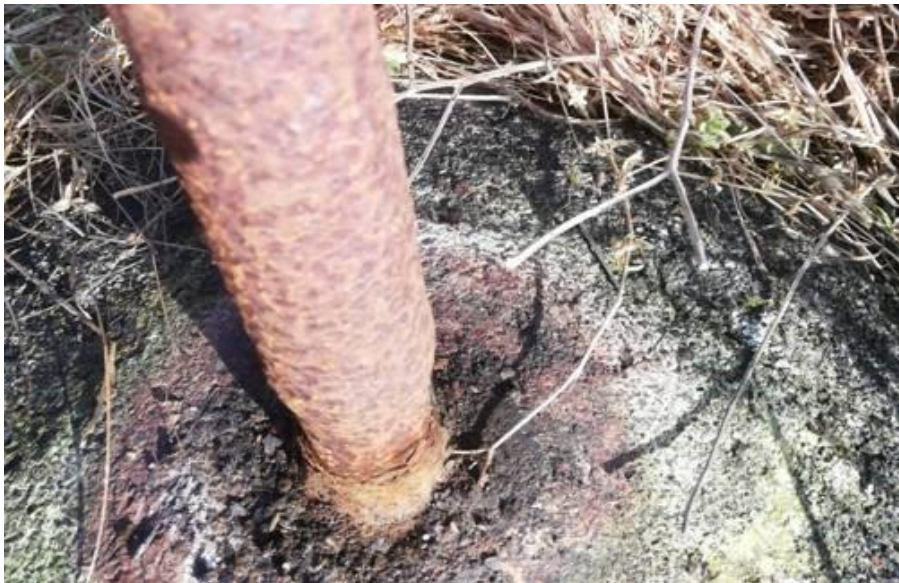
Figure 12: Close-up of the base of the axle showing corrosion

The construction of the swimming pool followed a tendering process involving the best engineering firms of the time (PRONI D 654/N5/18). The standard of work is still evident in the remains, almost a century later. However, despite several attempts many years ago at repairing the damage caused by erosion, the base of the structure is being undermined by tidal erosion and the metal features are being damaged by corrosion.

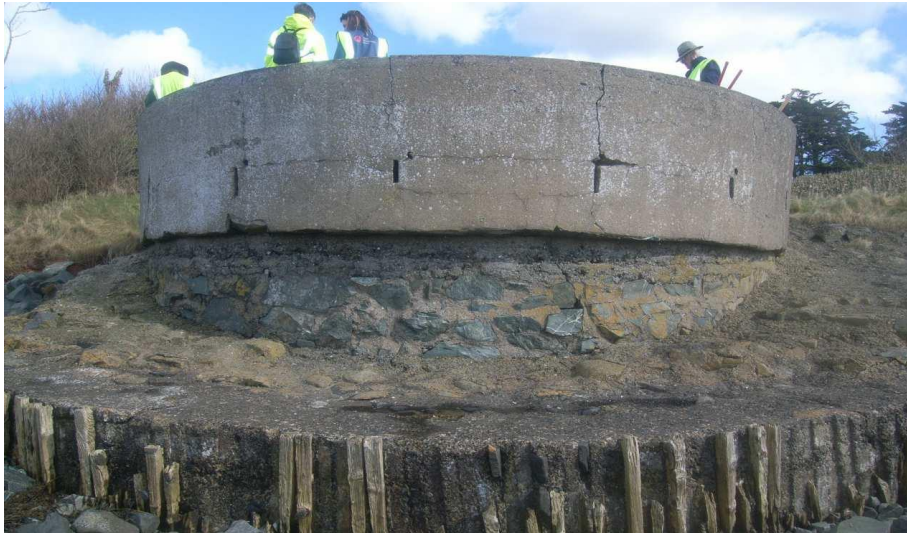
The photograph below shows the position of the summer house on the bank above the beach, the structure of the wall and the foundation base and the present condition of both.

Figure 13: Summer house, viewed from the beach, showing the base, protective wall and the foundation, looking east

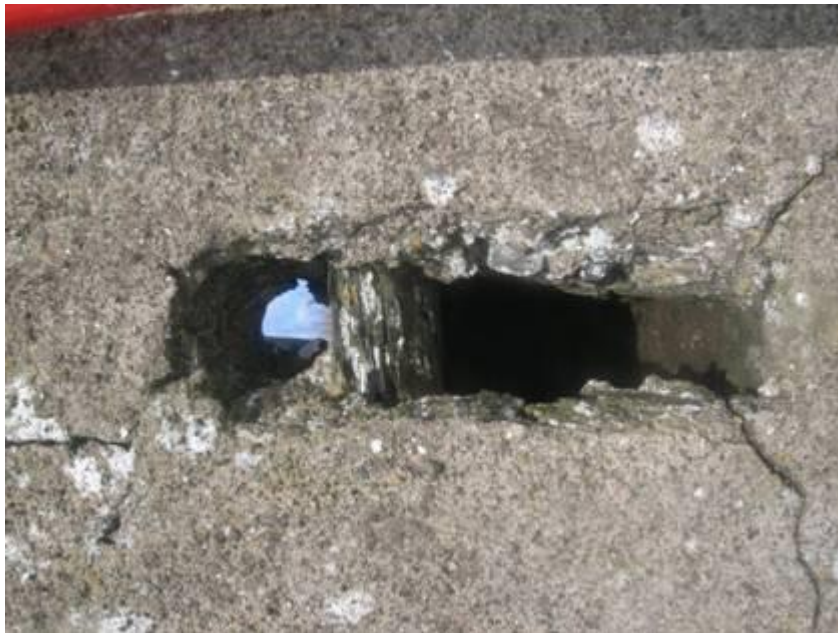
Figure 14: Hole in the wall showing cracks going right through the wall.

The 2018 survey of the remains of the revolving summer house identified the structural damage that has taken place there due to erosion and lack of maintenance. It is recommended that consideration be given by the National Trust to stabilising the existing structure before it is lost completely.

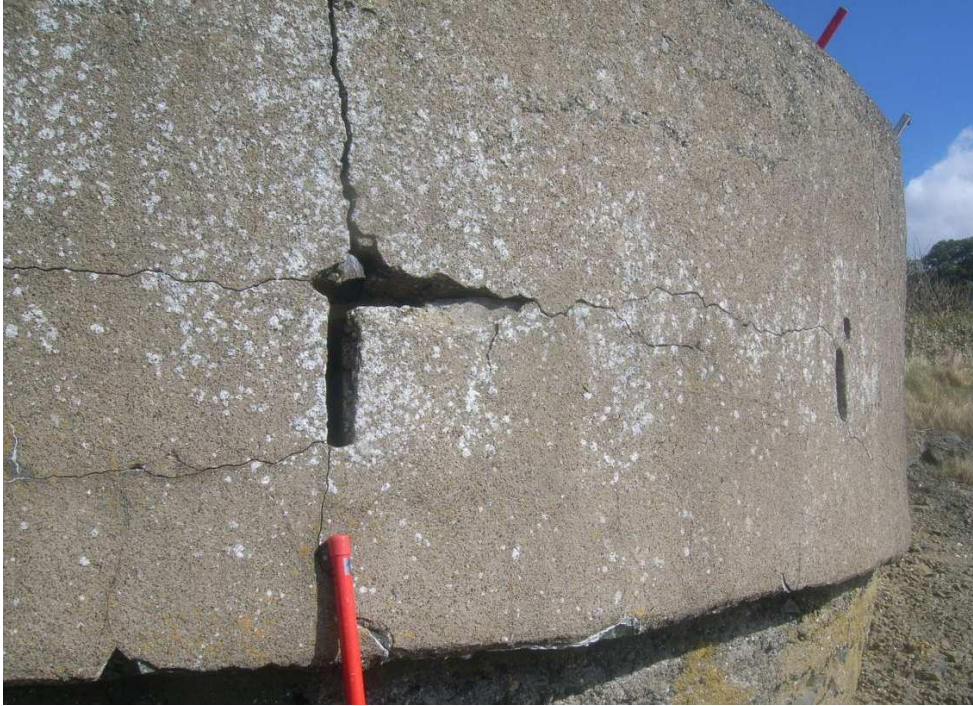
Figure 15: Vertical and horizontal cracks. The horizontal cracks follow the junction of the protective wall and the platform, looking east

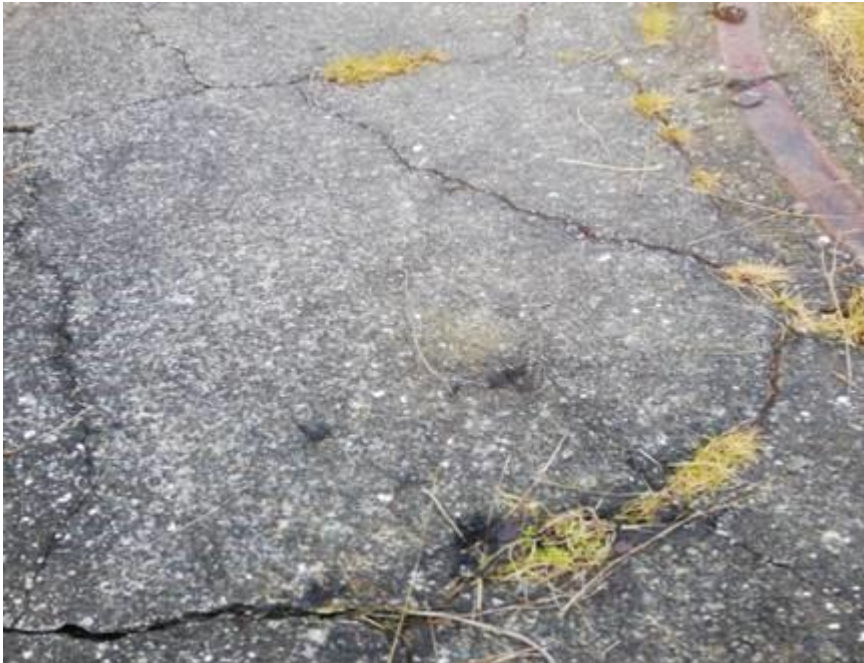
Figure 16: Cracks on the concrete circular platform for the sun house near the iron rail

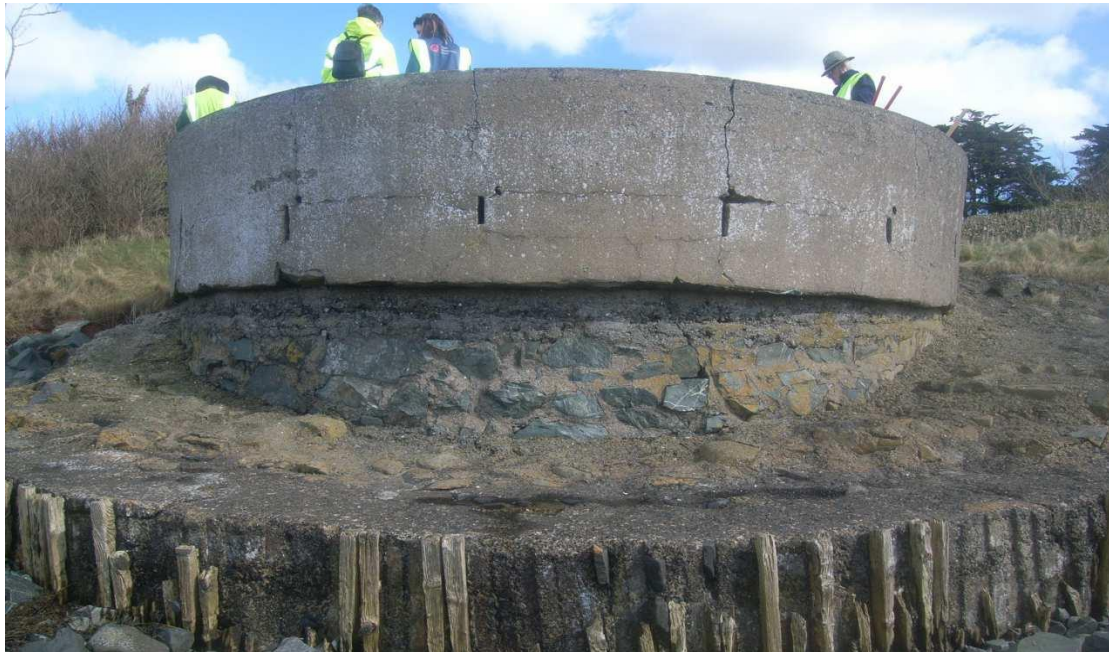
The foundation base of the summer house below the protective wall is made up of different layers of concrete with different mixes in and several concrete patches. The base has been eroded by the water and weather condition has begun to fall away

especially from the red clay of the bank. Repairs using concrete have been made at different times.

Figure 17: The summer house base foundation, looking east

Figure 17 shows the remains of the wooden shuttering at the base of the structure that would have contained the wet concrete mix until it set. This illustration also shows three separate concrete mixes, characterised by their individual matrices of composite materials. Also shown is the layer of red clay on which the base was constructed, now exposed due to erosion.

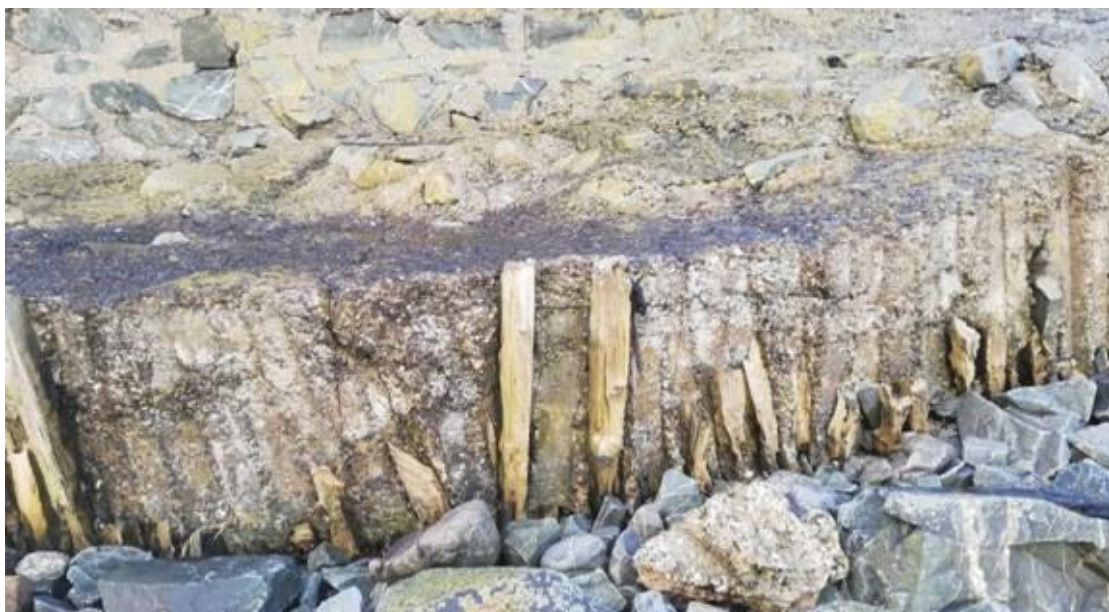
Figure 18: Remains of wooden shuttering at the base

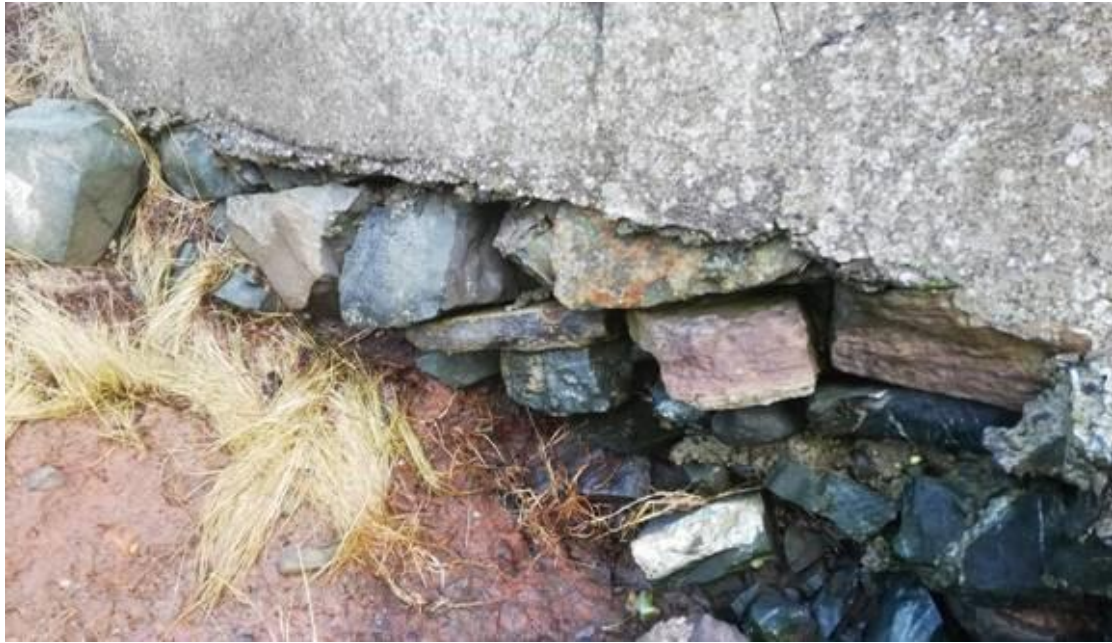
Figure 19: View of poorly-mortared matrix

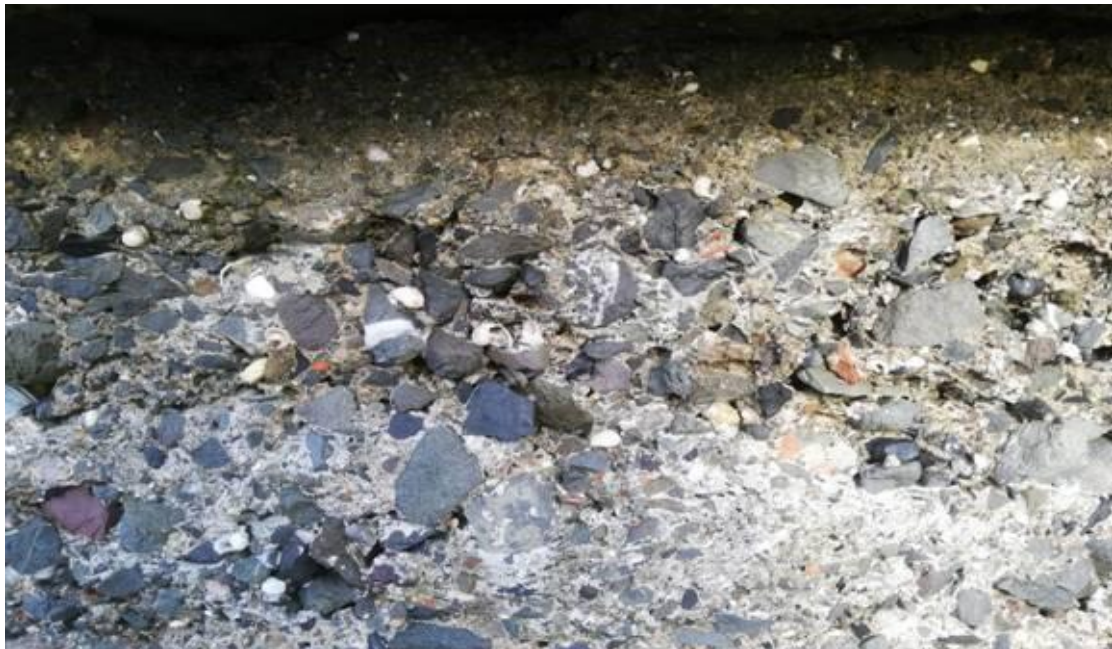
Figure 20: View of intermediate concrete mix

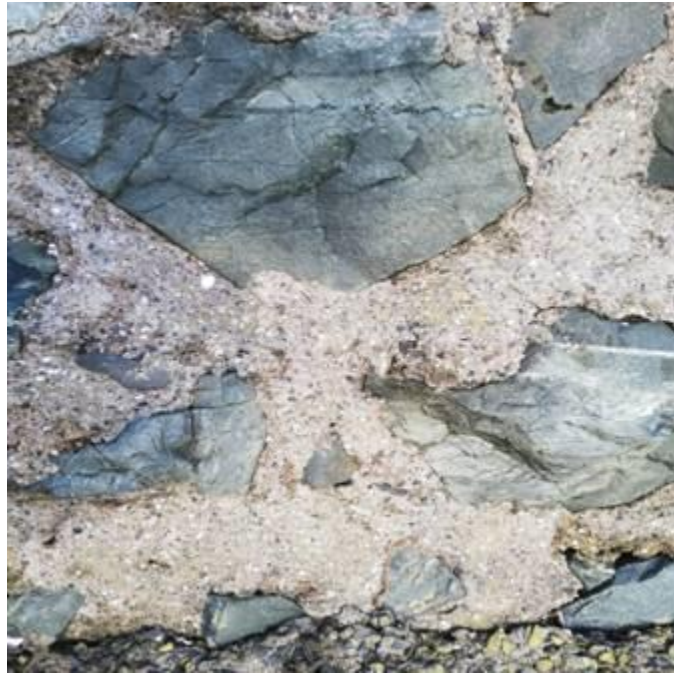
Figure 21: View of base concrete mix, with larger stone matrix

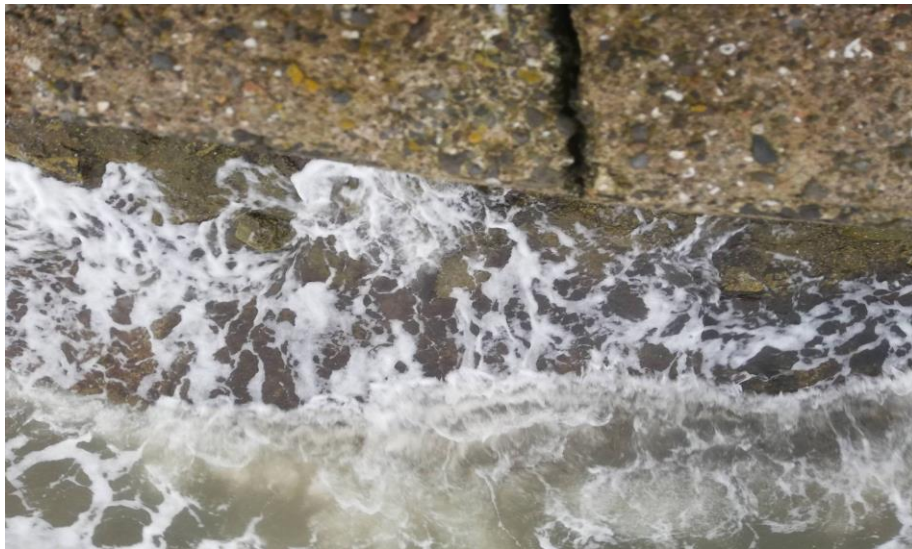
Figure 22: Waves undermining the base on a typical tide.

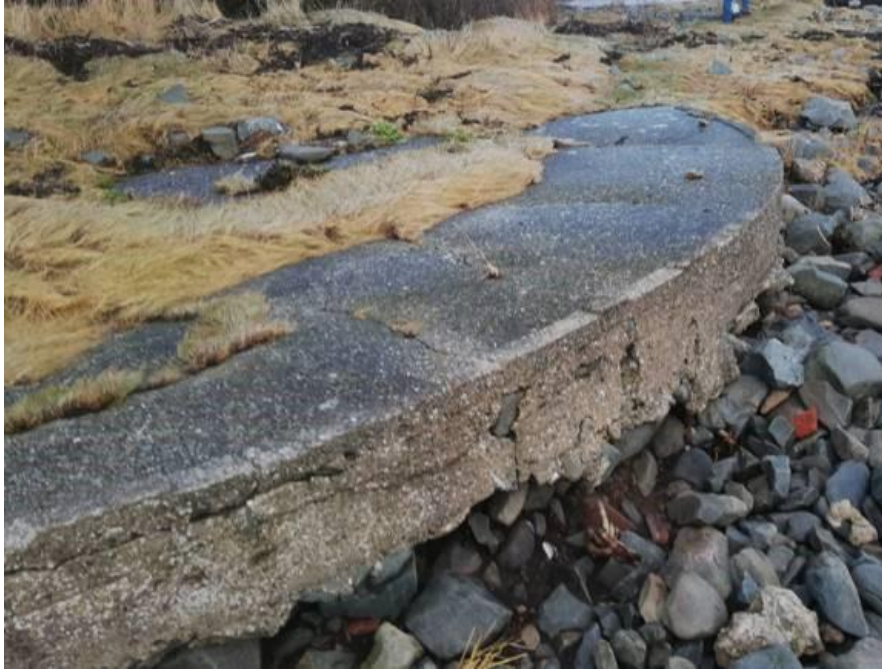
A few metres to the east of the revolving summer house there are the remains of another circular concrete base, the base of another possible summer house. None of the photos of the swimming pool complex show any building or structure on this base. Perhaps nothing was ever built on it, as it is very close to sea level so would often be submerged and covered in seaweed. It is also not in a good position for the afternoon summer sun. There is no sign of a metal rail or central axle so perhaps it was a static summer house, not a revolving one.

Figure 23: Circular concrete base of a possible summer house. Note the sea weed on the grass on land ward side of the base, looking north-east

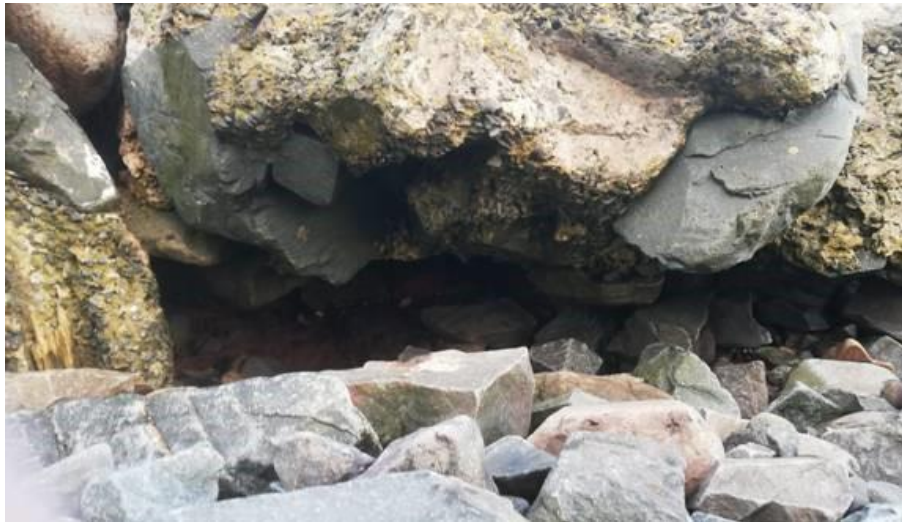
Figure 24: Undermining of the base of second summer house
