# Survey Report

Reference: **Survey Report No. 50**

**Glasshouses  
Walled Garden  
Florence Court  
Co.Fermanagh**

**THE NATIONAL TRUST**

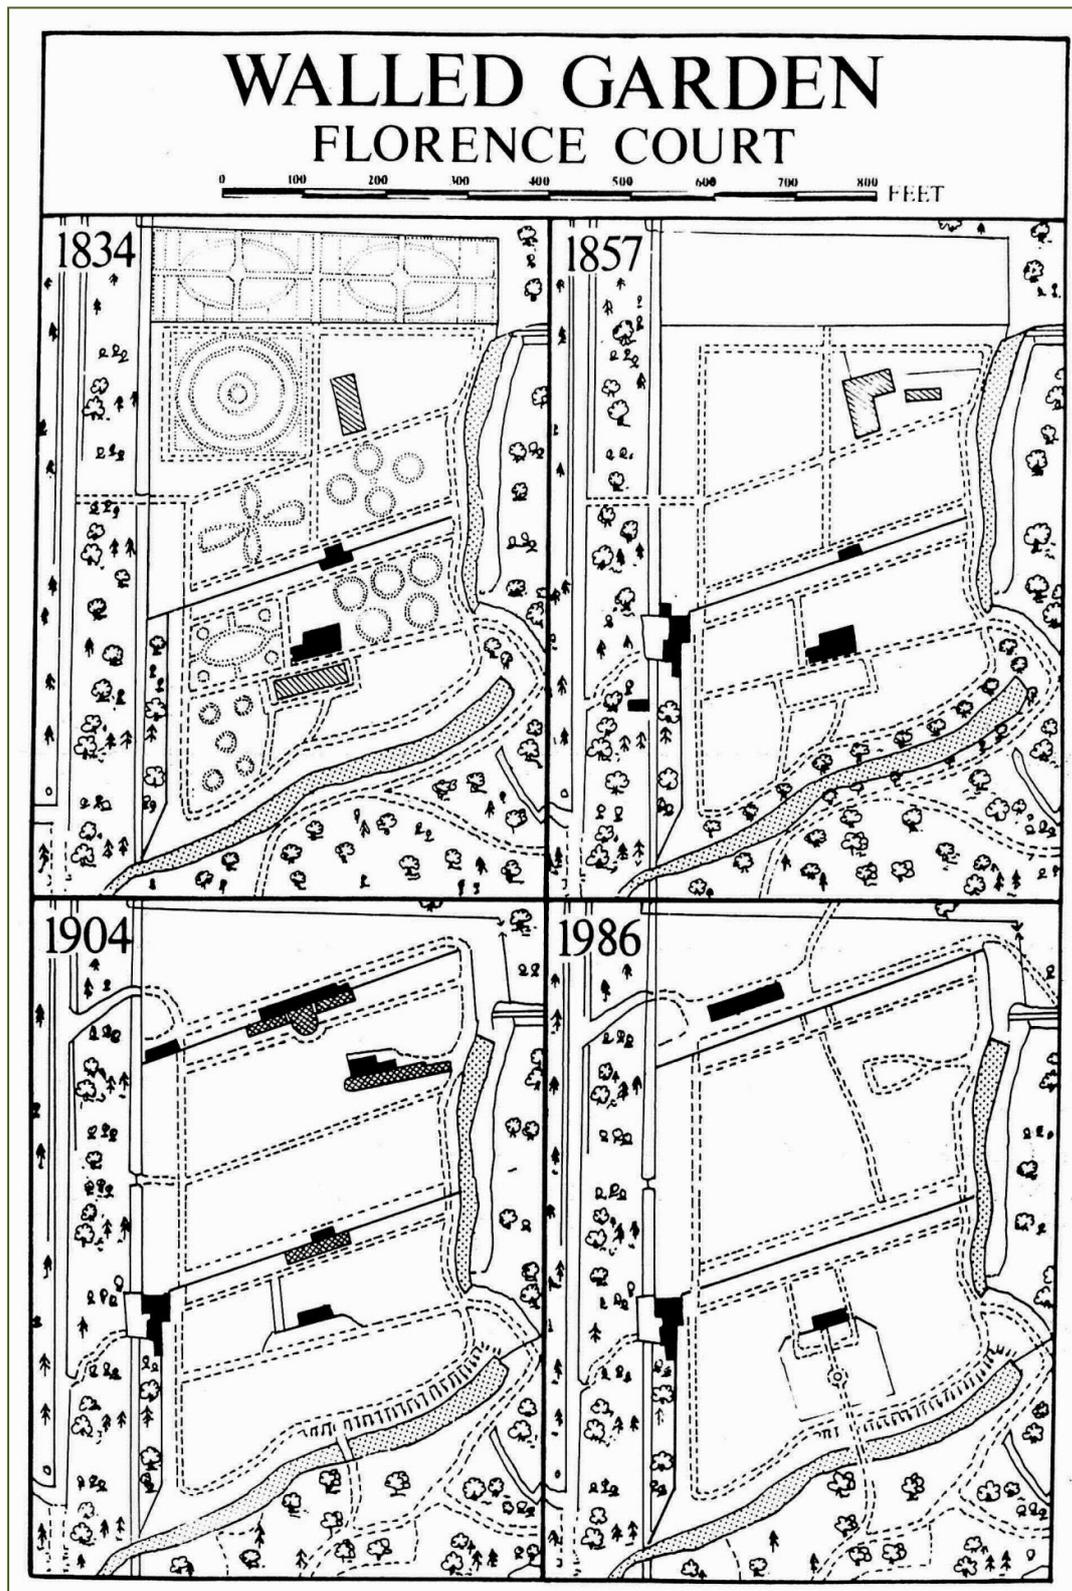
Figure 02: Florence Court Walled Garden: Progression of Layout: 1834, 1857, 1904, and 1986 OS Map extracts (after T. Reeves-Smyth 1990).

The Walled Garden design, as portrayed on the 1834 and 1857 Ordnance Survey maps (Figure 04) appears to have remained largely unchanged until 1869, when Viscount Cole, later to become the fourth Earl of Enniskillen, married Charlotte Baird, a rich heiress from Dumfriesshire in Scotland. As a result of this marriage, the Cole family fortunes were revitalised and one of the first projects undertaken was the building of the north wall to the garden, at the princely sum of £300. It was also at this time that the glasshouses in the Lower Garden were constructed. Originally, the vinery and apricot greenhouses against the north wall had a curvilinear central section, which were dismantled around the time of the First World War. Another glasshouse, which had been built against the south wall in the Upper Garden, was also dismantled at this time.

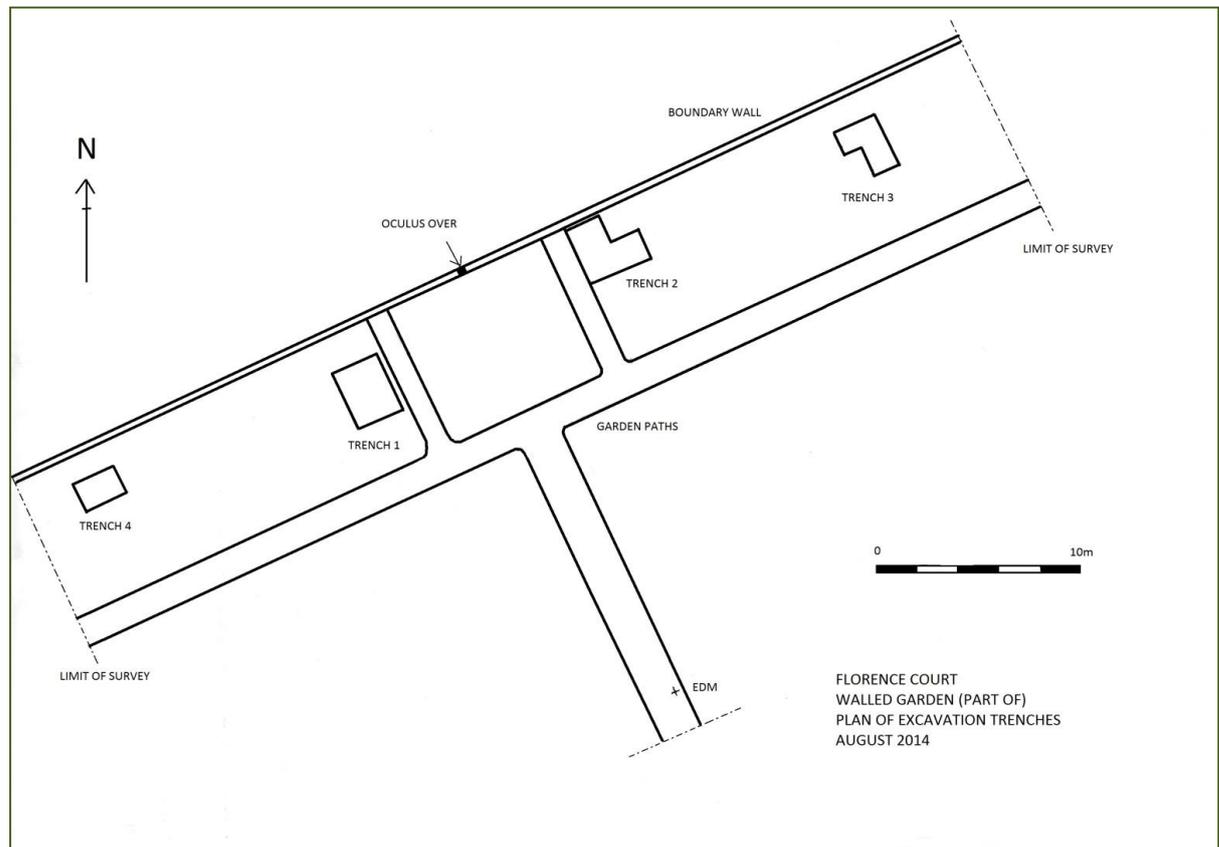
Figure 07: Layout plan of excavation trenches, Lower Walled Garden, Florence Court

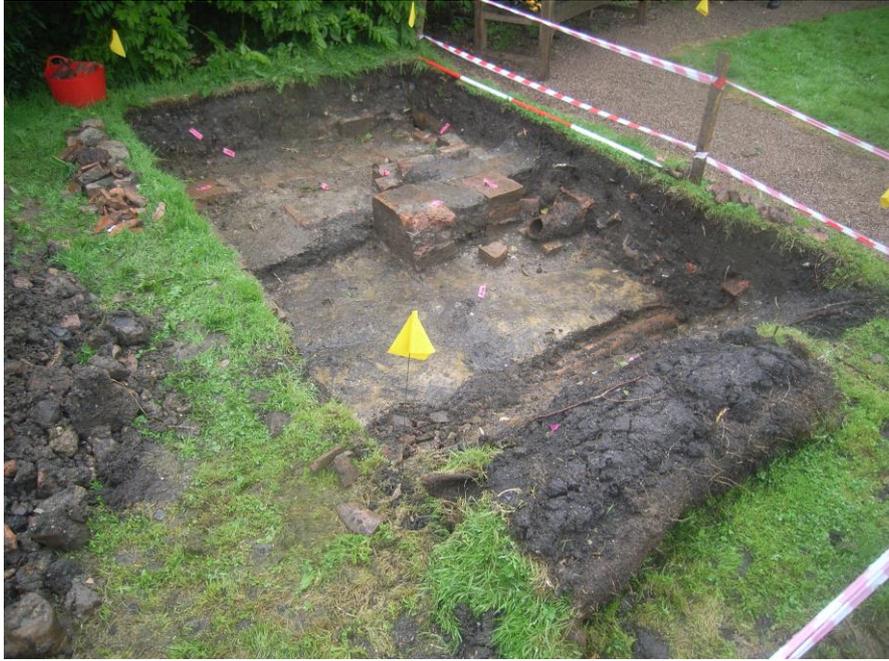
Figure 08: Trench 1 with pottery sherds and evidence of pipe, which provided the heating for the glasshouses

In Trench 1 a portion of the single heating pipe was found to be supported on single red bricks. This would suggest that the base level of the heating pipe may represent the floor level of the glasshouse. This arrangement was a common feature of mid-late nineteenth century and early twentieth century glasshouses, as seen in the vinery glasshouse in the Walled Garden at Crom, also in County Fermanagh. The vinery glasshouse in Mount Stewart's Walled Garden is of a similar design.

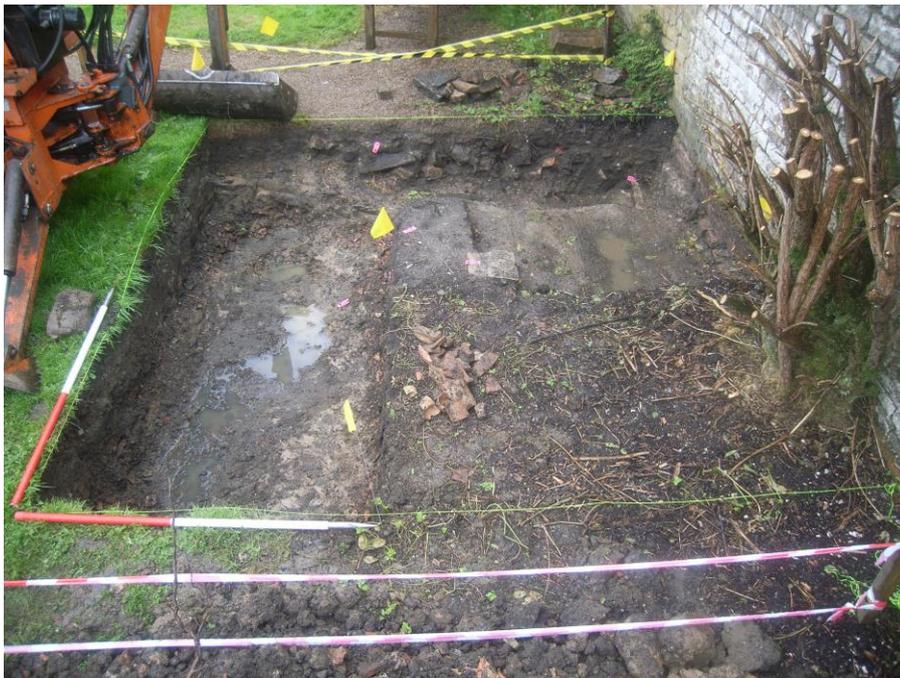
Figure 09: Trench 2 with pottery sherds and evidence of the original, white, painted wall formerly inside the glasshouses

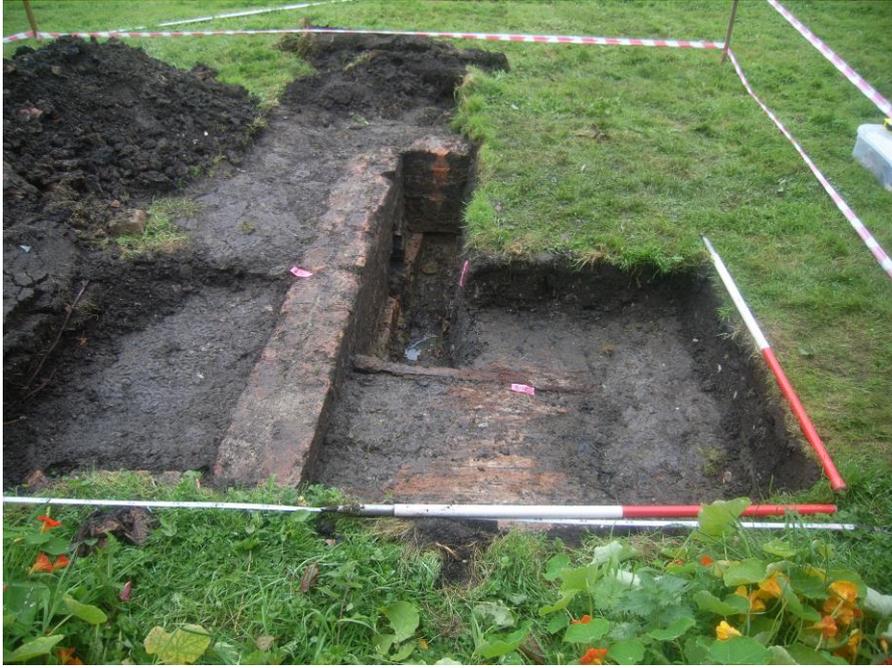
Figure 10: Trench 3 with evidence of robust red brick base and walls

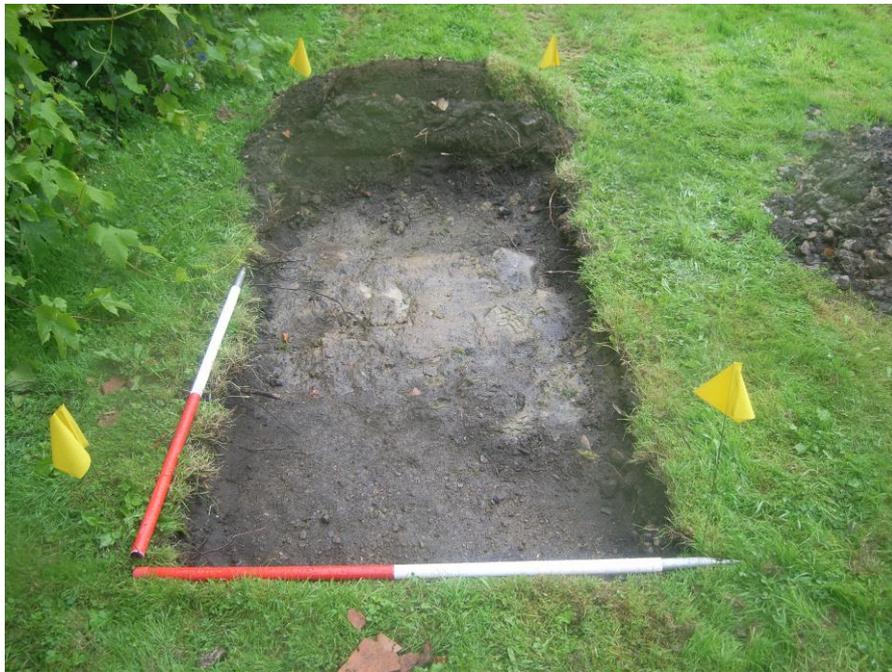
Figure 11: Trench 4 with its grey-brown metallised surface

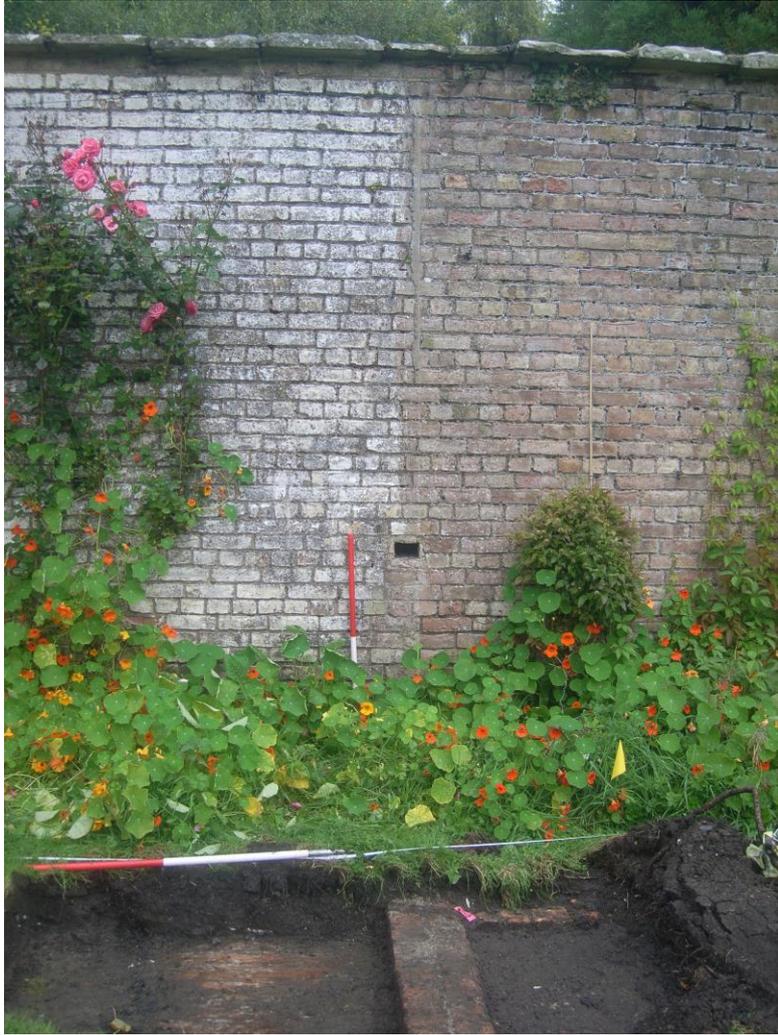
Figure 12: Trench 3 red brick wall, lined up perfectly with the white-painted wall, formerly found inside the glasshouses

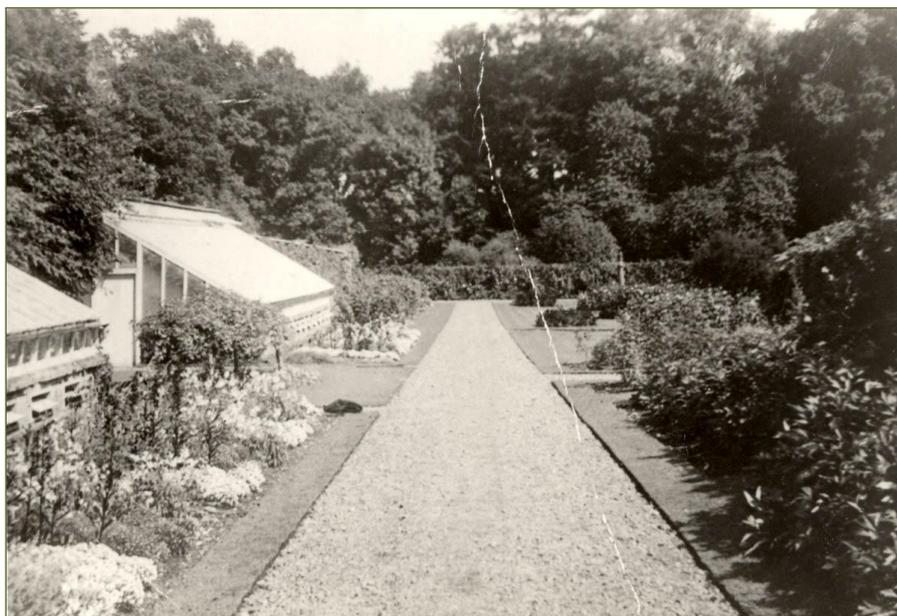
Figure 13: A 1930s view looking east along the north wall of the Lower Garden showing the lean-to glasshouses (R.H.Pierce)

The glasshouses along the north wall housed vines, peaches, nectarines and apricots. Nearby in the north-east quadrant, there was also a conservatory/greenhouse which featured chrysanthemums, ferns, melons and tomatoes. A building for mushrooms and a potting shed were also found nearby.

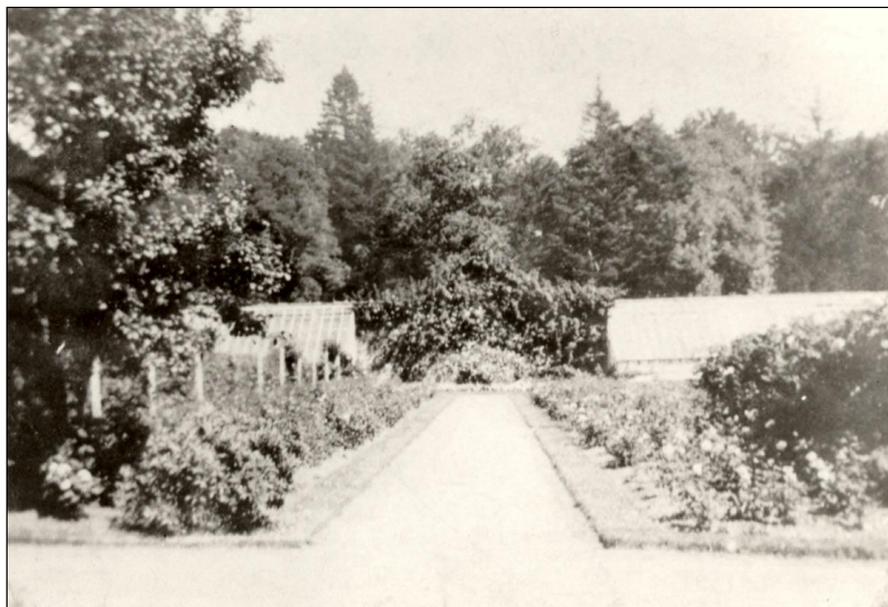
Figure 14: A 1930s view of the north wall of the Lower Garden showing the lean-to glasshouses and tympanum area (R.H.Pierce)

At the centre of Figure 14 above, you will identify a triangular arch between the two lean-to glasshouses, which appears completely covered in vegetation. At its apex a brick-lined circular aperture of c.1.2m in diameter is located. It has been suggested that this once contained a clock. However, it seems more likely that it was intended to provide additional light to the greenhouse, which stood here in this central position prior to World War 1.

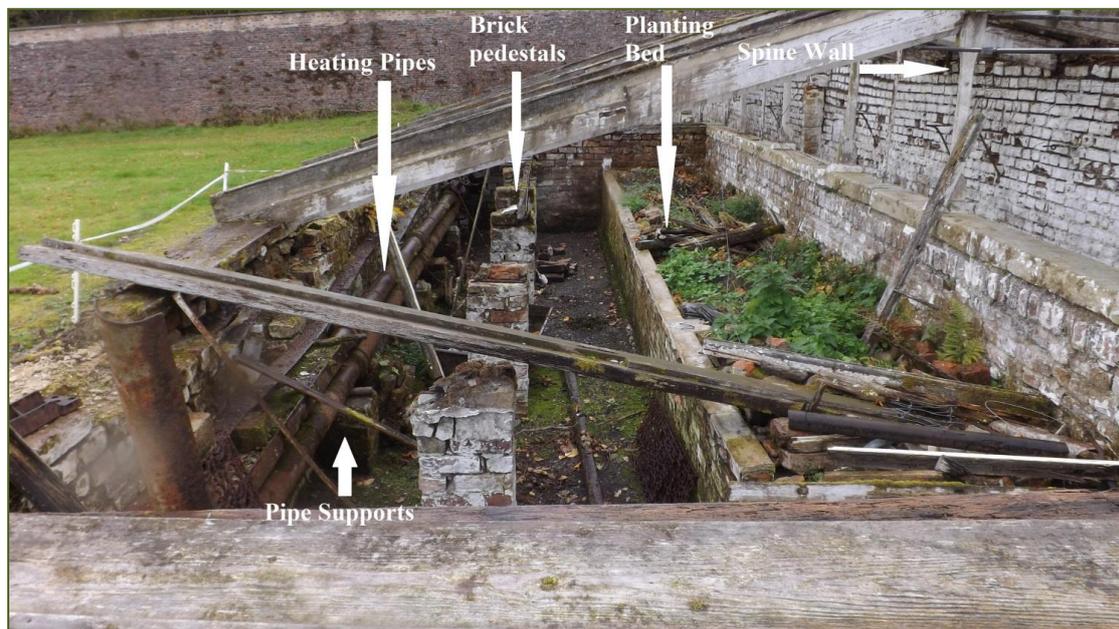
Figure 15: View of surviving internal arrangements of a ruined vinery glasshouse within the Walled Garden at Crom Demesne in County Fermanagh (M. Conway)

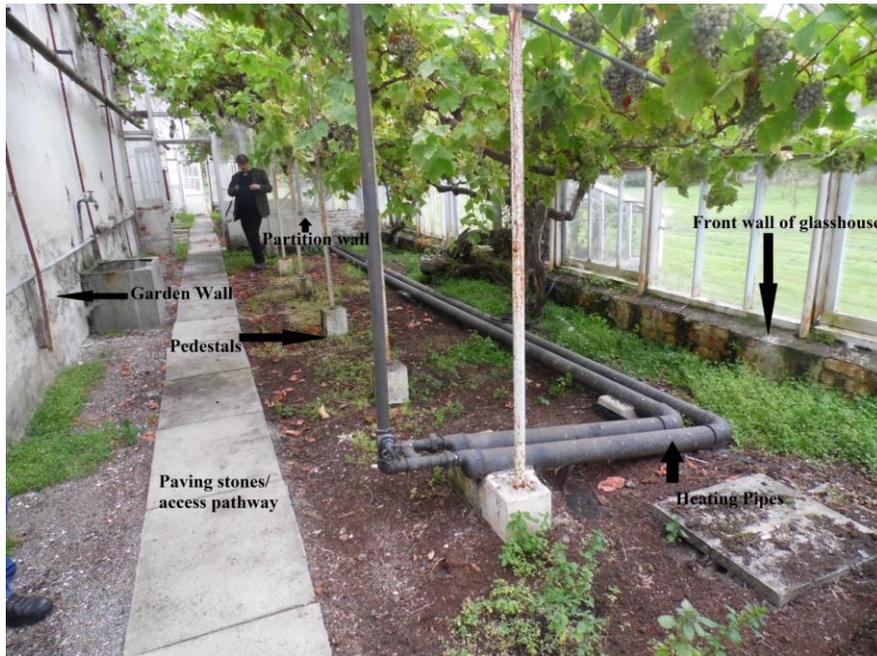
Figure 16: View of surviving internal arrangements of a vinery glasshouse located within the Walled Garden at Mount Stewart in County Down *M. Conway*

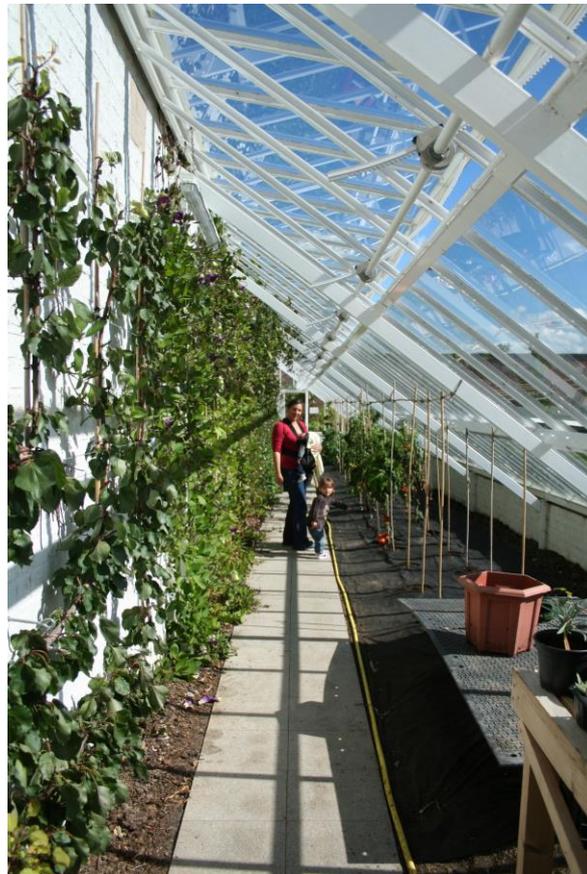
Figure 17: View of the internal lean-to glasshouse in the Walled Garden, Bangor Castle, County Down *H. Welsh*
