# ULSTER ARCHAEOLOGICAL SOCIETY

Survey Report: No. 33

Survey of East Yard, Bishop's Palace, Downhill,

County Londonderry

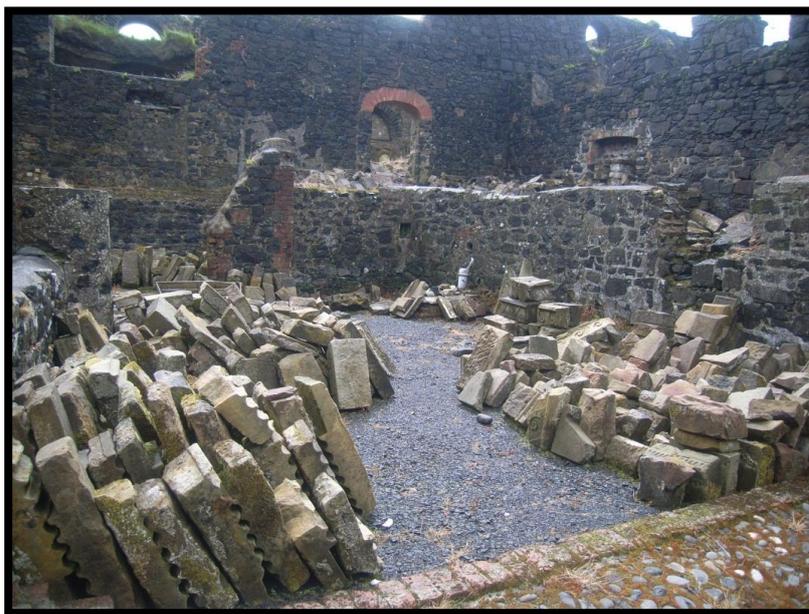
Figure 07: Large quantities of decorative stonework within the East Yard

At Downhill in 2009, almost 75% of the East Yard was cleared of rubble and prepared for detailed recording. The strategy was to fully catalogue the many architectural fragments recovered from the site and hopefully re-use some of these in future restoration or repair work at the Bishop's Palace.

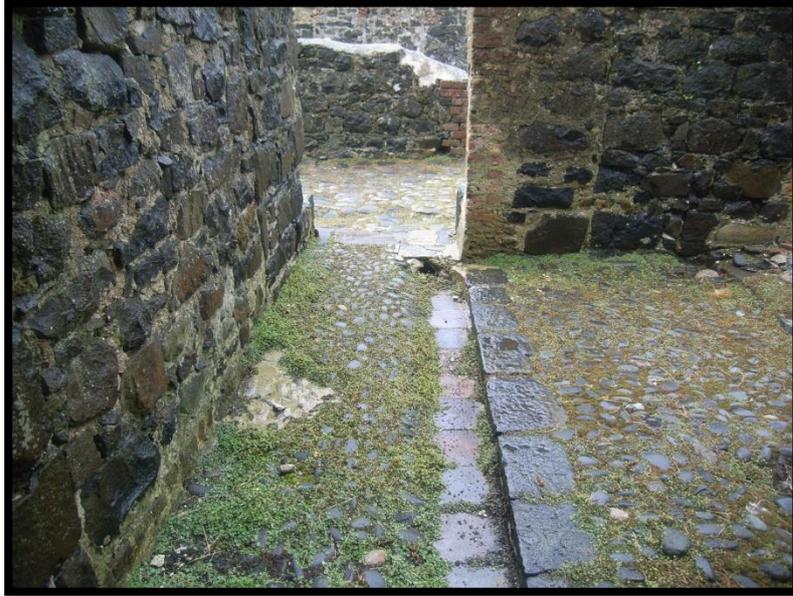
Figure 09: Original cobbled surfaces within buildings in the East Yard

Excavation revealed original cobbled surfaces lying intact below the rubble. A walled enclosure, partly cobbled and lying to the south, was also revealed and may have been a piggery. This building appeared to overlie an earlier structure, which may have been the original poultry house. Excavation also cleared out four compartments or buildings arranged along the south and eastern wall of the yard. All of these were found to retain their original cobbled floors.

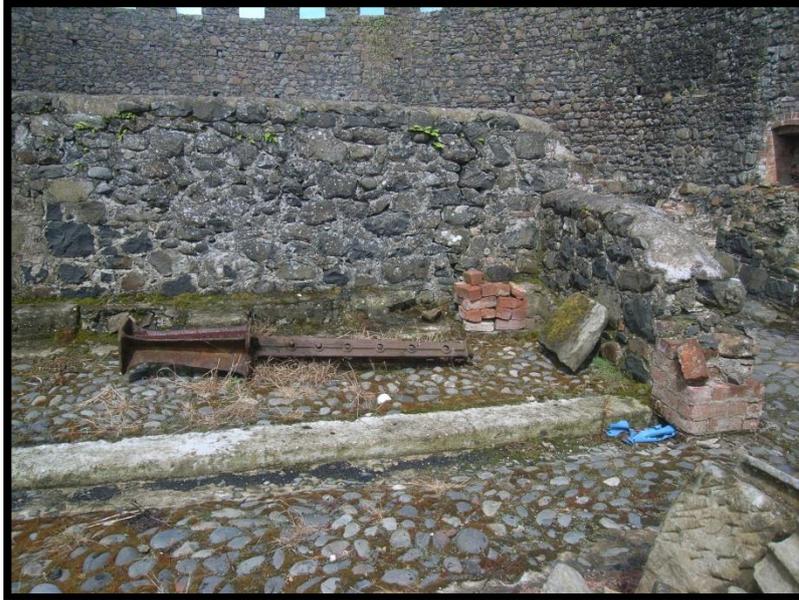
Figure 11: Cast iron fence post

In addition to masonry fragments, other interesting finds included metalwork. One large cast iron fence post was obviously detailed in design and in remarkably good condition.

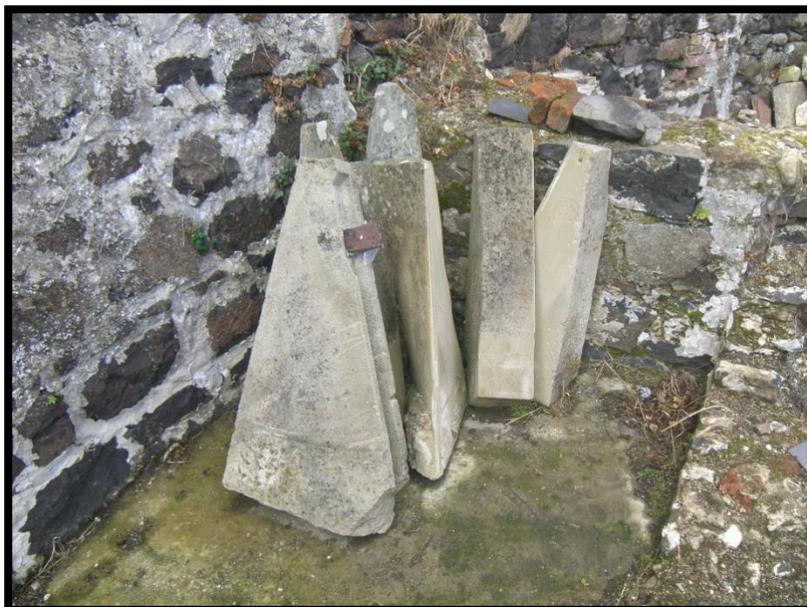
Figure 12: Individual stone steps of a spiral staircase

One unusual masonry find within the East Yard was individual stone pieces, which would have combined to form a spiral staircase. Where in the palace or yards did such a staircase exist?

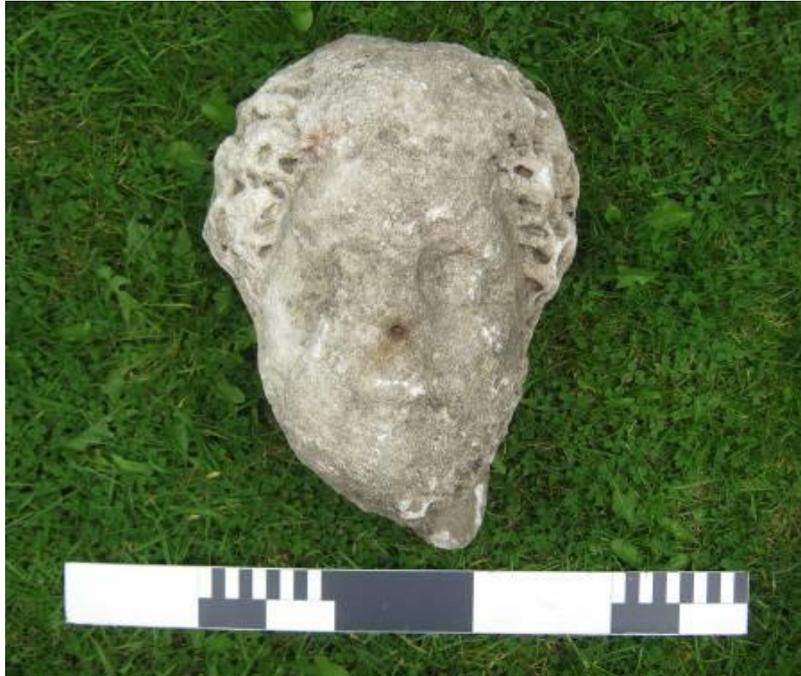
Figure 13: Sculptured stone head of a Roman Emperor, *National Trust*

The most striking and perhaps the most important single discovery made was of a sculptured stone head, which appears to be a Roman portrait of AD 161-196 of either the Emperor Marcus Aurelius or his son Commodus. Undoubtedly, this was purchased by the Earl Bishop in Italy, while on one of his grand European tours. It is a tangible reminder of the opulence, which once graced the interior of this palace.

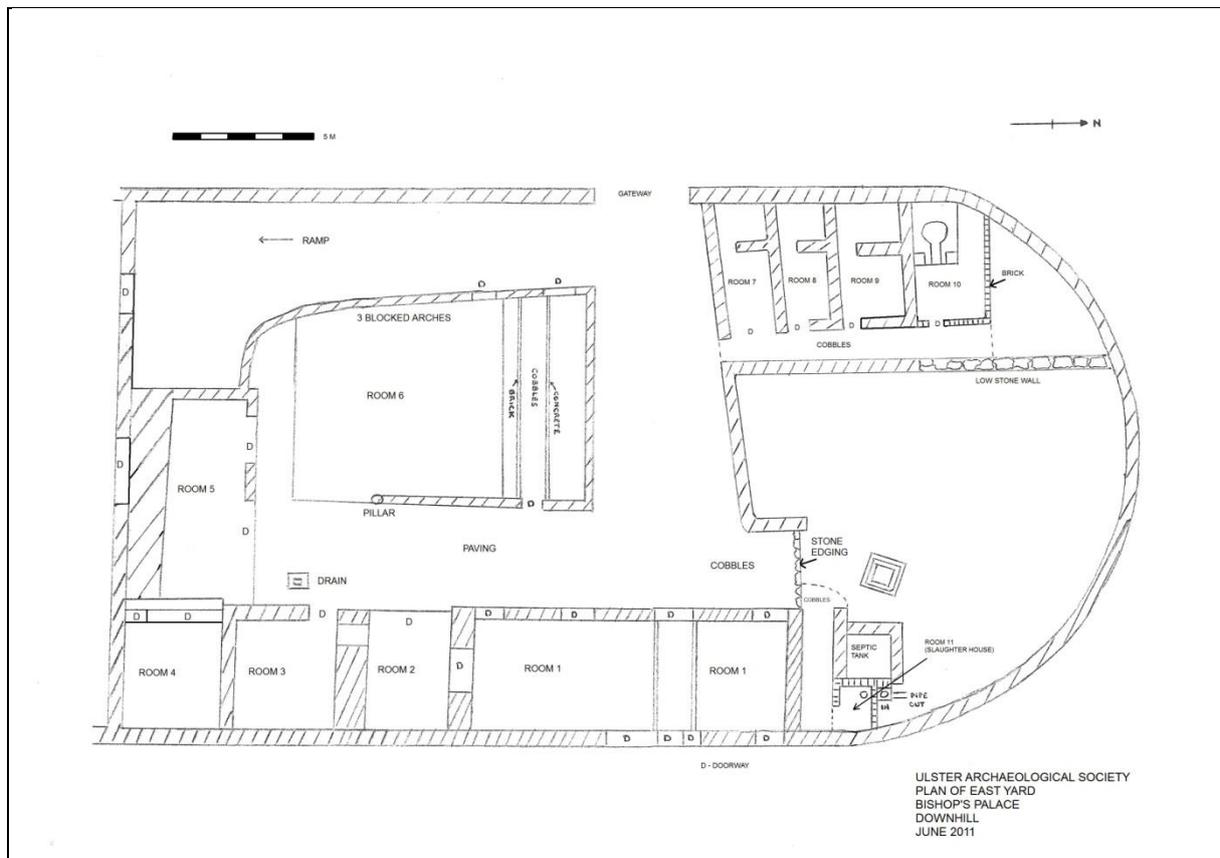
Figure 17: Plan drawing of the East Yard, Bishop's Palace, Downhill

Plan drawings were completed, using data obtained from the field survey. Measurements were obtained by using the society's *Leica Sprinter 100* electronic measuring device. Sketch plans at 1:100 scale were completed on site by recording these measurements on drafting film secured to a plane table and backing up the data on a field notebook for subsequent reference. Field plans were later transferred to a computer-based format for printing.

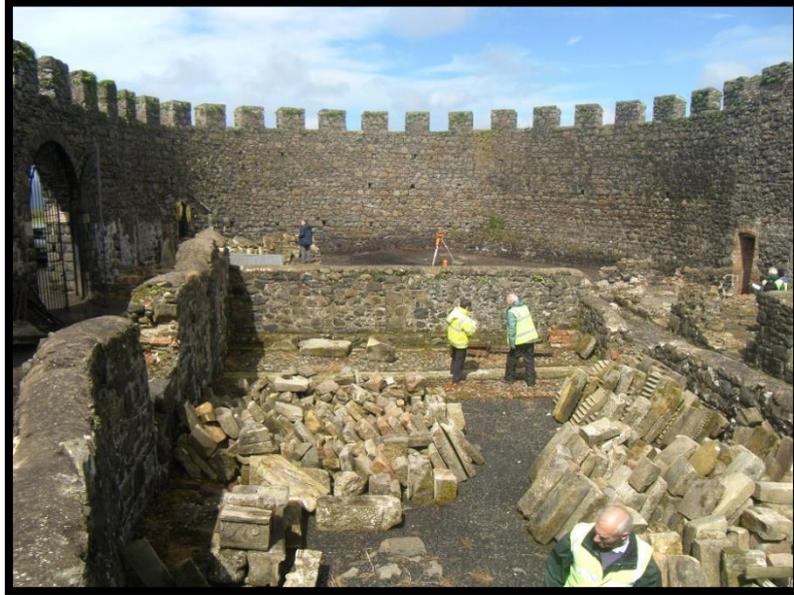
Figure 19: View of the crenellations within the East Yard, looking north

The East Yard consists of an enclosed collection of the remains of buildings and other features, within the estate of the Bishop's Palace. The Yard itself measures 35.5m north/south by 19m east/west. It is semi-circular in design at the north. There are impressive crenellations/battlements on top of the walls at the north, east and west, which create the illusion of a fortress rather than a stately home or mansion, especially when viewed from the sea. This was a deliberate construction at the time of the Napoleonic Wars, when such protection was deemed necessary.

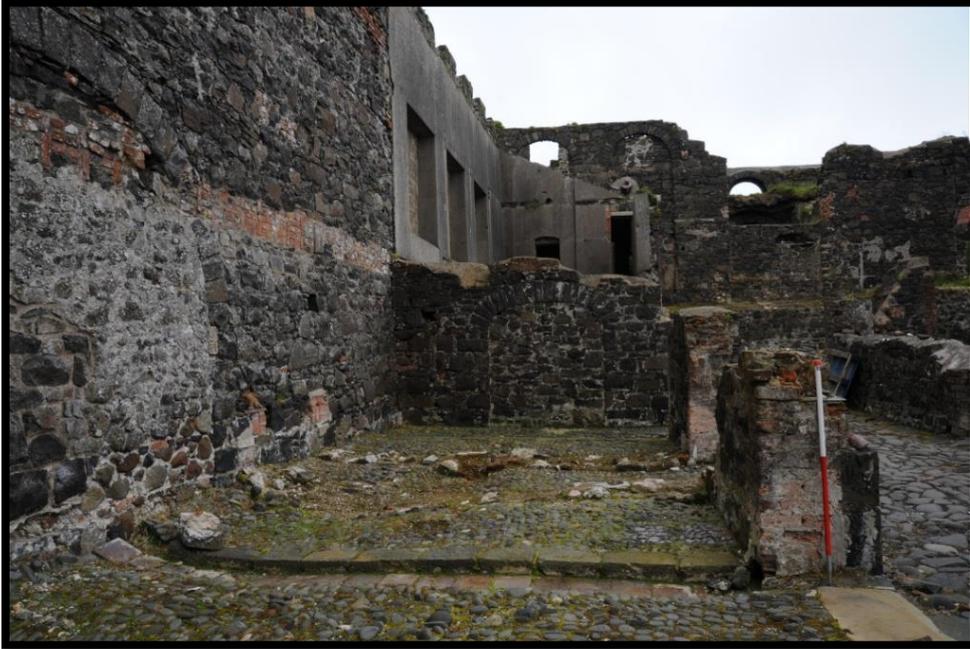
Figure 20: Room 1, with blocked-up arches and red brickwork at roof level, looking south

Room 1 measures 9.12m in length overall north/south, with a width of approximately 4.2m east/west. It appears to have been subdivided into four smaller rooms. The eastern wall is well built of stone and has a very large (3.02m) filled-in archway, which extends to the exterior of the building. This main archway is in-filled with stone and displays a later brick horizontal insert, which may have proved useful for roof joints.

The south wall of Room 1 displays a blocked archway into Room2. The west wall has a series of four openings with four large sandstone sills into the sub-divided rooms. Some of these openings are brick-edged and are invariably 1m wide. The three cross walls are very low and measure 4.2m from east to west. The floor has a series of cobbled areas and drains. The three drains running east-west are lined with quarry tiles, with a precise stone kerb on the north side and small, round cobbles on the south side.

1. An original exterior wall, with arched entrances internally on the west side
2. Insertion of the cross walls, from east to west
3. Blocking up of the archways and construction of the byres

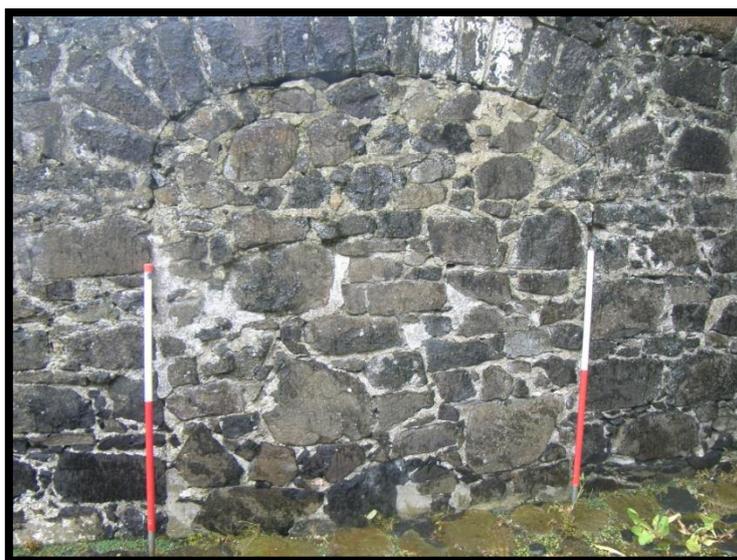
Figure 23: Blocked-up arch in the north wall of Room 2, looking north

This room, to the south of Room 1, may originally have been one large room, incorporating Rooms 2, 3 and 4, which has been subdivided. The interior of the north wall is constructed of stone rubble and has a 1.76m wide filled-in opening into Room 1. It appears to be original. Above this arch is a protruding stone which appears to match the one in Room 3 and may function as a corbel to support a beam for the first floor.

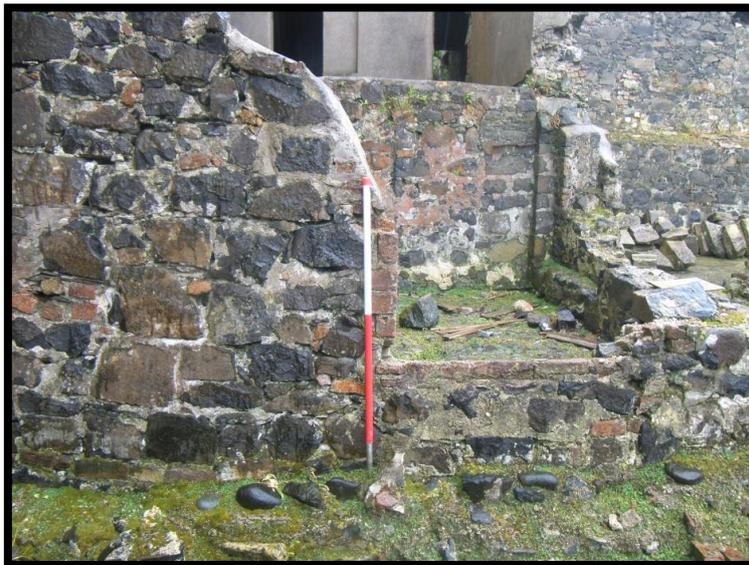
Figure 24: South wall of Room 2 within the East Yard, looking south

The interior of this south wall is constructed of stone rubble and brick, but does not appear to be tied in and could be a later division. The opening into Room 3 is revealed and also the whole room is slightly lower due to sloping ground.

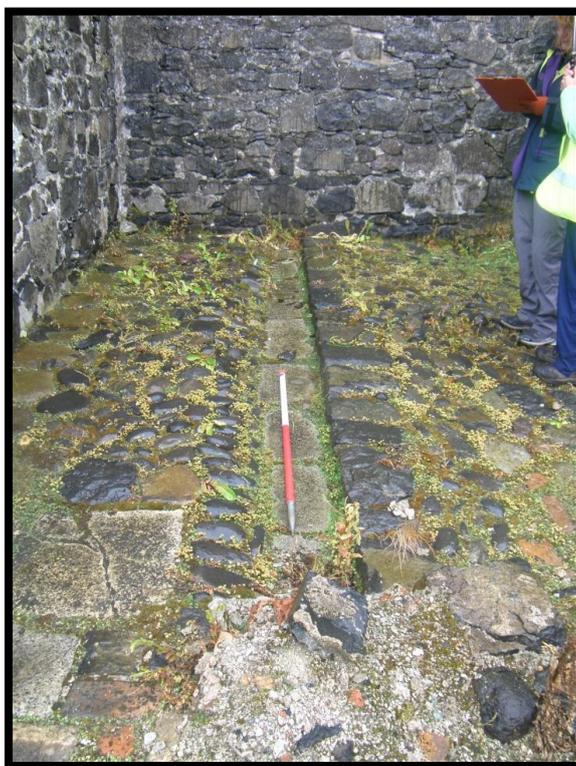
Figure 25: Room 2 from the west, showing drainage channel

The floor is mostly cobbled, with a distinct stone drain running east/west. This would be in keeping with usage for domestic animals such as cattle or pigs. The drain has dressed stones along the south side and neat cobbles on the north side.

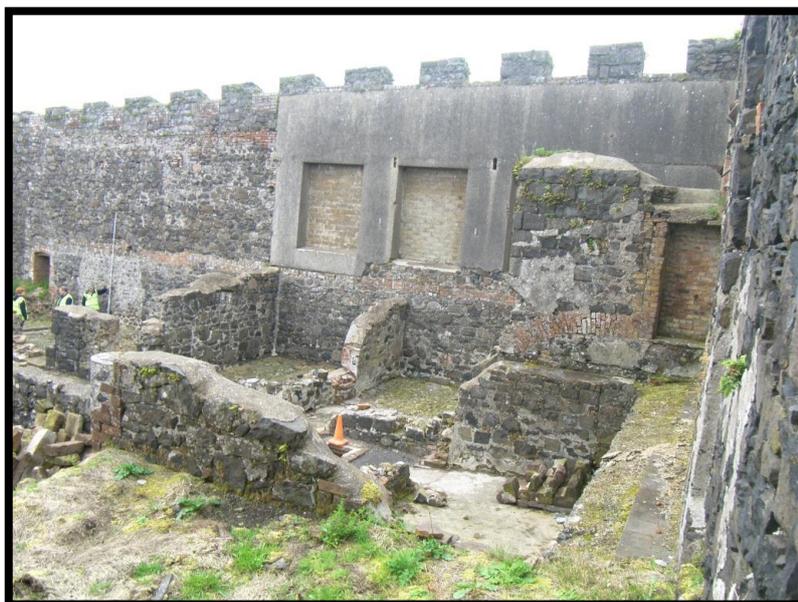
Figure 27: View of Rooms 1, 2 and 3 along the east wall, looking east

This room is in the south-east corner of the East Yard and is accessible from the main part of the yard. The interior of the south wall measures 4.2m long and 2.03m high. The remains of an archway, 0.64m wide and 2.2m high, can be found in the south-west corner. It is built of brick and in-filled with dressed stone and appears to have been a narrow doorway between Rooms 3 and 4. The wall does not appear to be tied into the east and west walls, suggesting that this later feature divided one larger room into what is now Rooms 2, 3 and 4. Another larger archway, 1.64m wide and 2.2m high, along this east wall is also built of brick and in-filled with rubble stone. A protruding stone may have supported a beam for a first floor.

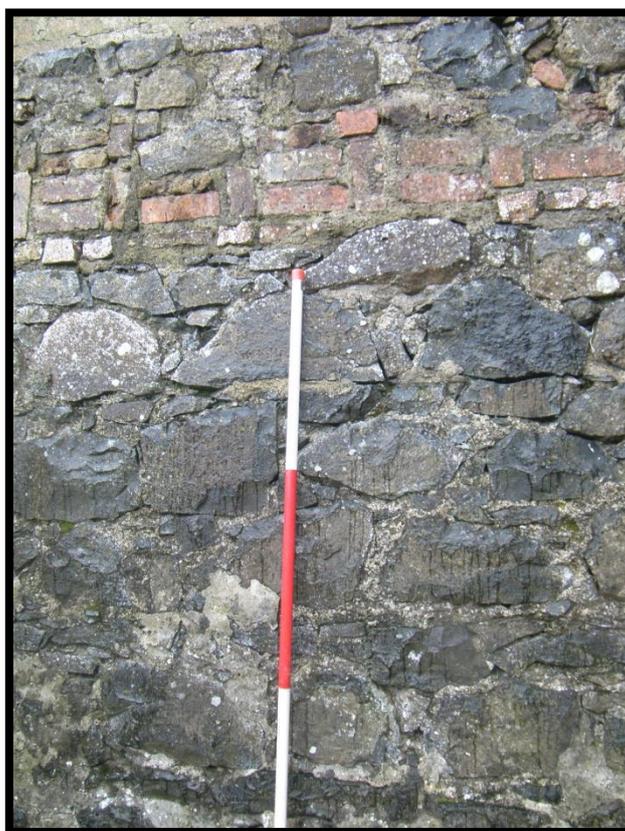
Figure 28: East wall of Room 3, looking east

The east wall is 4.07m long and at ground level it is mostly well built with stone, but it appears that brick has been used to fill gaps from some features, which have been removed. At 2.3m high the brick bonding is in a pattern of one vertical brick followed by a pair of horizontal bricks and this appears to be the junction between the ground floor and the first floor. The first floor wall has been concreted over and two large windows have been filled in with bricks. At the top corners of these windows, there appears to be what once might have been slots for beams/rafters. The crenellations/battlements remain intact at the top of this wall.

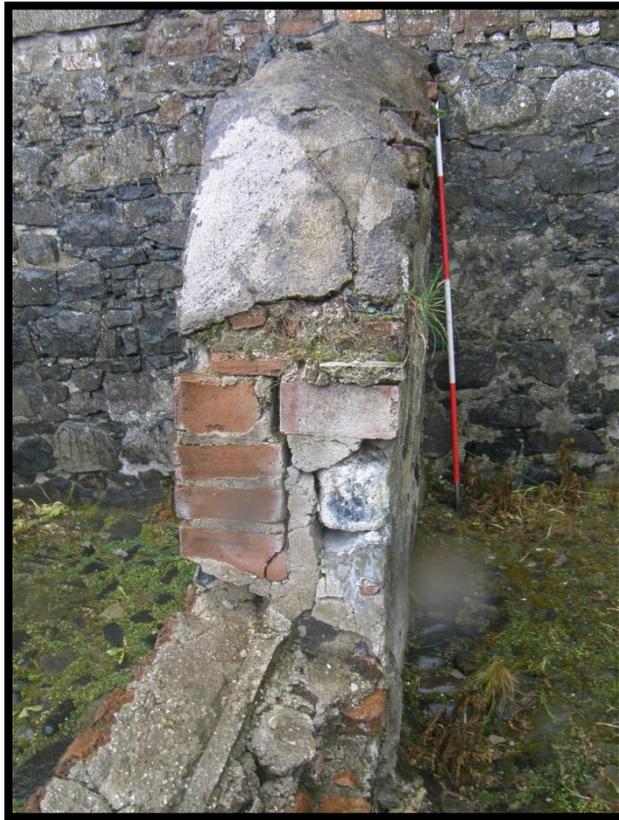
Figure 29: Possible window and sill in north wall of Room 3, looking east

The interior of the north wall is 4.7m long and 45cm wide, but its height ranges from 0.7m to 2.05m. The wall is a mixture of stone rubble and brick and does not appear to be tied into the east or west walls. There is a filled in opening, perhaps a doorway, into Room 2 at a height of 0.5m, which may have been re-used as a window.

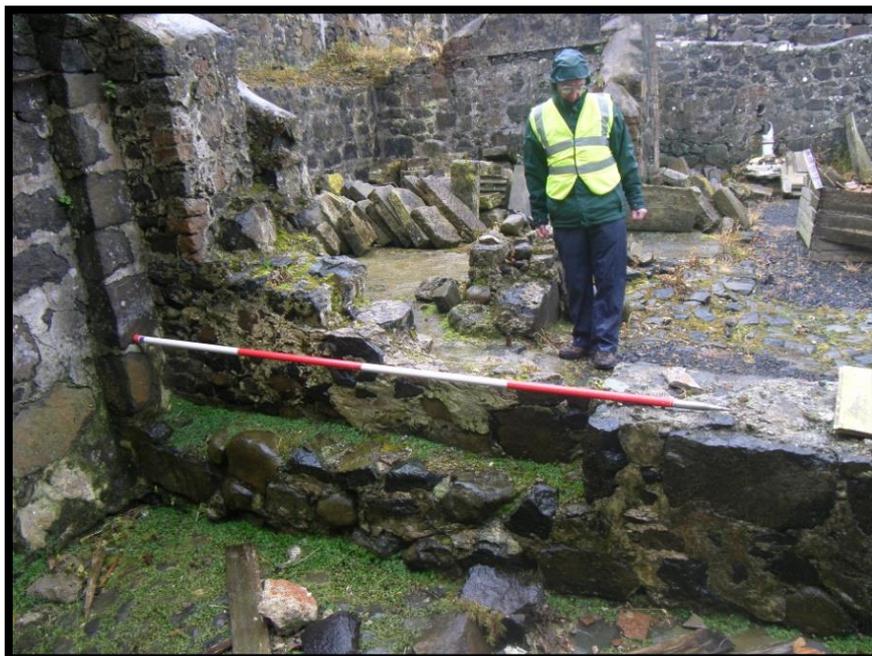
Figure 30: Archway span, 1.76m, in the west wall of Room 3, looking west

The interior of the west wall is 3.1m long and 0.6m wide, but only 0.45m high remains. The base course of stone appears to be original and above this may once have been part of an original archway, 1.76m wide. A doorway opening, 1.3m wide, is situated close to the north wall, with a metal door pin remaining on the south side. The floor is roughly cobbled, with cobbles measuring approximately 0.2m by 0.15m.

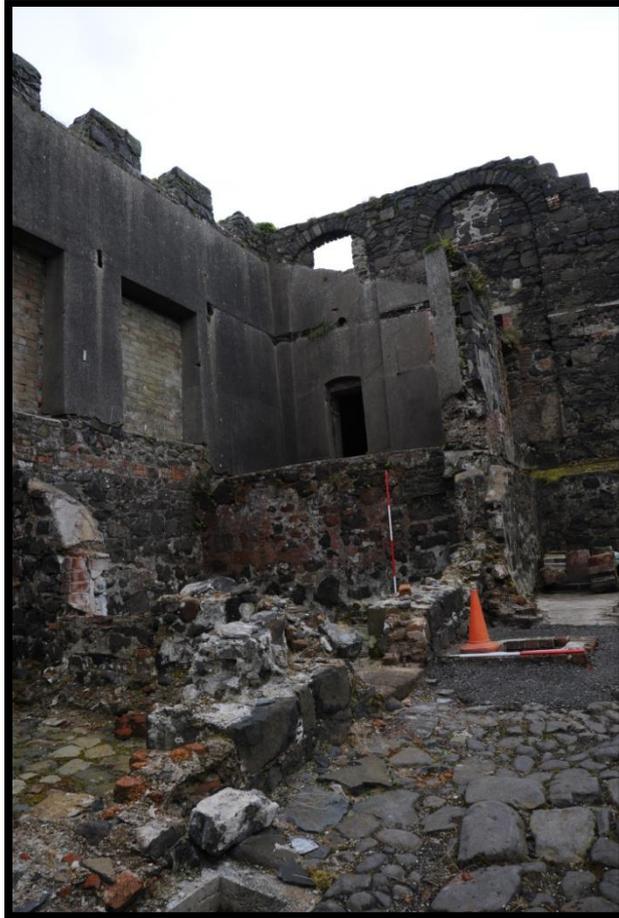
Figure 32: Doorway at first floor level between Rooms 4 and 5, looking west

It was impossible to gain safe access to Room 4, so measurements could only be approximate. Internally, its length is 2.7m and the width is 2.5m. The walls are approximately 0.5m thick. Two of the intact walls of Room 4 have been concreted over and a door opening is visible at first floor level, between Rooms 4 and 5.

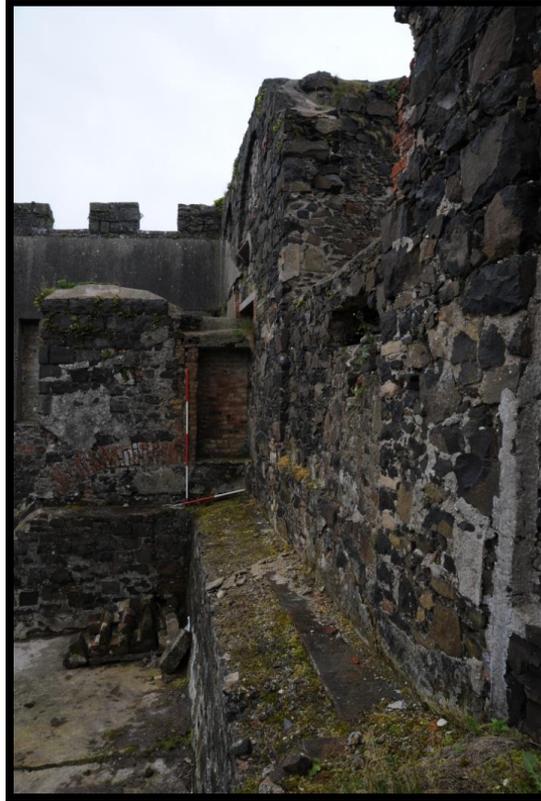
Figure 33: South wall of Room 5, with its retaining wall, looking east

Internally, it measures 5m in length east/west, with its width ranging from 1.8m to 2.3m north/south. Along the south wall is a well-built retaining wall, possibly offering support for buildings to the south of this room. Another doorway, which on this occasion has been bricked up, is visible where Room 5 meets Room 4 at first floor level. The flooring appears once to have been tiled, but concreted over at a later date.

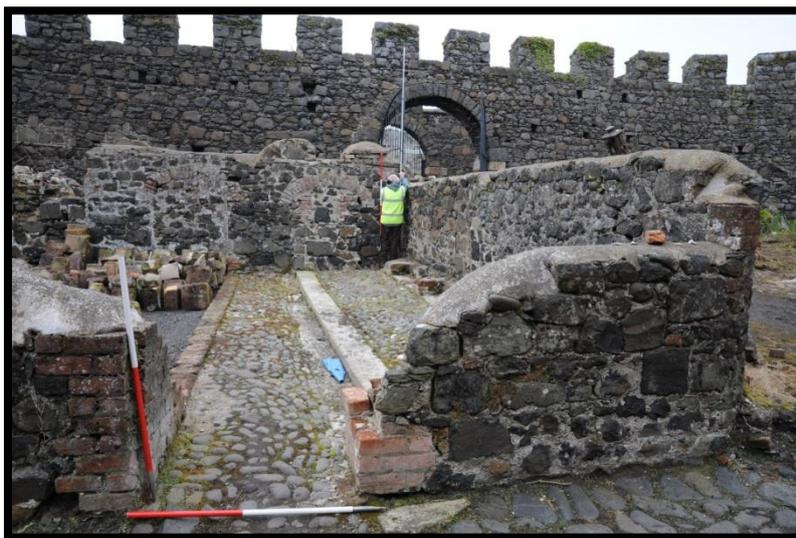
Figure 35: Doorway of Room 6, looking west

Internally, it measures 7.2m in length north-south and its width tapers from 5.1m to 4.5m east-west. The doorway measures 0.95m in width and marks the entrance of what appears to be animal pens. Whether the pens are designed for shelter or whether for dairying purposes remains unclear. The entrance corridor is cobbled and the stalls are also cobbled, with a 30cm concrete edging on one side and red bricks on the other side. Where the red bricks are found appears to be the footing of a wall, which has since been demolished. On the back wall three arches remain and all have been blocked-up. Behind this wall there is a steep ramp. With cobbling in one area, as indicated, the rest of the floor consists of loose stones.

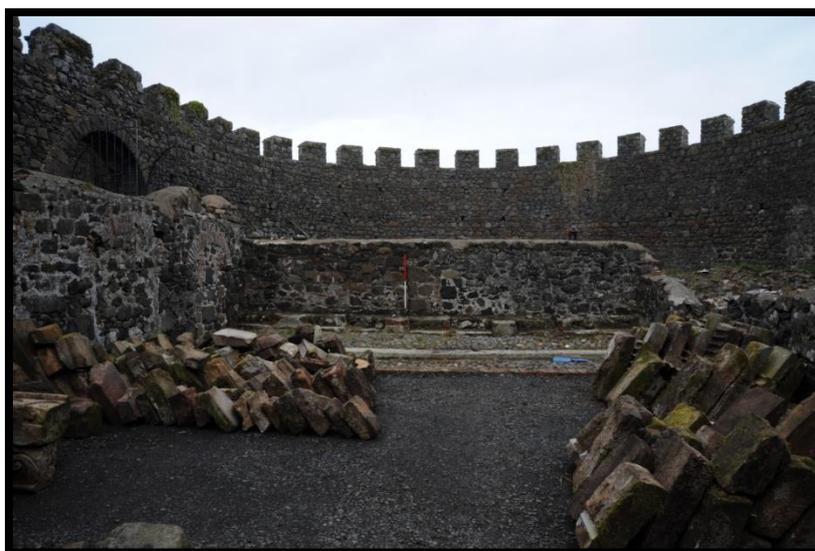
Figure 36: Back wall of animal pens, looking north

On this northern wall, there seems to be 8 individual animal stalls, each 0.78m wide and 1.8m deep. This area of animal stalls has a drop of 0.1m to the corridor cobbled floor. It was observed that a cart axle had been re-used as a door or gate hinge on the circular pillar of Room 6. At a distance of 2.9m, the rounded remains of a second circular gate post were found outside Room 5. These circular pillars each had a diameter of 0.96m.

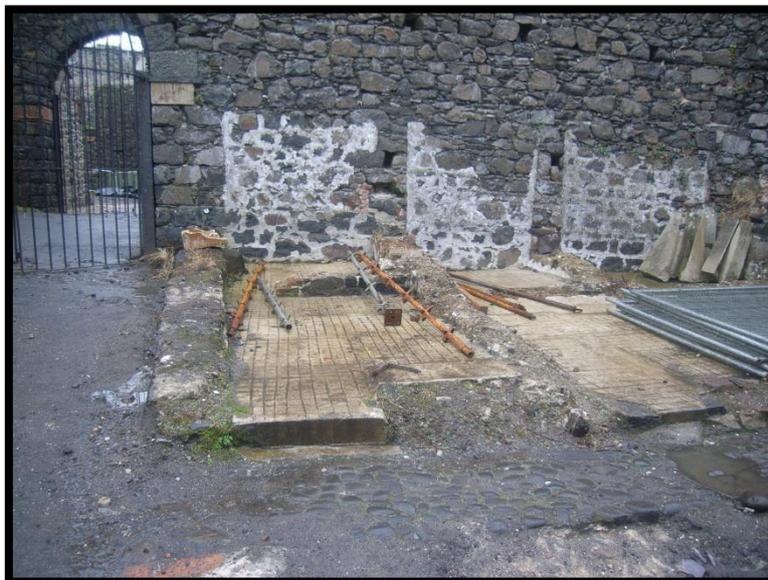
Figure 39: Rooms 7 and 8, looking west

Internally, both Room 7 and Room 8 measure approximately 5m east-west and 1.5m north-south. Room 9 measures 4.5m east-west and 2.25m north-south. The internal dividing walls of all three rooms are of similar construction, which consists of brick, slate and mortar. The west wall, which forms the back wall for all three rooms, is made of natural stone, most probably basalt.

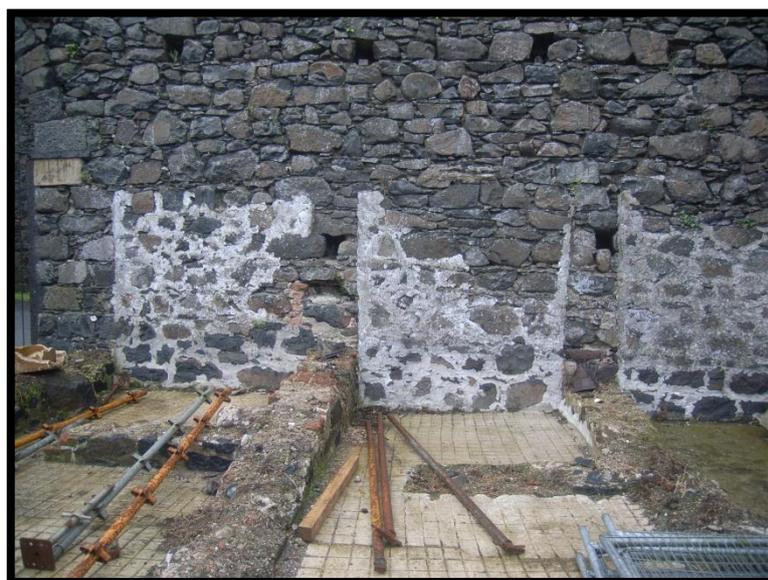
Figure 40: Rooms 7, 8 and 9, looking west

The floors appear to be concrete, which have been worked to look like tiles. Separate cubicles are visible, suggesting that these rooms may well have been shower blocks, constructed during the Second World War, at the time of occupation by the Royal Air Force.

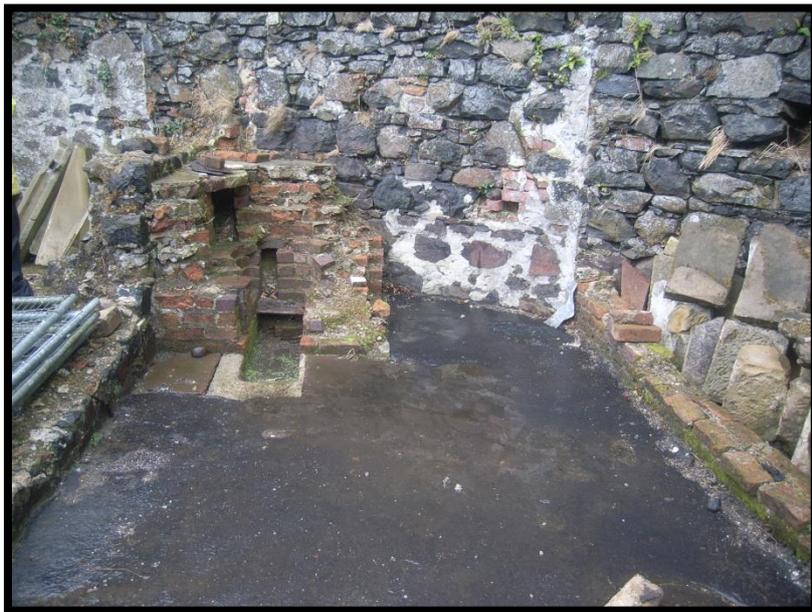
Figure 42: Room 10, looking west

Internally, Room 10 measures approximately 4.25m east-west and 2.5m north-south. Brick walls are to be found on the north and east sides and the floor surface appears to be bitumen. In one corner there is a well-built red brick fireplace structure, which may have supplied the means of heating water for the shower block close-by.

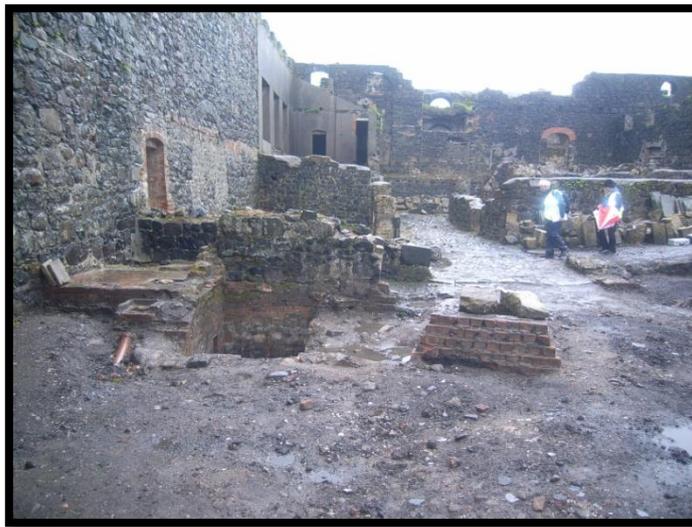
Figure 44: Room 11, looking south

Adjoining Room 1 there is evidence for what may have been a very small slaughter house, complete with an underground septic tank, allowing sewage to decompose through the action of bacteria, before draining away into the ground.

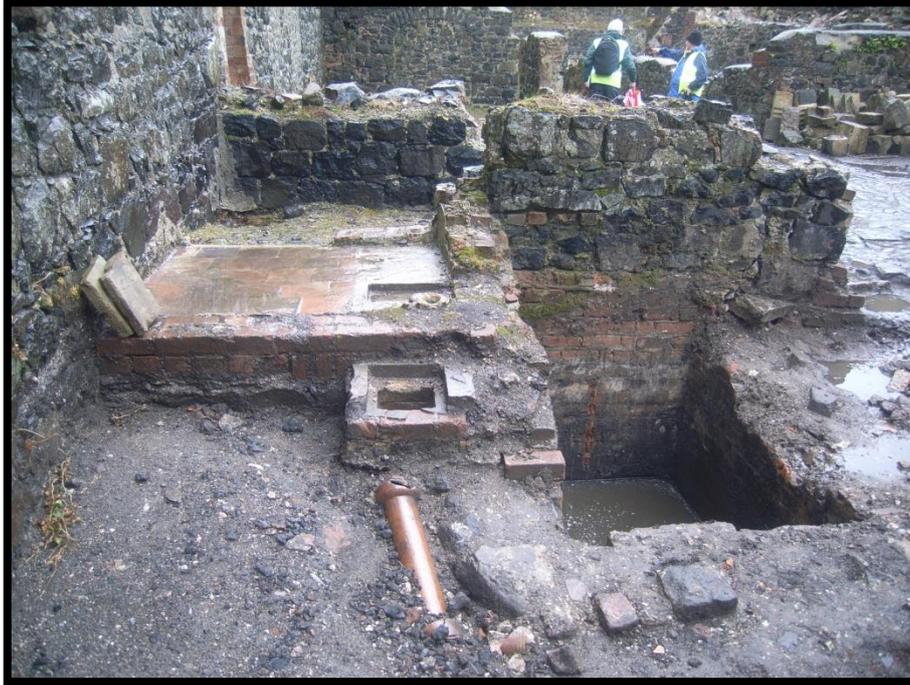
Figure 45: Room 11 with slaughter house and septic tank, looking south

As already stated above, this was indeed a very small slaughter house and could not have been used for large animals such as horses, cattle or sheep. It is therefore very likely that as the East Yard has been described as the poultry yard, this area was indeed used for dealing with all manner of poultry: chickens, turkeys, ducks and geese.
