ULSTER ARCHAEOLOGICAL SOCIETY

Survey Report: No. 26

**Survey of West Yard, Bishop's Palace, Downhill,
County Londonderry
UAS/10/04**

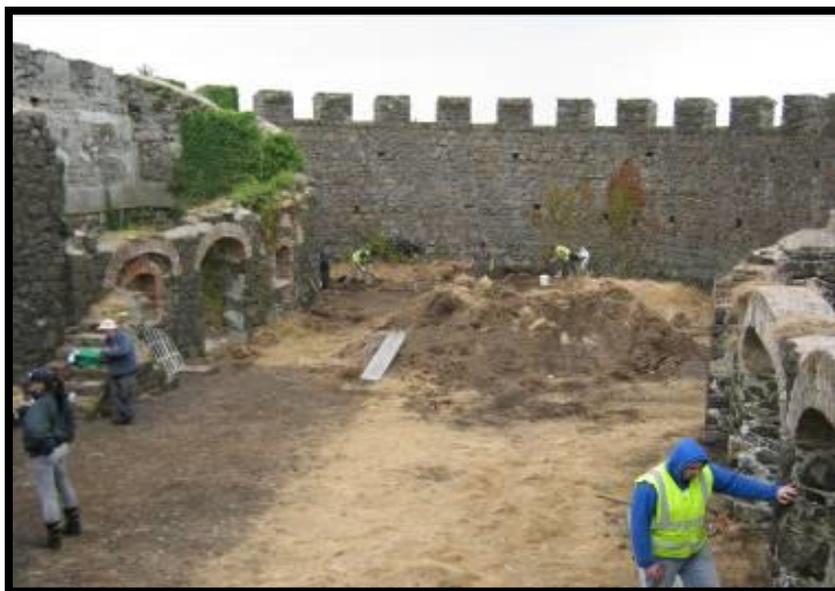
Figure 4: View of West Yard during excavation, *National Trust*

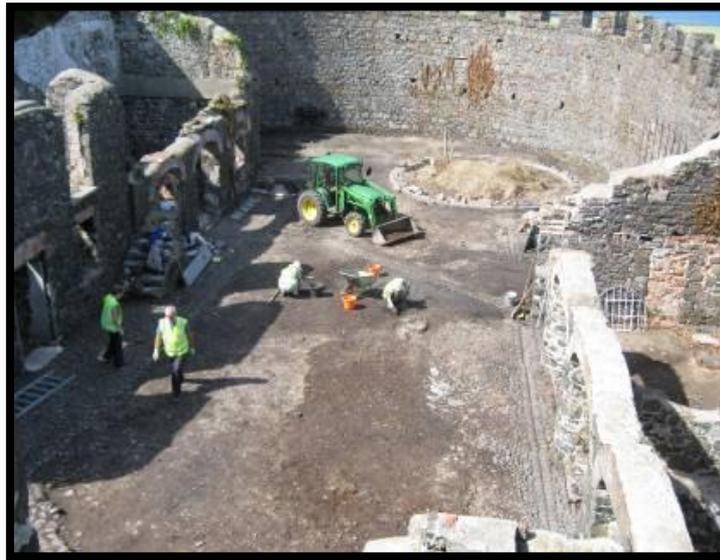
A large circular feature was identified in the north of the West Yard, which proved to be the upper rim of a gas holder. This had been installed in the 1870s, when John Lanyon was employed to repair the house after the fire of 1851.

Figure 5: Gas holder uncovered within the West Yard, *National Trust*

Throughout the 2012 season, it was necessary to backfill the gas holder, in the interests of safety within the West Yard. A team of masons also worked on the fuel stores within the West Yard, as the arches of this structure had become unsafe. The masons also had to dismantle and rebuild the north wall of the West Yard.

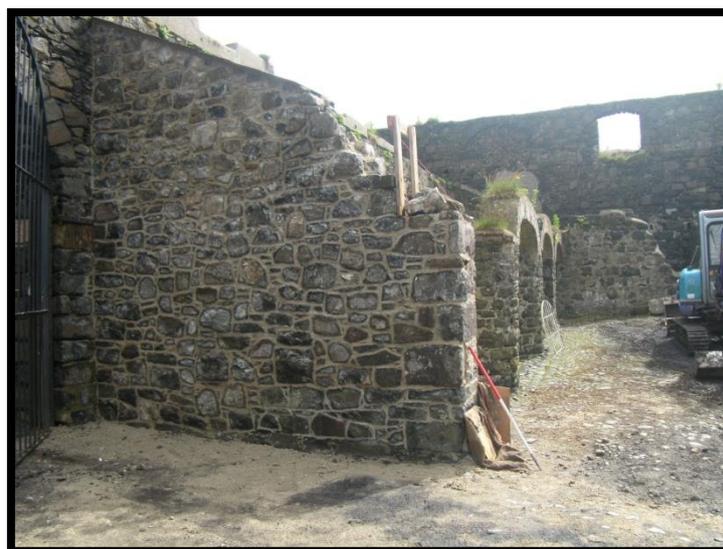
Figure 6: North wall of the West Yard rebuilt

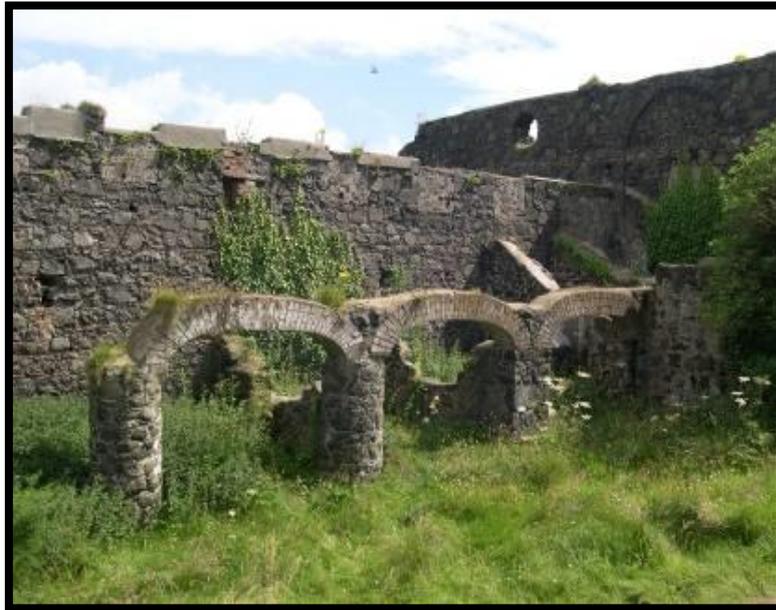
Figure 7: Arches of the West Yard before excavation, *National Trust*

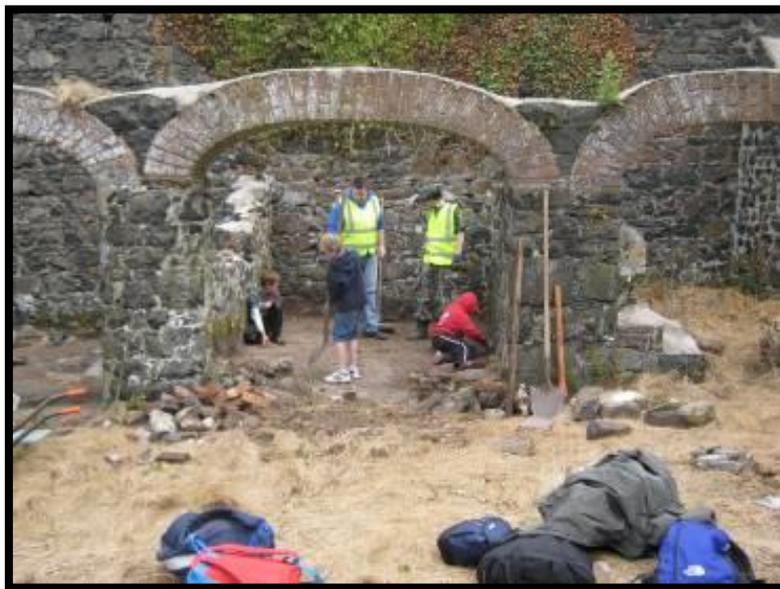
Figure 8: Arches of the West Yard during excavation, *National Trust*

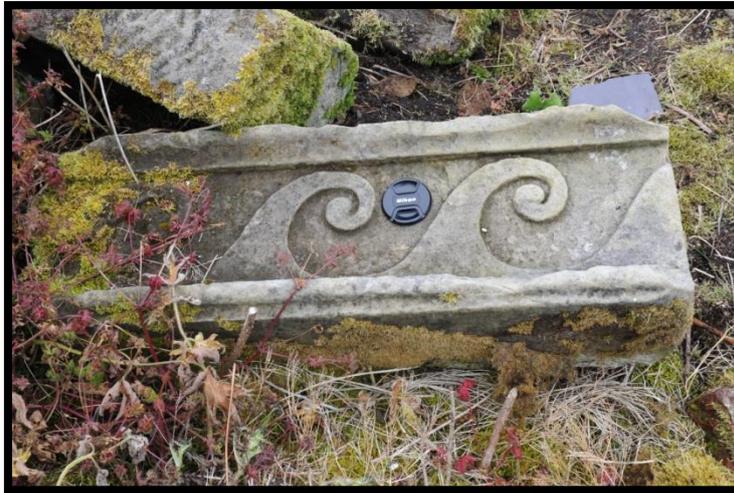
One of the outstanding achievements of the excavations was the recovery of a large collection of architectural fragments, including decorative pilasters and cornice from the exterior of the building.

Figure 9: Decorative stonework from exterior of Bishop's Palace

It is hoped to catalogue this material and re-use it in future repair and restoration of the palace. Small finds included ironwork, glass and pottery. Some of those pottery fragments were plates and cups bearing the stamp 'RAF 1942'.

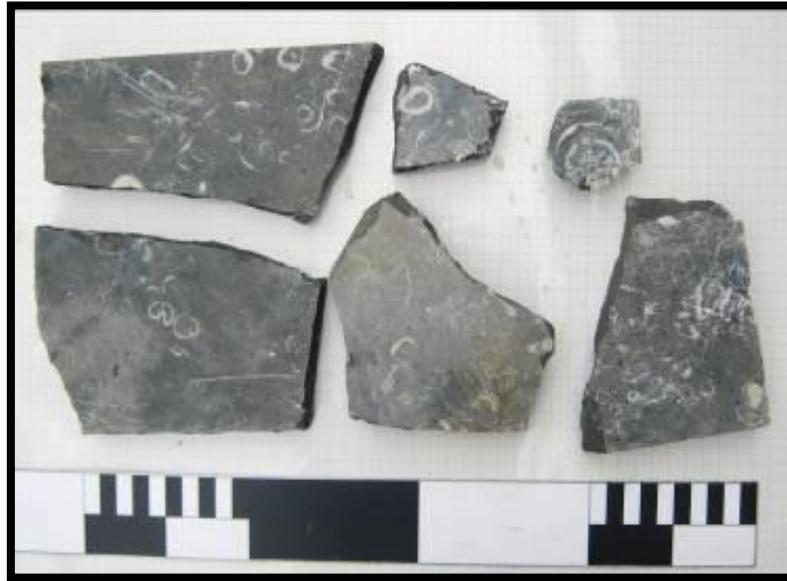
Figure 13: Wenlock-type oolitic limestone from the West Yard, *National Trust*

It is interesting to note that the above fragments of oolitic limestone closely resemble another find from the Queen Anne House at Castle Ward in County Down during excavation in 2008. These rich landowners clearly had access to materials from various parts of the country, as this particular limestone was identified as being from Shropshire or Wales.

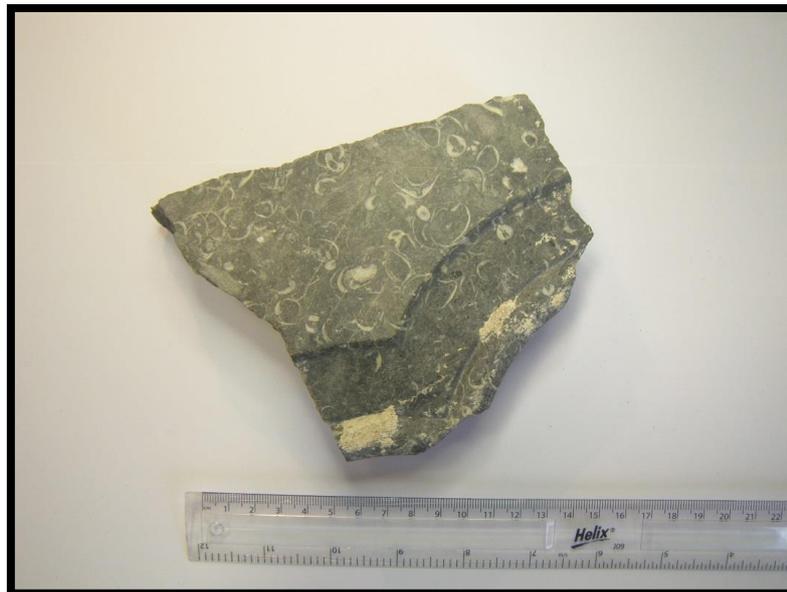
Figure 14: Wenlock-type oolitic limestone from the Queen Anne House at Castle Ward

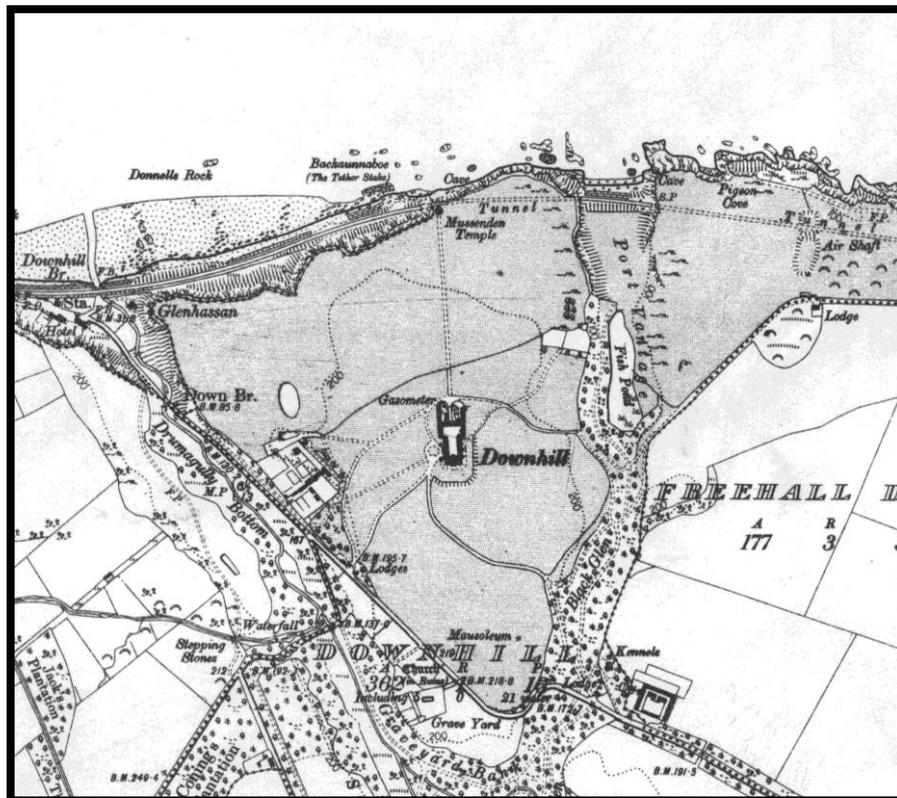
Figure 17: OS County Series, Sheet 2, 1906

The 1906 OS map clearly denotes more detail within the West and East Yards and of particular note is the Gasometer, actually named on the map.

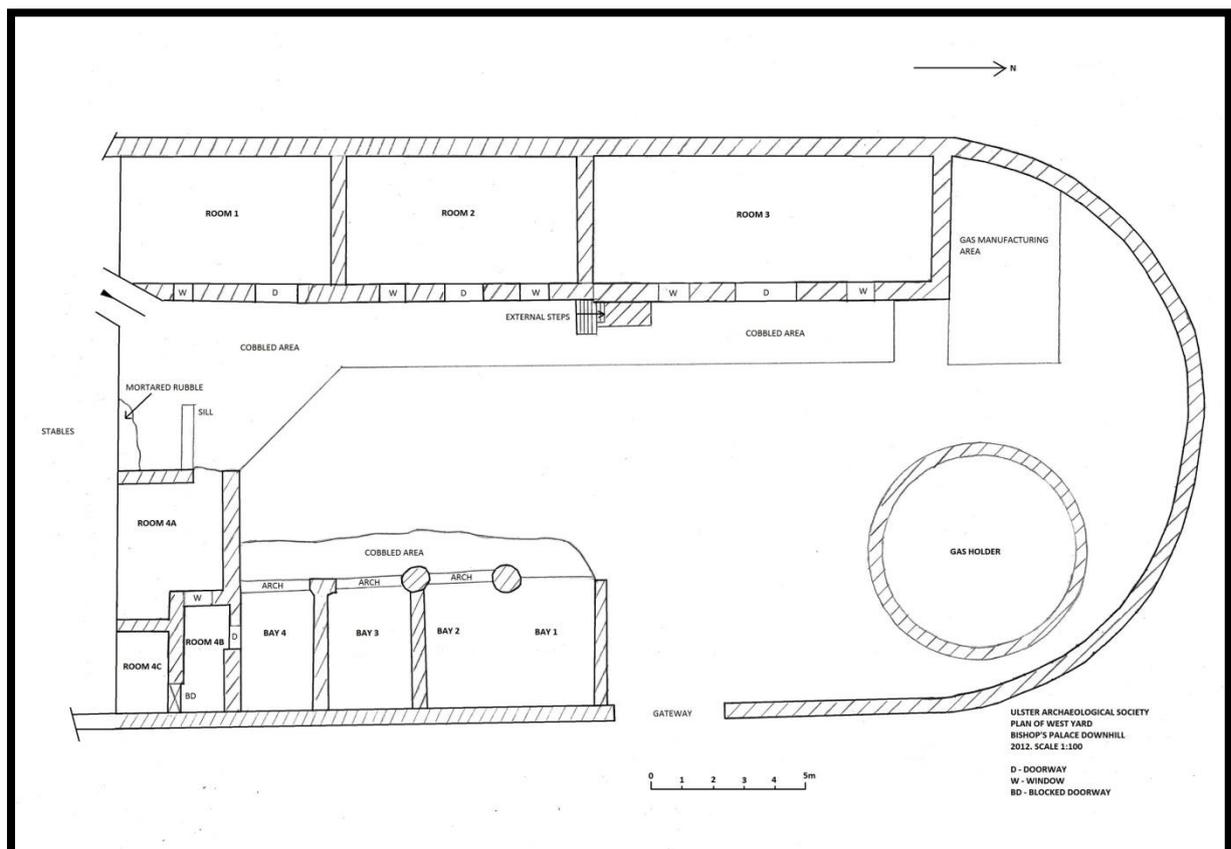
Figure 19: Plan drawing of the West Yard

As can be seen from the plan drawings, individual rooms or bays have been allocated numbers to enable greater clarity in differentiating between the many buildings within the West Yard.

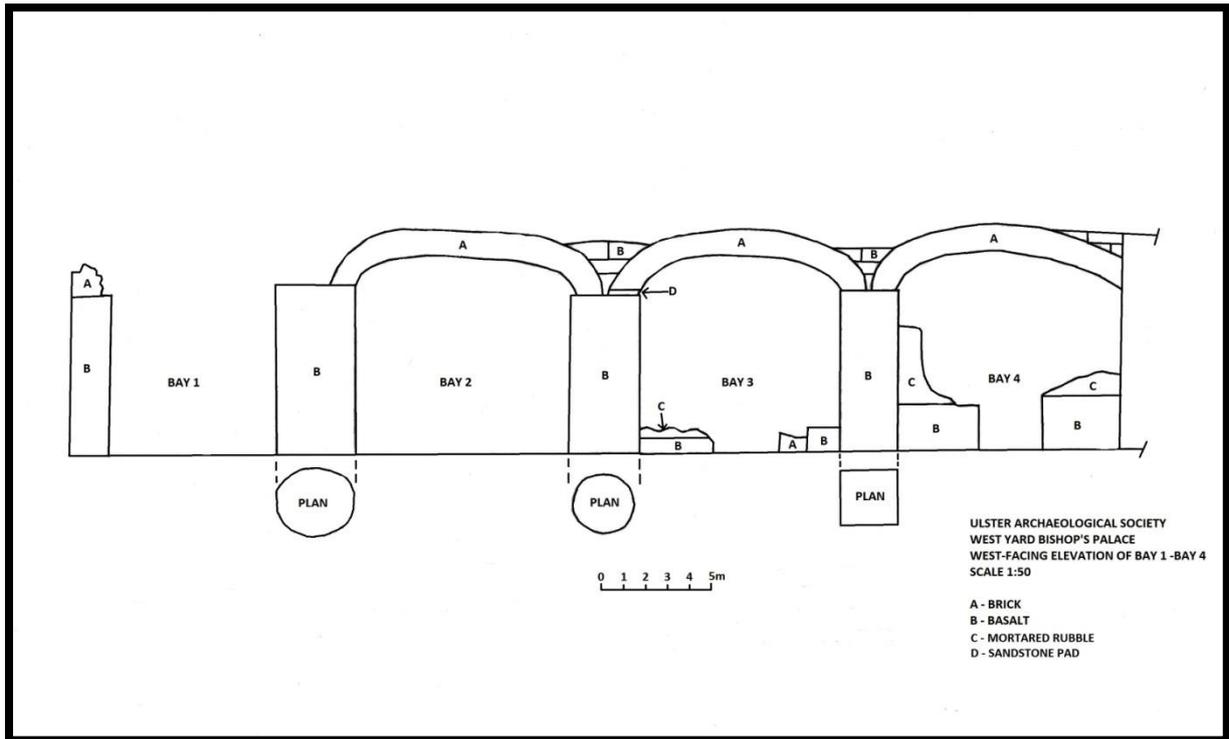
Figure 20: West-facing elevation of Bays 1-4

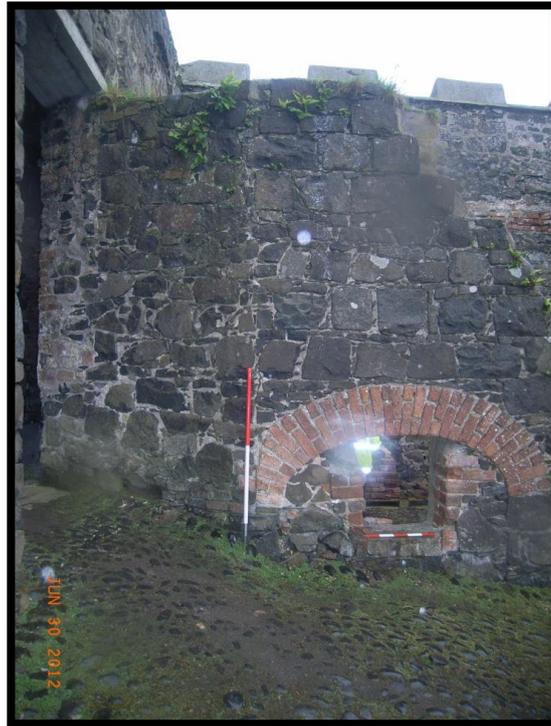
This 2-storey building was built as an extension to the main house and like Rooms 2 and 3 it had been constructed as a lean-to. It measures 7m in length and approximately 4.25m in width. Wall thickness is 0.6m. The upper room of this 2-storey building also had a ceiling and above this was a roof space, which travels the length of Rooms 1, 2 and 3. This is not a third storey. A doorway was cut through between Room 1 and the stables. The slope of cobbles outside evidently came later, explaining the lower level of the window, with its red brick arch.

Figure 22: Doorway into stables and lower level of red brick arched window

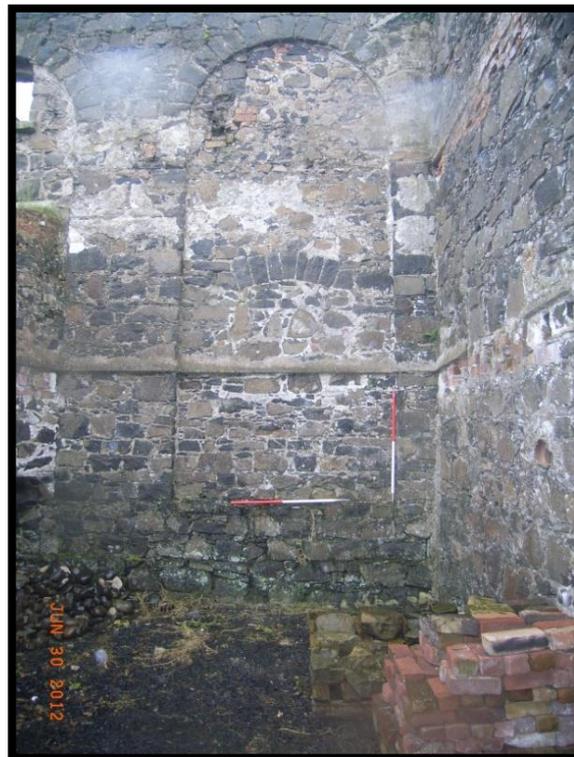
The main material for all three buildings is natural stone, with red brick edging around the windows and doors. The bonding material is mortar, which is full of sand and shells. A circular vent in the back wall may indicate that this room had possibly been used as an animal shelter. The original stable wall had five large arches. The internal floor had been raised, but at present, it consists of loose stones.

Figure 23: Circular vent and evidence for original arches

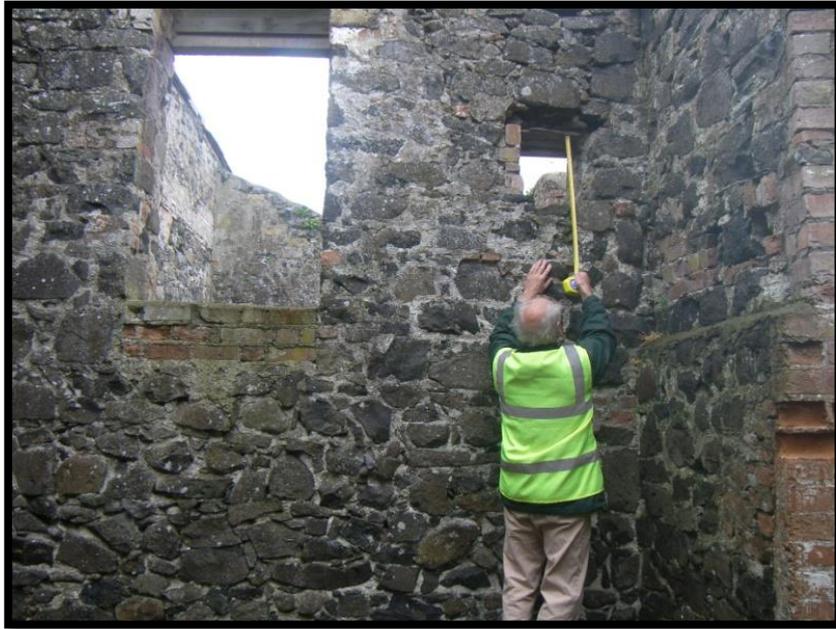
The main doorway for Room 1 measures 1.3m wide externally and 1.27m wide internally. On the first floor level, a tall doorway exists between Rooms 1 and 2. It is 0.96m wide. From ground floor level to the bottom of this door is approximately 2m. A small hatch is found at one side of this doorway and is also common to Rooms 1 and 2. This hatch is approximately 0.4m tall and 0.35m wide.

Figure 24: Doorway and hatch common to Rooms 1 and 2

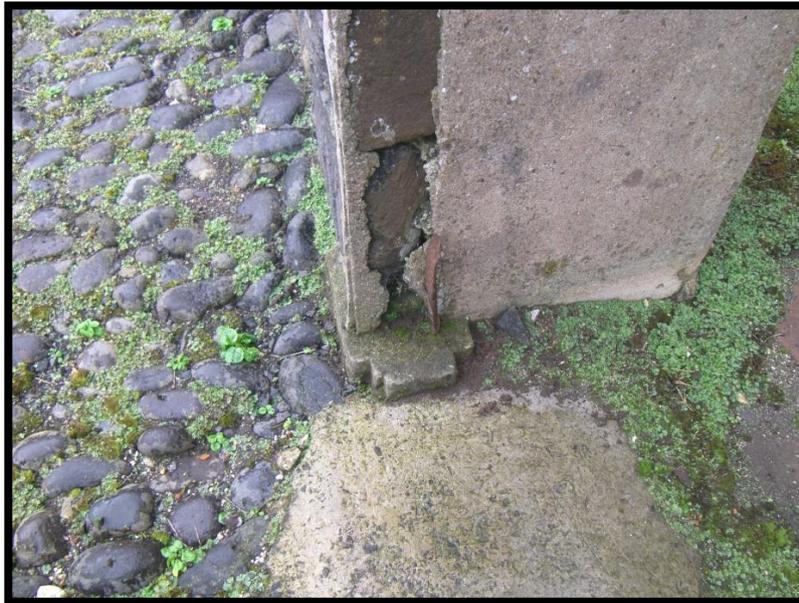
It measures 7.5m in length and 4.25m in width. There are substantial floors and windows and this building appears to have two distinctive rooms. One area is cobbled and the other has concrete ribbed paving, which may possibly have enabled animals to grip more easily. One metal ring remains on the back wall, which perhaps had been used for tethering animals. Red brick lintels are found above the door and the windows. The upper windows have brick edging on the inside but natural stone on the outside. Concrete beams have been inserted above the doorway. Perhaps, this is a modern feature used to strengthen the structure. At the bottom of the ground floor door jamb, there is a decorative edging on both sides at floor level.

Figure 25: Decorative edging at front step of Room 2

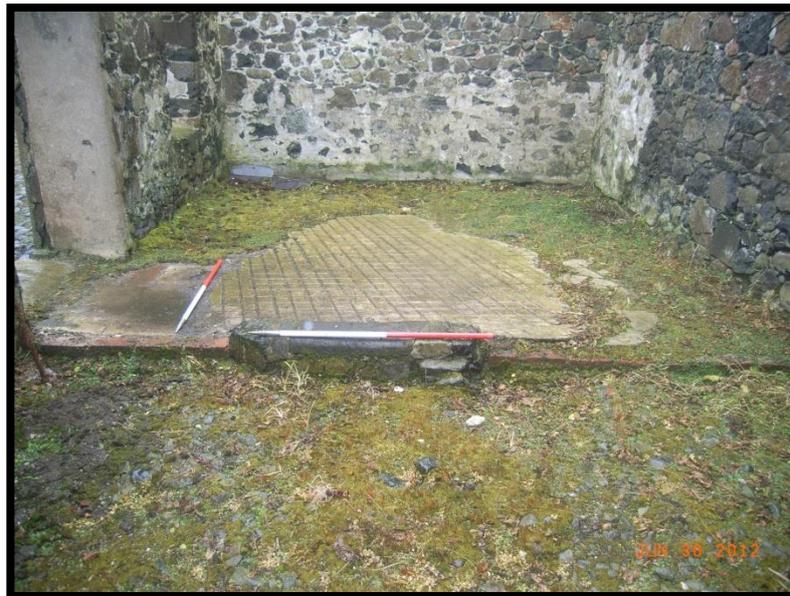
Figure 26: Evidence for two distinctive areas within Room 2 and the connecting doorway

A partition is evident between the two distinctive rooms/areas within Room 2 and there appears to be a doorstep also. The doorstep has holes drilled into it and the distance between the two holes measures 0.95m.

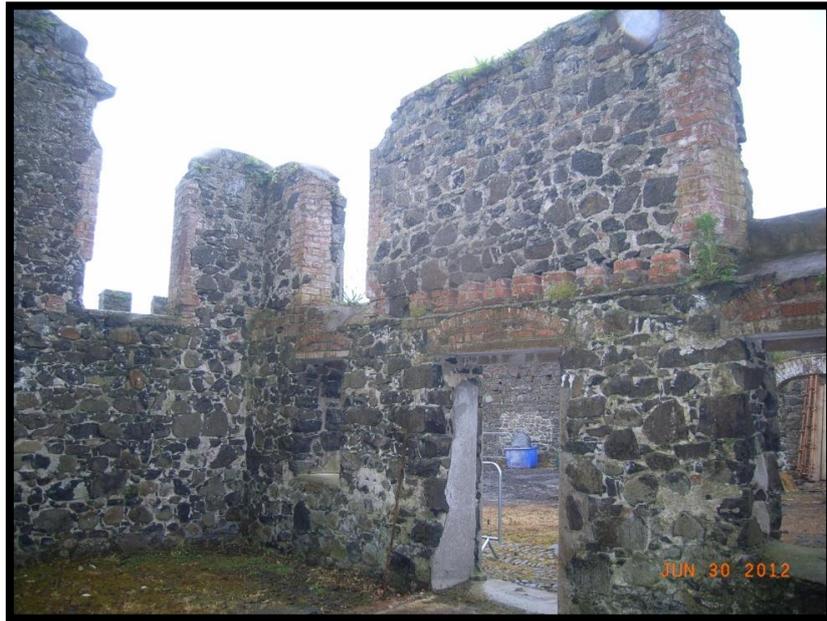
A doorway exists on the first floor, leading to Room 3. This door measures 1.04m in width and is approximately 2.6m above ground floor level from within Room 2. When viewed from Room 3 side, the doorway measures 1.12m wide and 2.82m from ground floor level to the doorway sill. The main entrance to Room 2 has an unusually wide doorway, measuring 1.26m from the inside and 1.22m from the outside. This doorway is 2.02m tall. The windows are quite symmetrical with two small windows at ground level and two larger windows on the first floor. The two ground floor windows measure 0.78m wide/1.34m high

and 0.75m wide/1.29m high respectively. The upper windows are 1m wide on the outside of the building and 1.1m from the inside. These upper windows have concrete sills.

Figure 27: Interior of Room 2

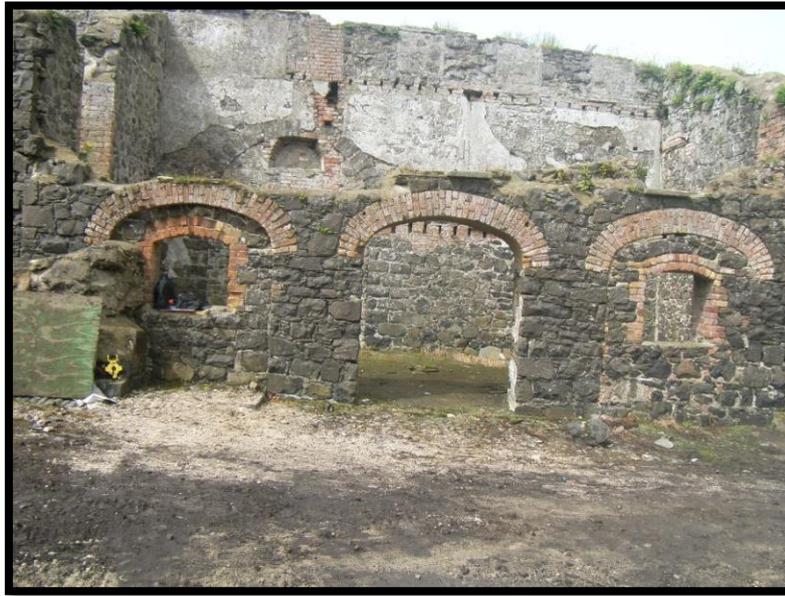
This 2-storey building is more impressive in every way, with an ornate frontage of three substantial red brick arches and several windows. The overall length of the building is 10.8m and its width is 4.25m. It is possible that this was indeed the site manager's residence or the gas manager's residence, as the actual domestic gas works are close by. The three red brick arches are identical in size, but the two outer arches have later been blocked with stonework and decorative brick edged windows. On the left hand side of the doorway, the blocked-up stone/brickwork is not perfectly keyed into the main structure, but on the right hand side it is perfectly keyed into the main structure, as illustrated below. The upper floor had three windows directly above the three arches. Once again, the walls are 0.60m thick.

Figure 28: East-facing elevation of Room 3

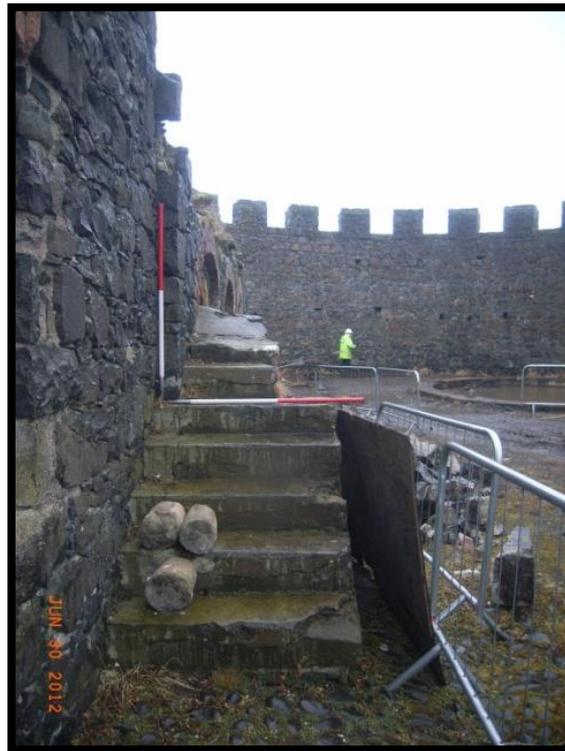
Outside steps lead to the loft, which runs the entire length of Rooms 1, 2 and 3. At present only 7 steps survive, each approximately 1.2m wide. This flight of steps does respect the window and it is thought that a platform was built up like a landing to enter the door.

Figure 29: External steps leading to loft area

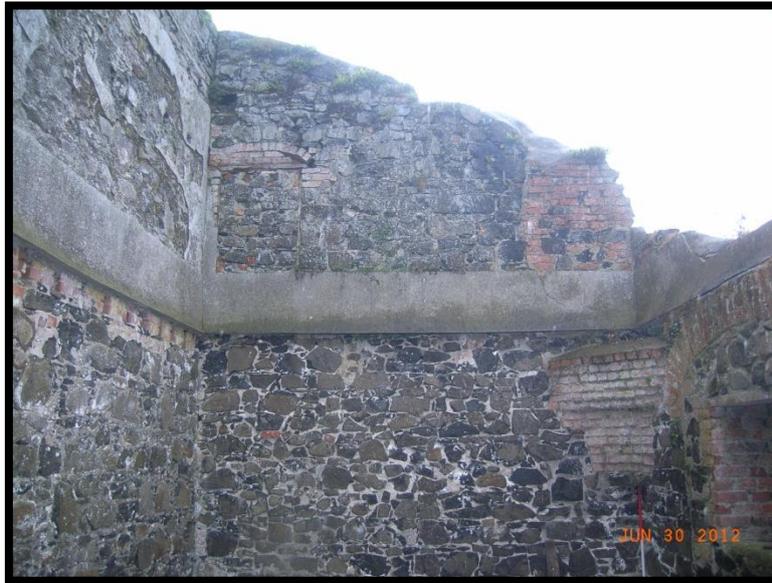
The walls are plastered and substantial concrete skirting is found on three walls of one room on the first floor. Perhaps this concrete skirting was designed as an attempt to mouse-proof the building. There is evidence for a chimney, which is now bricked up. In one corner of the ground floor there is red brick corbelling, which perhaps was intended as additional support.

Figure 30: Concrete skirting above and red brick corbelling below

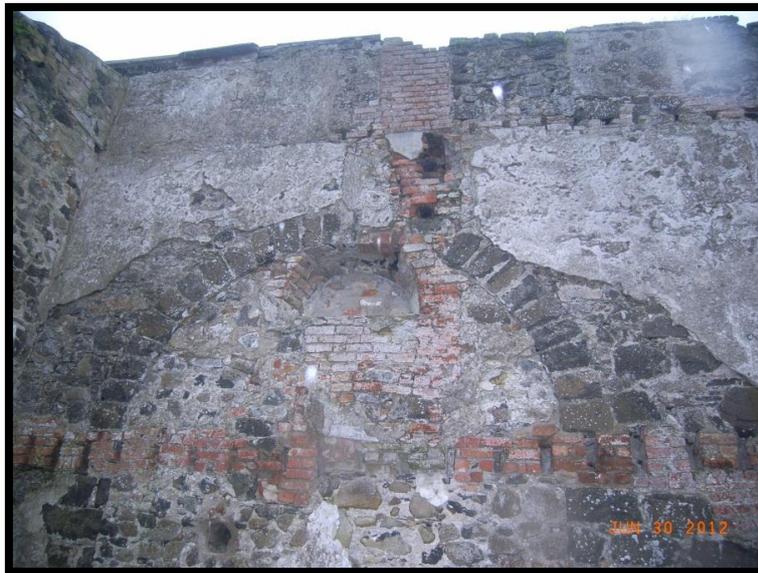
To the left of the doorway of Room 3 and set into the west wall, a huge original stone-edged arch starts at the dividing wall and it follows through this building, matching the exterior perfectly. This arch is 3.3m wide.

Figure 31: Original stone-edged arch within the west wall of the West Yard

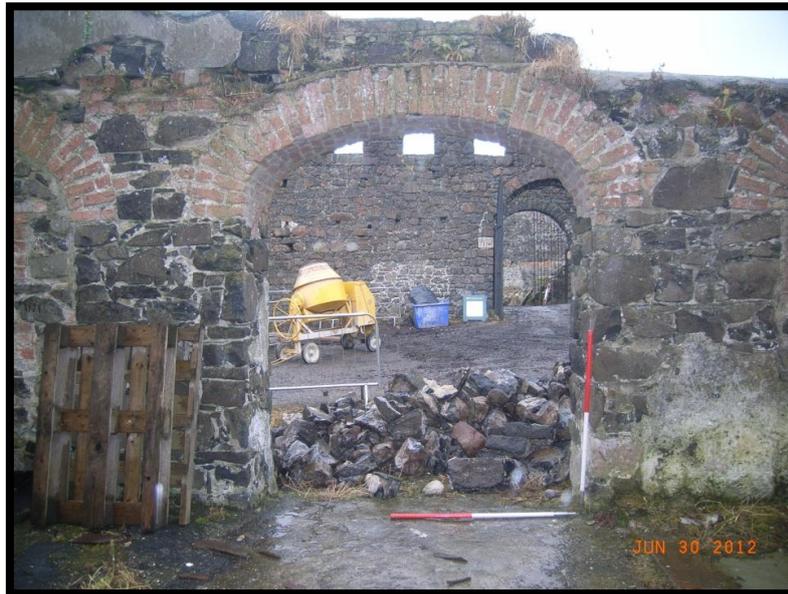
At this point, there is a row of large, what appears to be parallel arches from West Yard to East Yard, marking the gateway into the West Yard, the gateway into the East Yard and a gateway in the east wall of the East Yard.

Figure 32: Evidence for parallel archways, travelling through West and East Yards

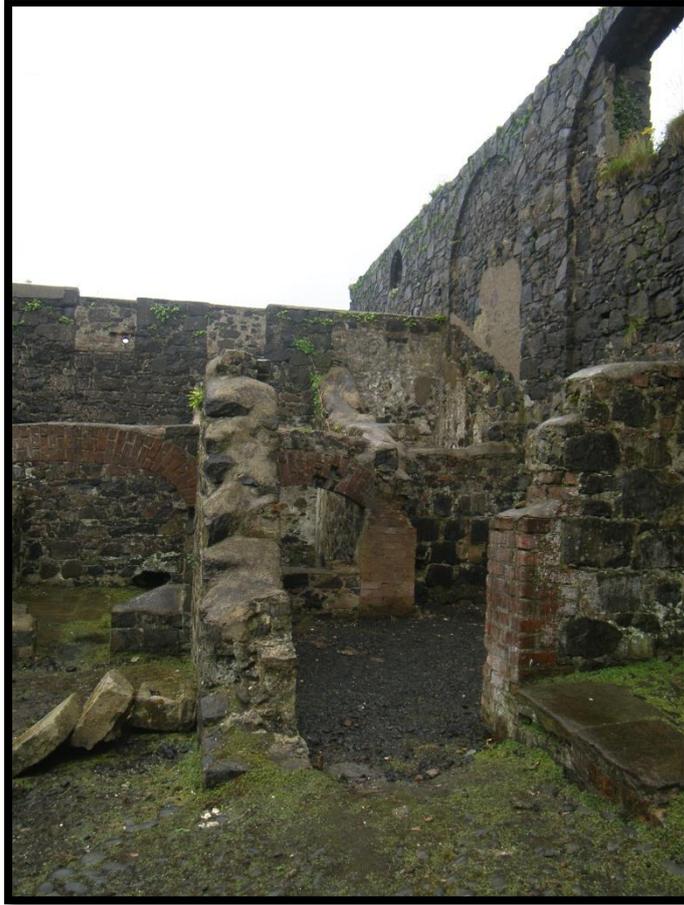
The doorway at one corner appears to be at a height, but the floor level is matched on the other side. The walls in this part of the building are 0.50m wide. One floor in 4b has large flagstones, each approximately 0.5m square. A window, which was originally a doorway, measuring 0.8m wide, is evident between Rooms 4a and 4b. The wall on the left hand side of this window measures 0.41m wide and on the right hand side, the wall measures 0.3m wide.

There is a blocked doorway between 4b and 4c. This originally measured 1.3m wide, but as it is now blocked on one side by red brick, its width has been reduced to 1m. The internal width of the doorway is 0.9m. A ledge along the wall measures 0.25m wide and stands 0.42m high. This ledge or footing appears to be the actual foundation for the main stone wall.

Figure 33: Rooms 4a, 4b and 4c, with Bay 4 arch visible on the left

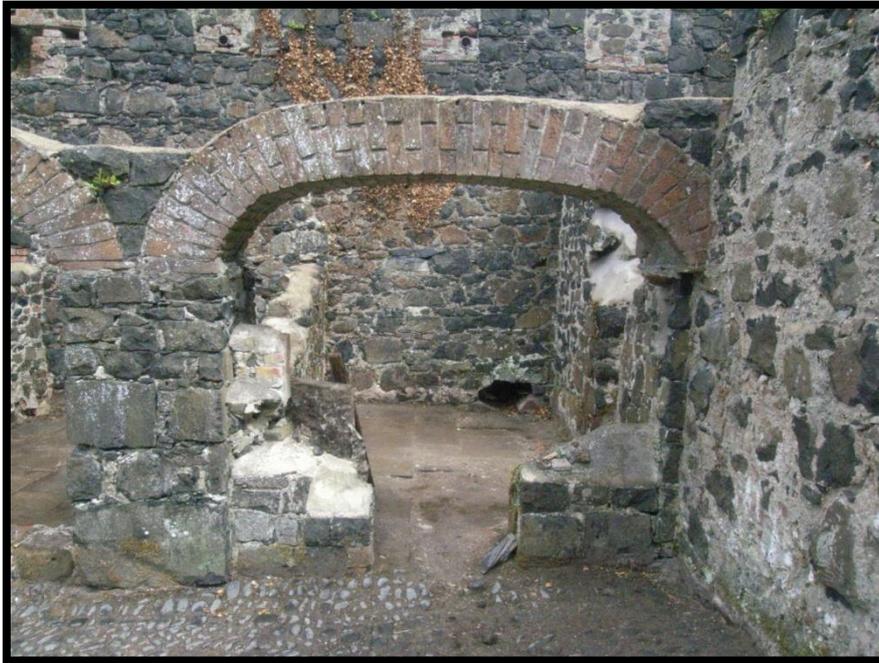
These bays are currently referred to by the National Trust as fuel stores. It is highly probable that this fuel included coal and coke, which were both associated with gas-making. Coal, logs and peat were all likely to have been used within the mansion for domestic purposes.

Figure 34: Bay 4 with its red brick arch, adjoined to Room 4b

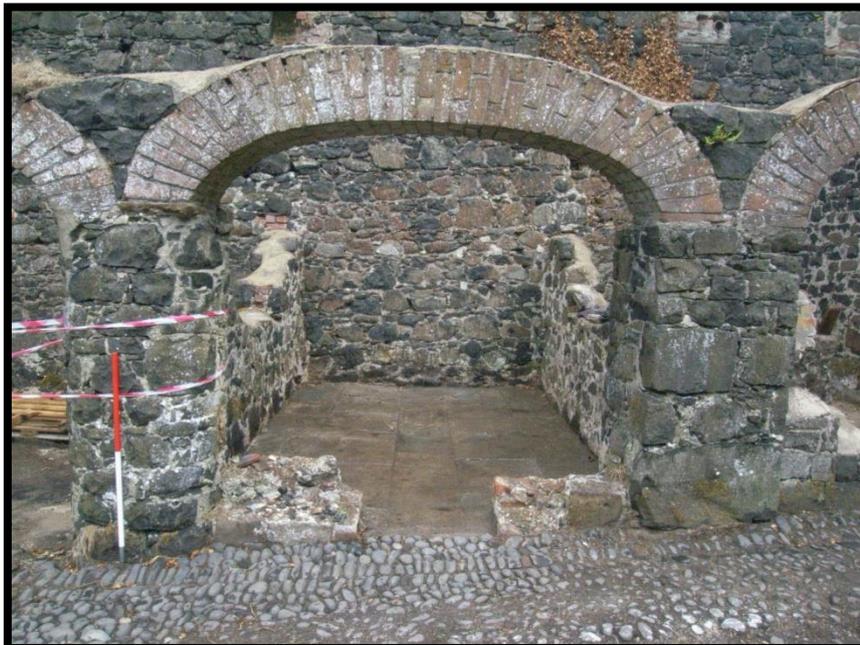
Figure 35: Bay 3 with a well-preserved area of cobbling adjacent to the entrance

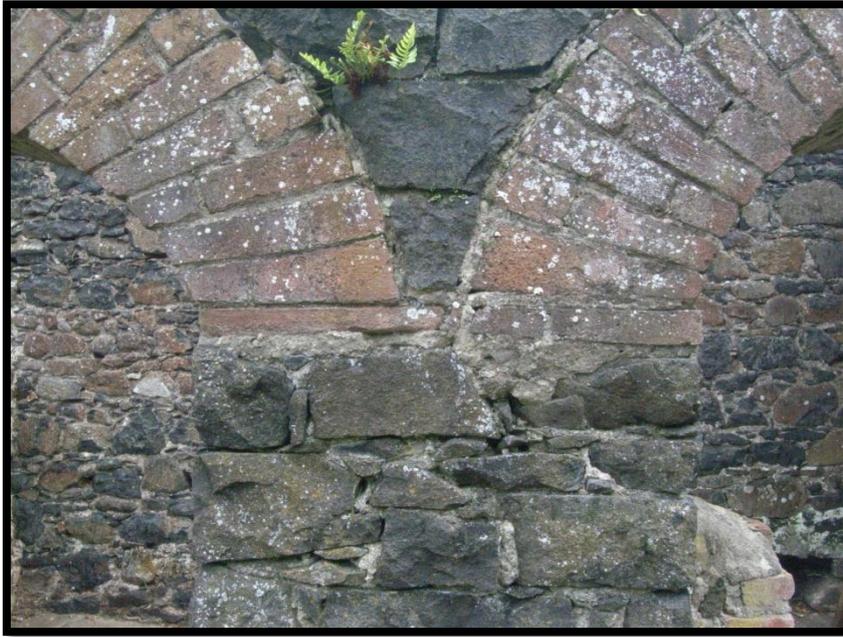
Figure 36: Well-constructed red brick arches identified in Bays 1-4
