# **ULSTER ARCHAEOLOGICAL SOCIETY**

Survey Report: No. 10

Survey of Davagh Lower, Stone Circles and Alignments, County Tyrone UAS/07/04

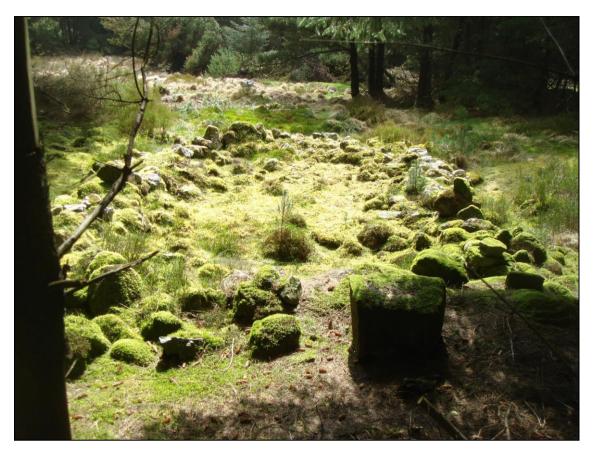
Figure 9: Hut Site viewed from the north

Site VI, the "hut", has been largely cleared of vegetation. Its original purpose remains enigmatic. It consists of a dry stone walled structure built of fairly well rolled boulders from the boulder clay, but incorporating at least one large glacial erratic at the north end which seems to be in its original position embedded in the foot of the esker. The structure measures 8.85 m by an average of 5.10 m internally and 11.60 m by roughly 6.80 m externally. This is slightly longer than Davies' measurements, which reflects the very tumbled nature of the walls. Its shape is as described by Davies, roughly parallel sides and two apsidal ends. However, it should be remembered that the whole construction is far from precise. It appears too wide in its minor dimension to be a hut of the historic period. Internal clearance of the site may reveal internal post holes and possibly a hearth, typical of a Neolithic house, but it could just as easily be an 18<sup>th</sup> - 19<sup>th</sup> century sheepfold. Whatever it is, there is no apparent entrance opening in the walls, although the tumbling of the stones could be concealing one."

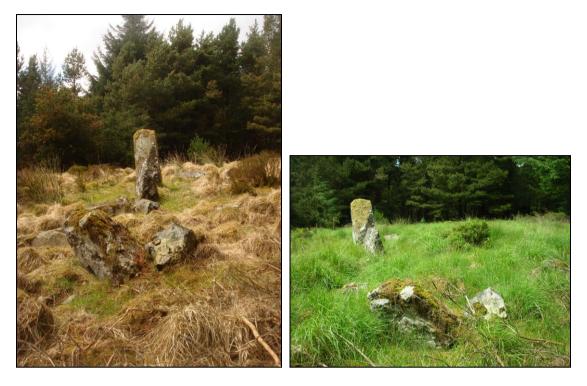
Figures 10a & 10b: Tangential alignment viewed from west (April 08 & July 07)

On its north side is a short tangential avenue, ENE-WSW, the south side of six stones in a 30ft (9m) long line, the west[sic] a meandering 44ft (13.4m) of ten stones.

The survey revealed that there appears to be a significant extension of the tangential stone alignment for up to 30 m in an easterly direction within the forest. The forest clearance of 1977 only served to expose the most obvious archaeology, leaving the smaller stone circle, as described by Davies, and the possible continuation of the stone alignment covered and therefore very difficult to survey (see fig 17 below).

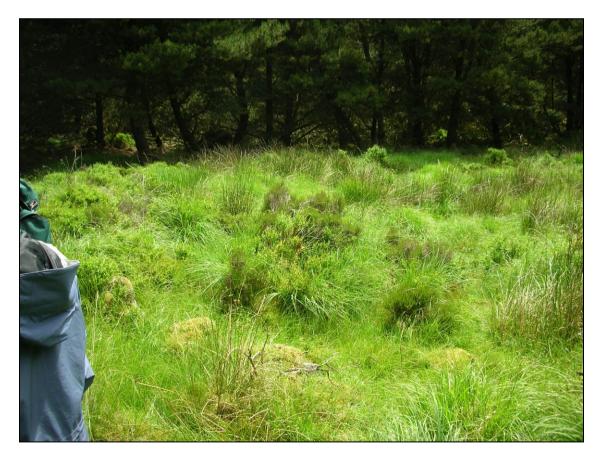
Figure 11: Double stone circle viewed from north

A. It is an *oval ring* 53 ft (16.2m) across, but with its almost contiguous stones, 1ft 6ins to 2ft 6ins (0.5 - 0.8m) high, encircling what may have been a 6ft (2m) wide bank lined with inner slabs. There are many slabs missing at the north and east.

The double stone circle, arguably the largest and most important feature of this site, is almost impossible to see in its current overgrown state. It was not formally surveyed, however a photograph was obtained with members of the survey team standing on the perimeter of the outer circle to give an idea of its size:
