Survey Report

Reference: Survey Report No. 48

Stone Enclosures Avish County Londonderry In association with:

Avish circular enclosures

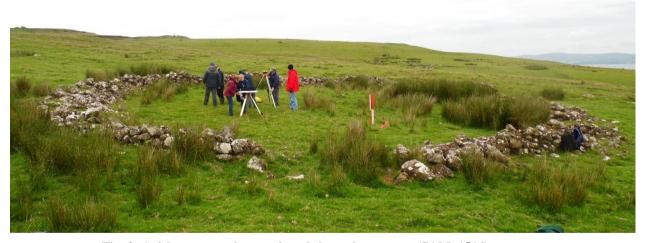
Fig. 3: Avish upper enclosure viewed through entrance (SAM_1514).

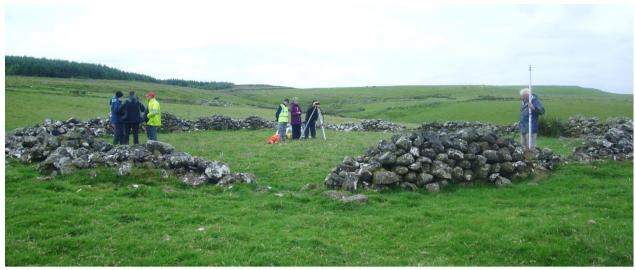
Fig. 4: Avish lower enclosure viewed through entrance (RIMG0007).

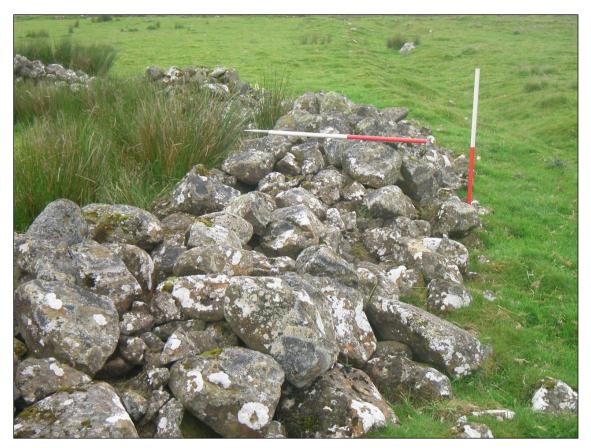
Fig. 8: Upper enclosure, west side from north, dry ditch to west. (RIMG0021).

Outside the enclosure to the west a ditch runs in a northerly direction (fig. 8). From this a bank runs in an easterly direction, keeping north of the enclosure, and becoming part of a field system (fig. 14). This bank forms the southern boundary and the ditch the western boundary of a small field approximately 36m (E-W) by 23m (N-S). Beyond this field is a trackway, 3m wide and 43m - 46m north from the outside wall of the enclosure. The track is defined by a bank of boulders, 2m wide, on the north side and a grassy slope with cropping rock on the south side (figs. 23, 31). The track continues to the clachan in a WSW direction, almost parallel to the Bishop's Road. The clachan is divided by, but mostly beyond, a little ravine which looks like the course of a stream (fig. 30). The bed was dry and grassy although a large amount of rain had fallen two days before. Some gorse grows on the steep slopes.

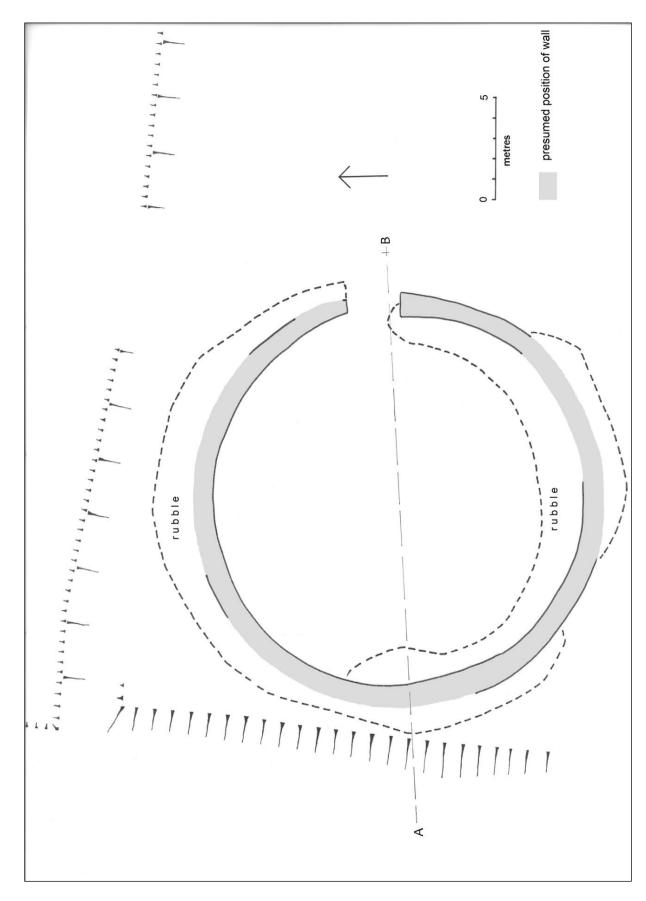
Fig. 9 Plan of upper enclosure.

The enclosing wall is drystone build of irregular basalt fieldstones, ranging in size from 0.1m to 0.65m maximum dimension. The wall has a present height varying from 0.1m to 0.9m. The original footing and face of the wall is much obscured by tumble. In part, especially the NW quadrant, there appears to have been an attempted repair. The thickness of the wall seems to have varied 0.60m - 1.00m.

On the eastern side is a gap, which may have been the original entrance. The north side of the gap is faced with a sub-rectangular boulder 0.7m wide (E-W), 0.35m high, and 0.38m thick (figs. 9, 13). The south side of the gap lacks definition, but *in situ* wall material begins at a distance of 2.75m from the face of the described boulder.

The limit of spread of the fallen rubble was surveyed and the outer and inner faces of the wall where they were exposed.

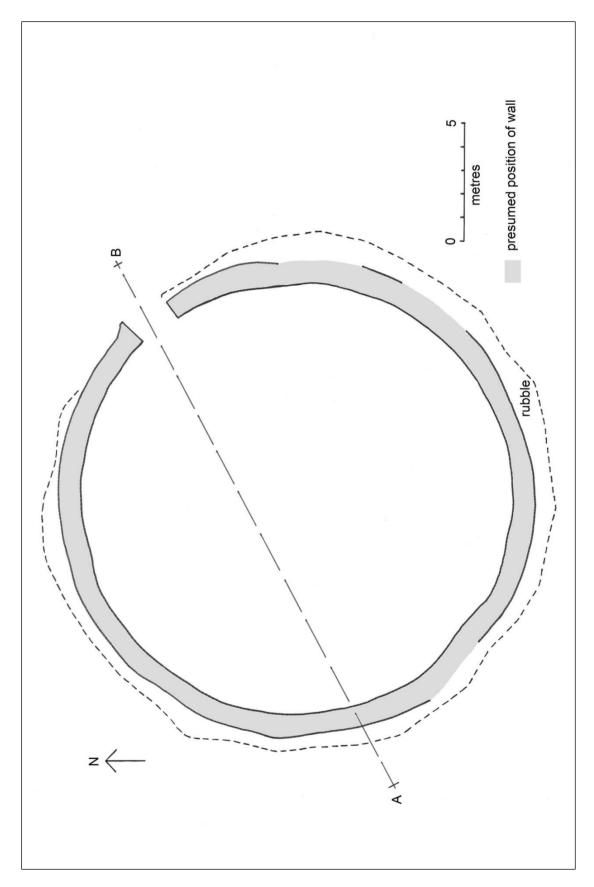
Fig. 10 Plan of lower enclosure.

The wall is made of basalt field stones heavily encrusted with various types of lichen (black, white, grey, orange/brown) and moss. The outside wall has patches of definable wall face with much tumble up to about 1m from the wall face. There appears to be an earth-fast alignment of stones around the base of the tumble consistently about 1m from the wall face. The inner wall is much better defined, standing 1m in places with well faced surface. Where the wall is best preserved it appears to be constructed of two parallel faces infilled with smaller rubble (figs.

16, 17). In places a certain amount of rebuilding is suggested where stones are built up without regard to the formation of a regular face.

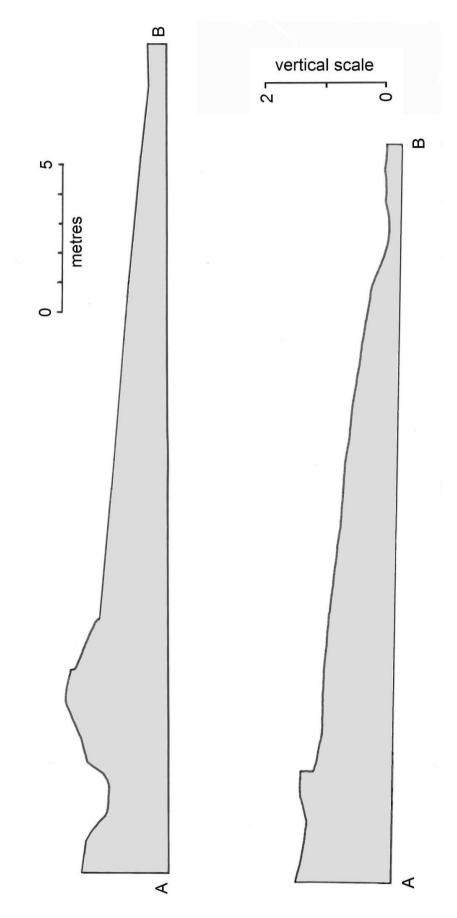
Fig. 11: Section, upper enclosure. Fig. 12: Section, lower enclosure.

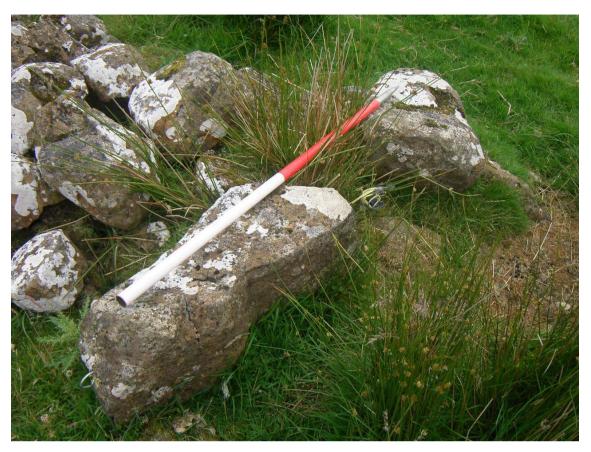
Fig. 13: Upper enclosure, stones at entrance, north side. (RIMG0029).

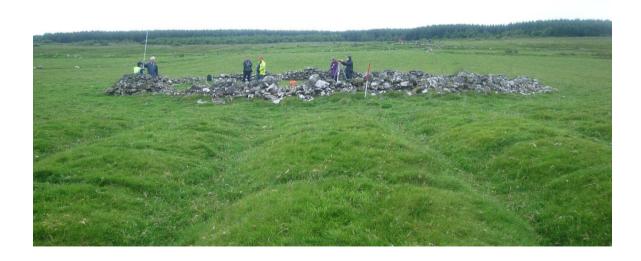
Fig. 15: lower enclosure from north showing lazy beds (RIMG0013).

Immediately north of the enclosure are strongly defined lazy beds, running north-south (figs. 15, 27). Generally they are narrower at the north end, but some are wedge-shaped and do not reach the south edge of the cultivated area.

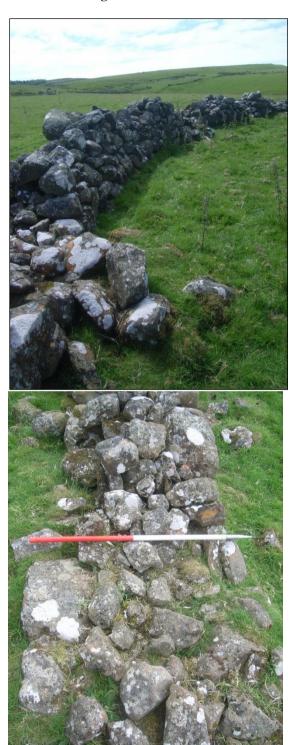
Lower enclosure Fig. 16: interior (RIMG0088)

Fig. 17: wall width, collapsed section (RIMG0035)

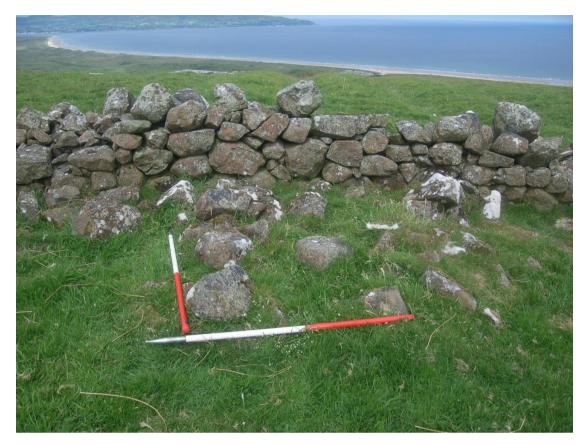
Inside the wall, and butted against it, are a number of "stone structures". Though difficult to interpret, most are about 1m x 1m. One at the W/WNW is a little larger (fig. 18). In some places there also appears to be an arc of stones paralleling the wall.

Fig. 18: lower enclosure, internal structure against wall (RIMG0059).

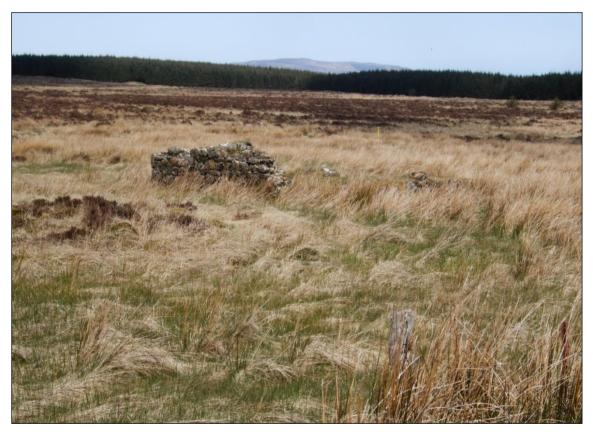
Fig. 25: remains of the cottage occupied by Ross and then Cummins.

Ross lived in a cottage 1.5 km southeast of the enclosures, beside a road which connected Articlave and Milltown with Limavady, but was not maintained across the deep bog, so became merely an access road for turbary. The cottage was in the ideal position for monitoring peat cutting. It did not appear on the OS map of 1852, so was presumably new when he moved in (fig. 25).

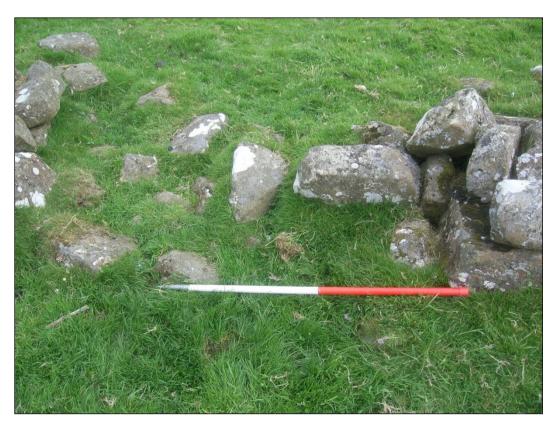
There is an apparent entrance on the east side (fig. 26). Here the wall profile can be clearly seen on the north side where it is about 1m wide, tapering slightly to the top. On the south side of the entrance, on the inner face, there is a squared stone defining a possible small niche. On the west side there may be another entrance, though the wall is more disturbed here.

Fig. 26: lower enclosure: entrance on east side, looking east. (RIMG0043)

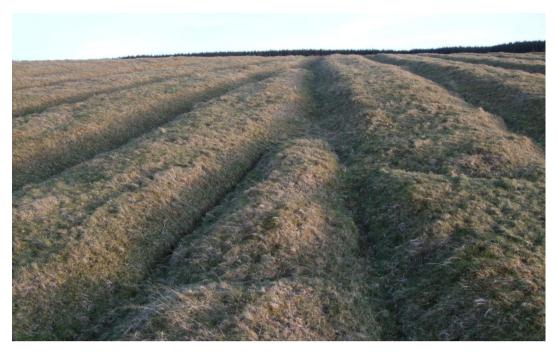
Fig. 27: lazy beds north of lower enclosure – looking south.

A map which accompanies Bulter's *Survey* is dated 1824 and beside "Evish" has the note, "grain grown at 550 feet". If the beds beside the lower enclosure were used for grain (barley, oats, or rye), harvesting with hand tools would leave their shape undisturbed.

The irregular pattern of the ridges north of the lower enclosure leads to the assumption that spade cultivation was not superseded by mechanised agriculture, which requires straight, regularly spaced drills (Bell 1999 : 410), but by grazing, which has preserved the surface from the time of the last crop.
