Evaluation Report No. 234

Glynn Old Church
Glynn townland
Glynn
County Antrim

AE/11/111

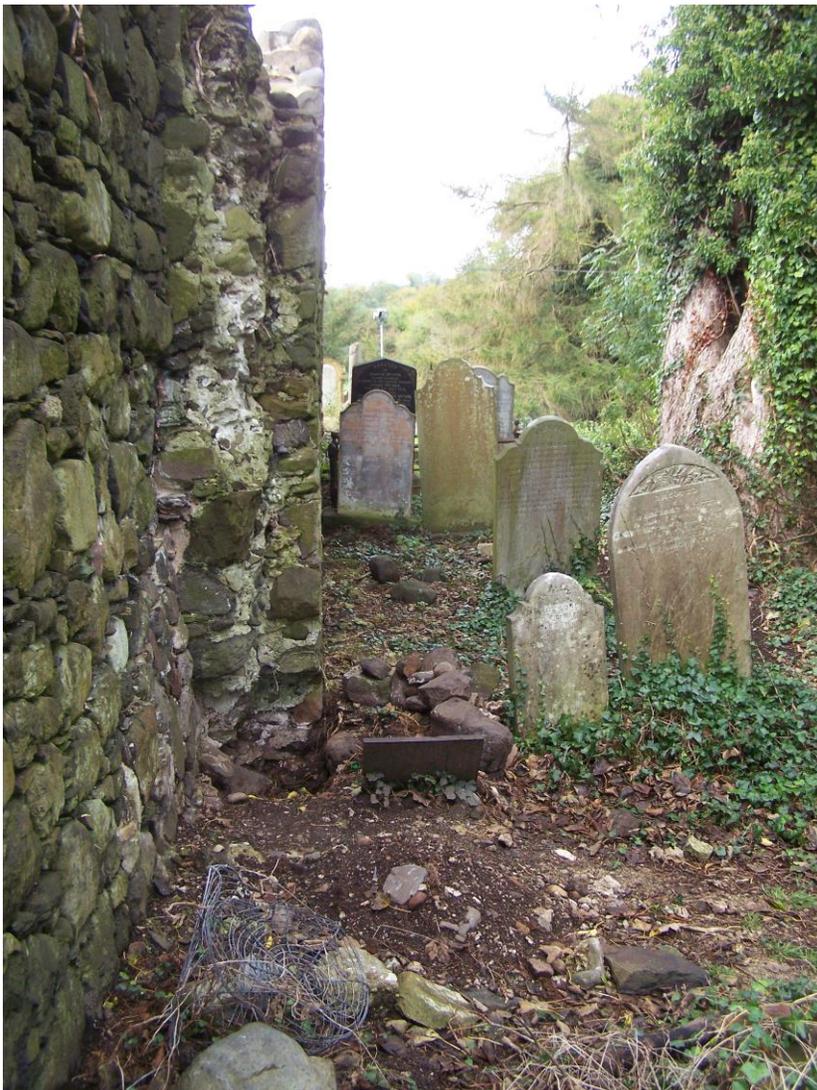
An area 1.00m (along wall) by 0.50m (out from wall) was opened. Only one context was excavated, a graveyard soil of dark brown loam, which contained some bone. Stones became loose and fell from the wall below ground level as soil from round them was removed. During the second day of excavation Andrew Gault requested that work be discontinued due to health and safety concerns and concerns about the undermining of the walls. An average depth of 0.60m had been reached in the test pit.

Plate 1: Exterior north wall of chancel where it meets exterior north-east corner of nave, and location of Test Pit 1; looking west.

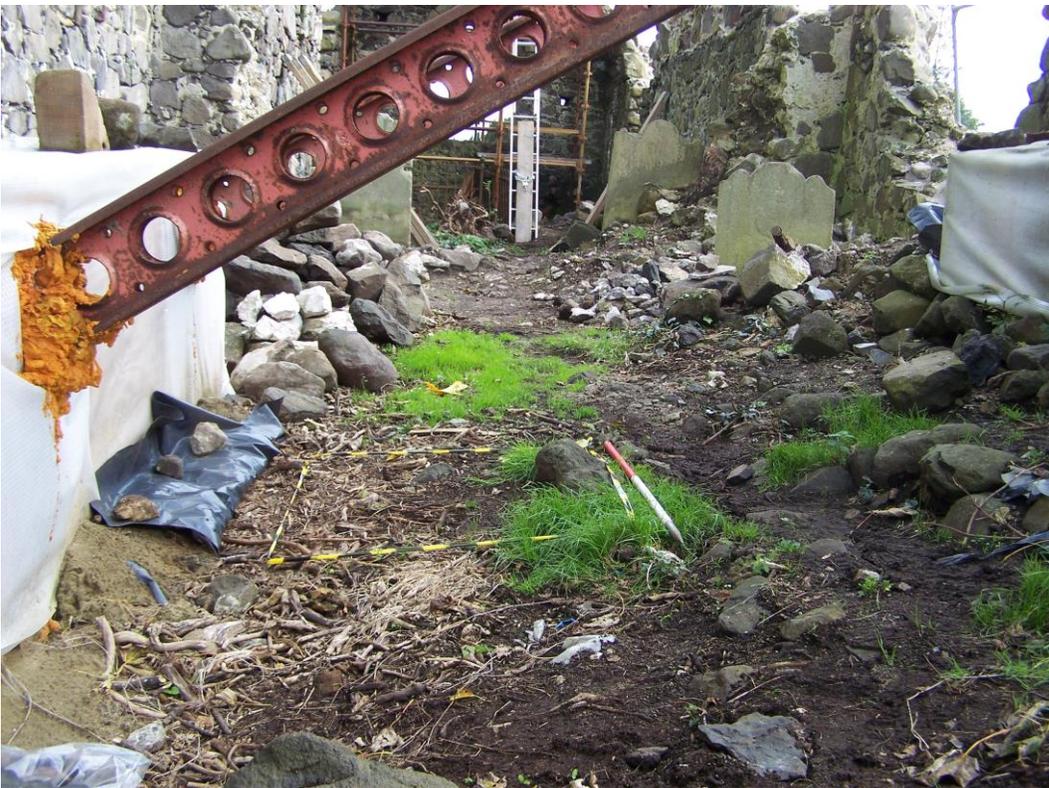
Test Pit 2 was located in the interior of the nave, it measured 1.00m by 1.00m and was an average depth of 0.15m to 0.20m. A structural engineer's report stated that the prop pad would have to be set 0.15m into the ground and would have dimensions of 0.90m square. This test pit was required to hold a prop pad, the prop would lean against the interior of the longest south wall of the nave to help support it. Removed from this test pit was soil that had built up inside the church containing some bone (30 pieces, probably human), stone and modern waste (plastic). No articulated human remains were encountered.

Plate 9: Interior of church, looking east from west end of nave to east wall of chancel (behind scaffolding), with Test Pit 2 pre-excavation in foreground. (scale 1m)

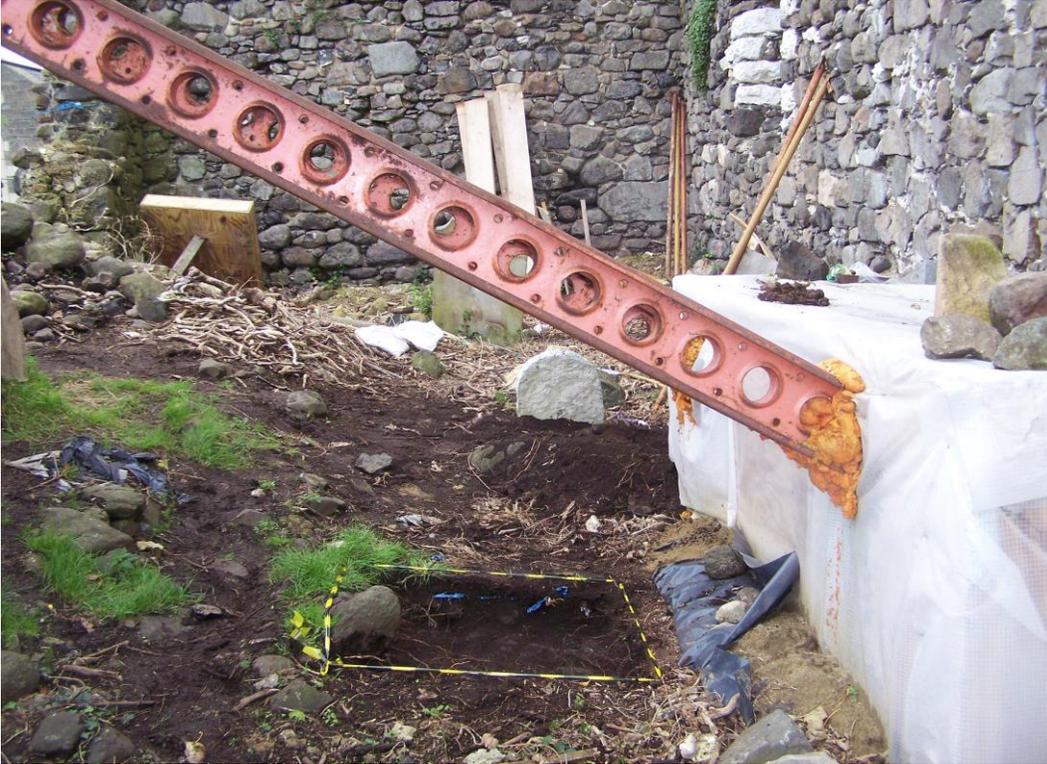
Plate 10: Interior of nave looking west to west wall of nave, with Test Pit 2 post-excitation in foreground.
