ULSTER ARCHAEOLOGICAL SOCIETY

Survey Report: No. 17

**Survey of the Doon Enclosure at Murlough Bay,
County Antrim
UAS/09/02**

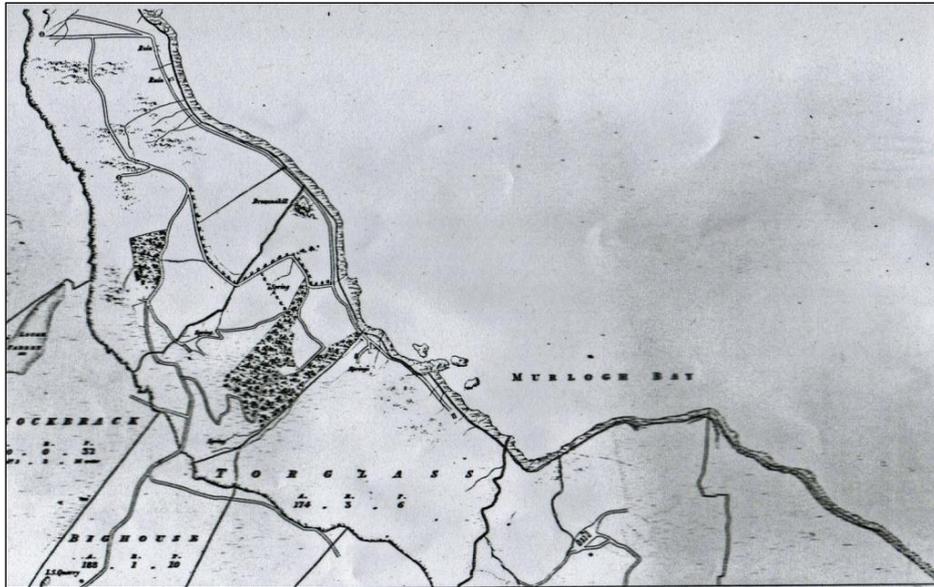
Figure 3: OS County Series Antrim Sheet 5 (part of) 1834

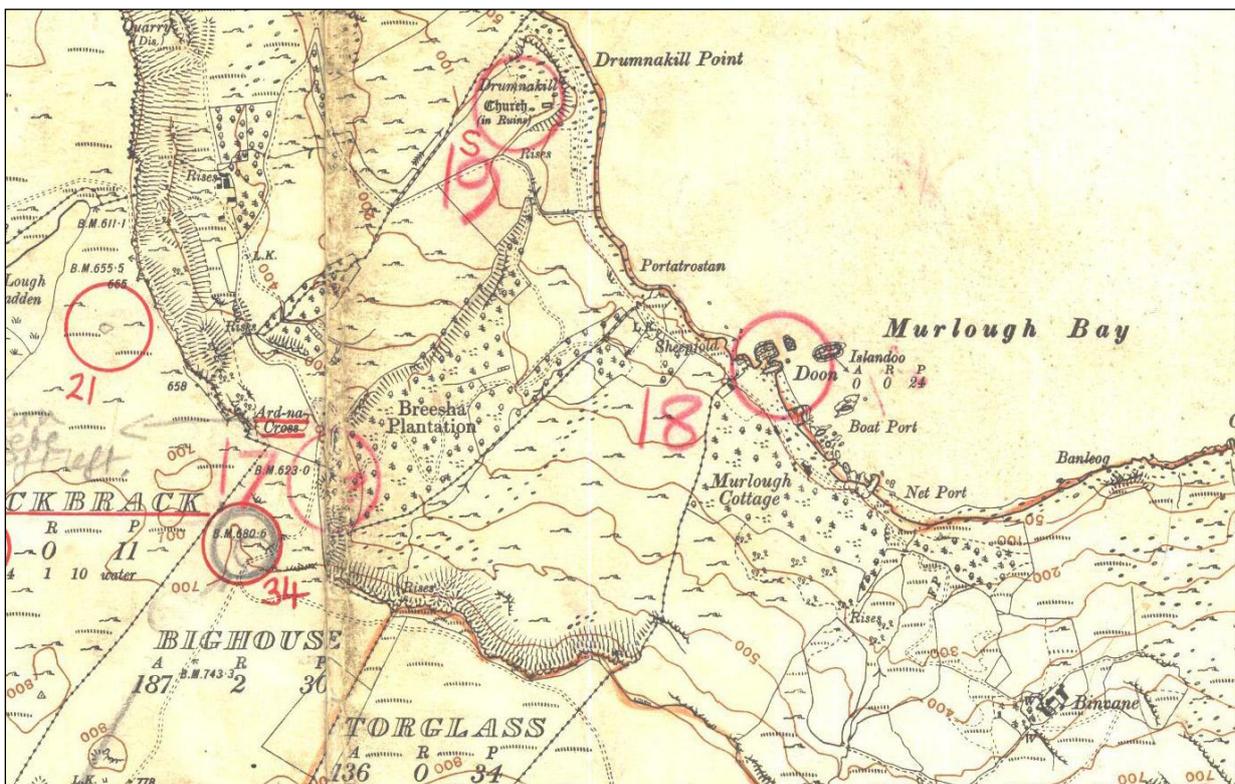
Examples of the OS maps surveyed are illustrated below. A brief survey note SMR 5:18 dated Oct 1992, for site 18 in Fig. 4 exists in the NIEA archive. The note focussed on the adjacent cone shaped rock outcrop (Doon), noting that it provides a good vantage point. The author also describes the Doon enclosure as “the footings of a modern rectangular wall” abutting the outcrop.

Figure 4: OS County Series Antrim Sheet 5 (part of) 1935
(The Doon Enclosure is located in area 18)
