ULSTER
ARCHÆOLOGICAL
SOCIETY

Survey Report

Reference: **Survey Report No. 56**

**Horse Gin
Creevyloughgare
Saintfield
County Down**

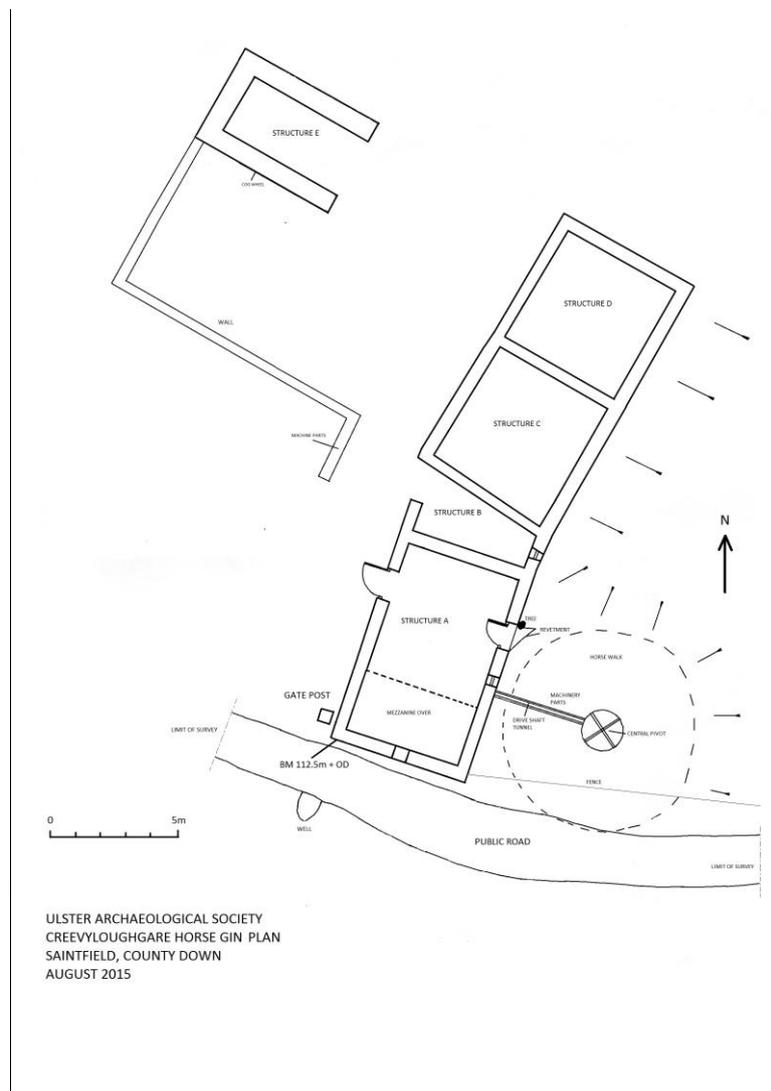
Figure 05: Plan of horse gin and vernacular buildings

The principal aim of the survey was to record the part of the horse gin mechanism that had been exposed during the archaeological excavations of August 2015. However, it was observed that the remains of a number of vernacular buildings were present in the area and these were also investigated.
