ULSTER ARCHAEOLOGICAL SOCIETY

Survey Report: No. 24

Survey of Gasworks, Castle Ward, County Down UAS/10/02

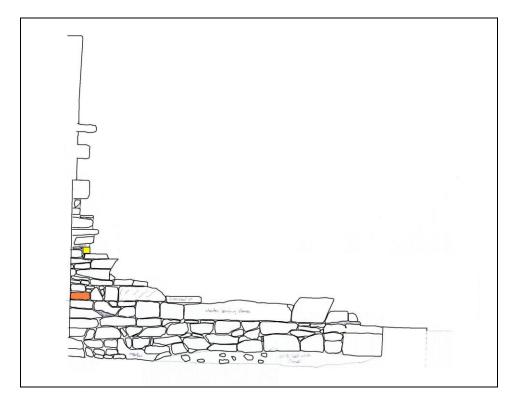
Fig. 10: Elevation of south wall of Retort House, interior. (by Malachy Conway)

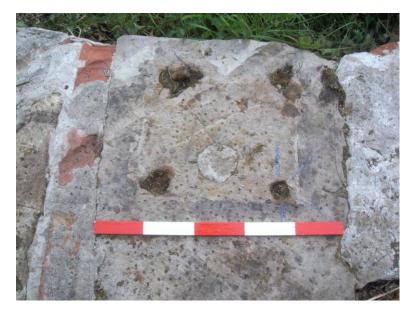
Three embedded sandstone blocks are equidistant from one another and each has four holding-down bolts and a mason's mark on the upper surface (figs. 18 & 19). Two of the blocks are square, but that in the SW is less regular. The rest of the circle is an alternation of concrete with voussoir-shaped stones, apparently of coarse yellow sandstone, brighter in colour than the three finer-grained blocks. The tank has been filled with spoil (reportedly a safety precaution about 1980) and has not been excavated during the project, so the depth remains undetermined.

Fig.18 Sandstone block with bolts (RIMG0079)

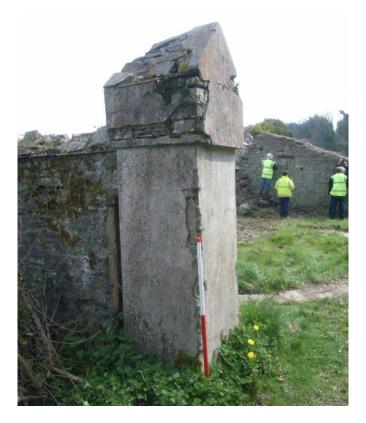
Fig. 20: North gate, east pier. (RIMG0103)

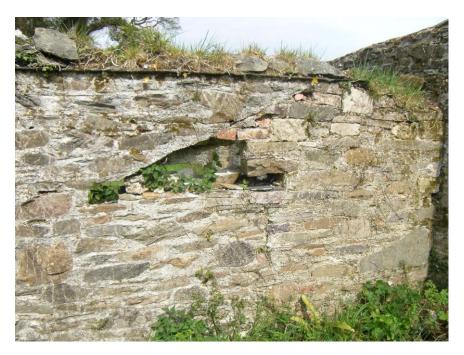
The group of gasworks structures was contained by a wall 45cms. thick, of stone rubble and lime mortar. It abuts the demesne wall at NE and SE and the two rear corners of the coal store. At a height of 1.85m there is a creasing course of slate. Above this a single pitch deflects rainfall to the outside, and the total height reaches 2.15m.

Fig. 21: North yard wall, interior. (RIMG0030)

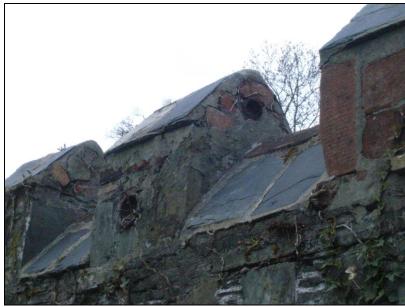
Fig. 23: Merlon near gasholder. (RIMG0092)

A 6" diameter pipe is embedded in the north side of the most northerly merlon, but almost immediately is stepped down to a 3" bore. The second merlon has a 3" diameter iron pipe entering both its eastern and western faces and another on the north side 34 cms. higher (fig. 23). Ivy has choked the pipes so communication between the various ends was not proved.

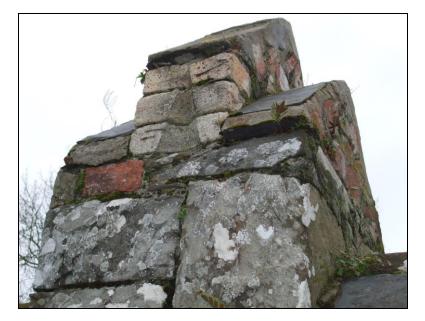
Fig. 24: Double-step merlon. (DSCF1424)

Next to the four single-step merlons comes the five double-step. Their lower steps are similar in treatment to the first four, but for each the upper step is effected with three yellow bricks placed as stretchers, one above another (fig. 24). A tall triangle has been carved into the stretcher face and rises through the full height of all three bricks forming a small niche. The niche is repeated on both outer and inner faces. Ornamental battlements are a common feature on the buildings in and around the farmyard, but none exhibit these dwarf niches.

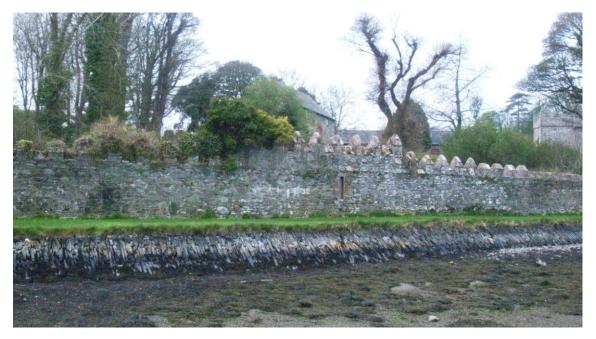
Generally the demesne wall is built of local stone rubble and lime mortar. The top is single pitch deflecting outwards. However, for a length of about 70m, including the gasworks and Coal Quay gate, the wall is crenellated (fig. 25). All crenelles and merlons are double pitched (figs. 23 & 24).

Fig. 25: Demesne wall, farmyard and tower house beyond. (RIMG0095)

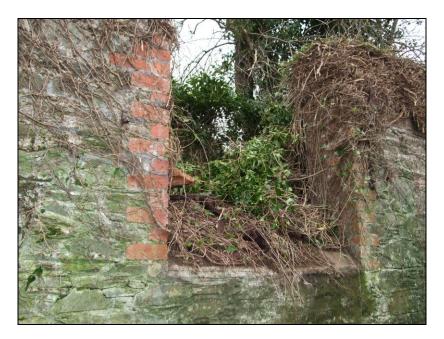
Fig. 32: Interior of Coal Store: chute (3.3.3). (DSCF0840)

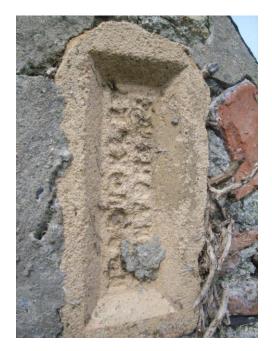
Fig. 34: Buckley brick in merlon. (RIMG0109)

The coal store is trimmed with yellow brick. The brick at the top of the SE corner has parted from sufficient mortar to allow a reading of several letters of the frogmark: "... KLEY". A single yellow brick has been built into the most northerly merlon on the demesne wall leaving its frogmark fully exposed (fig. 34).

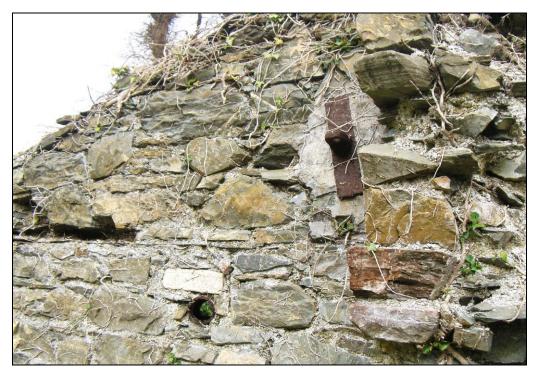
Fig. 39: Interior north wall of purifier house: through-pipe and iron bracket. (RIMG0113)
