Survey Report

Reference: Survey Report No. 68

Survey of Revolving Summer House Sea Plantation, Mount Stewart, County Down In association with: **National Trust**

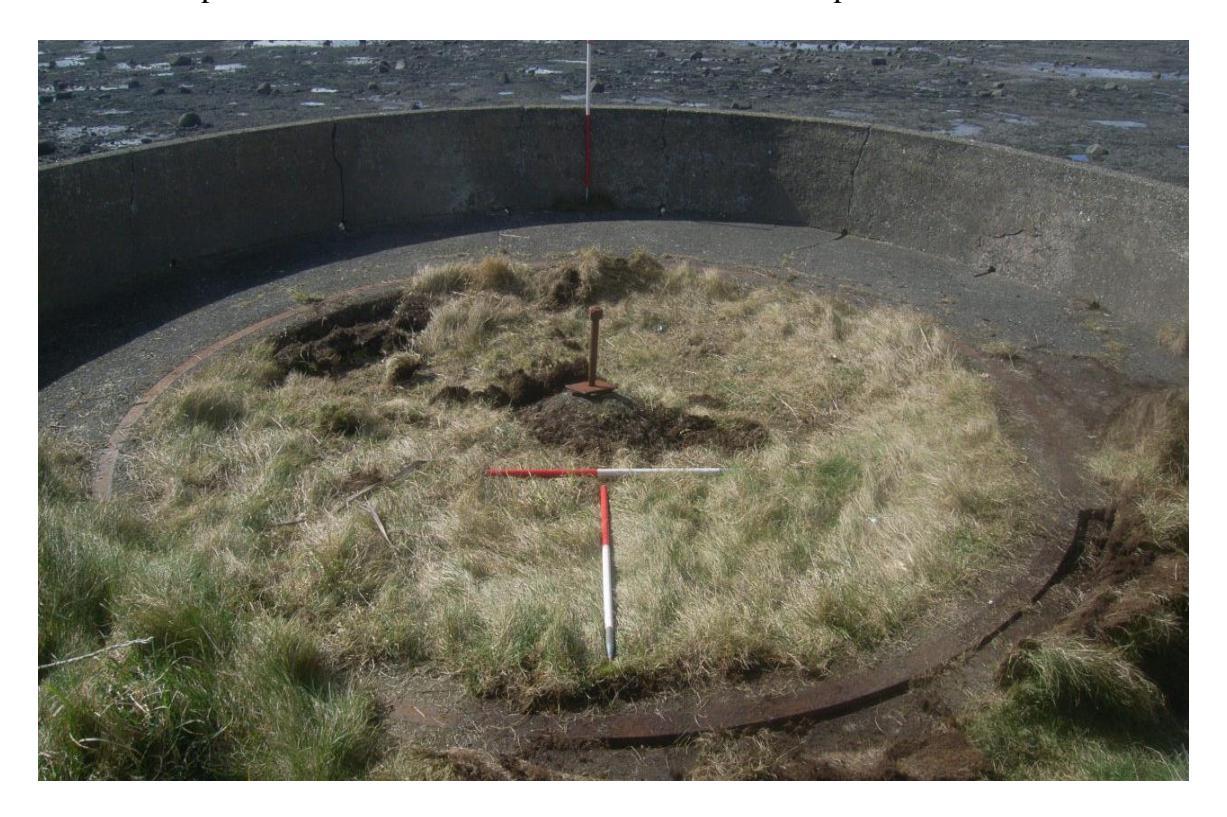
3.6 The revolving summer house at the time of the survey. The circular platform structure of the summer house is still in place.

Fig10 Summer house protective wall, circular platform, iron rail and central axle.

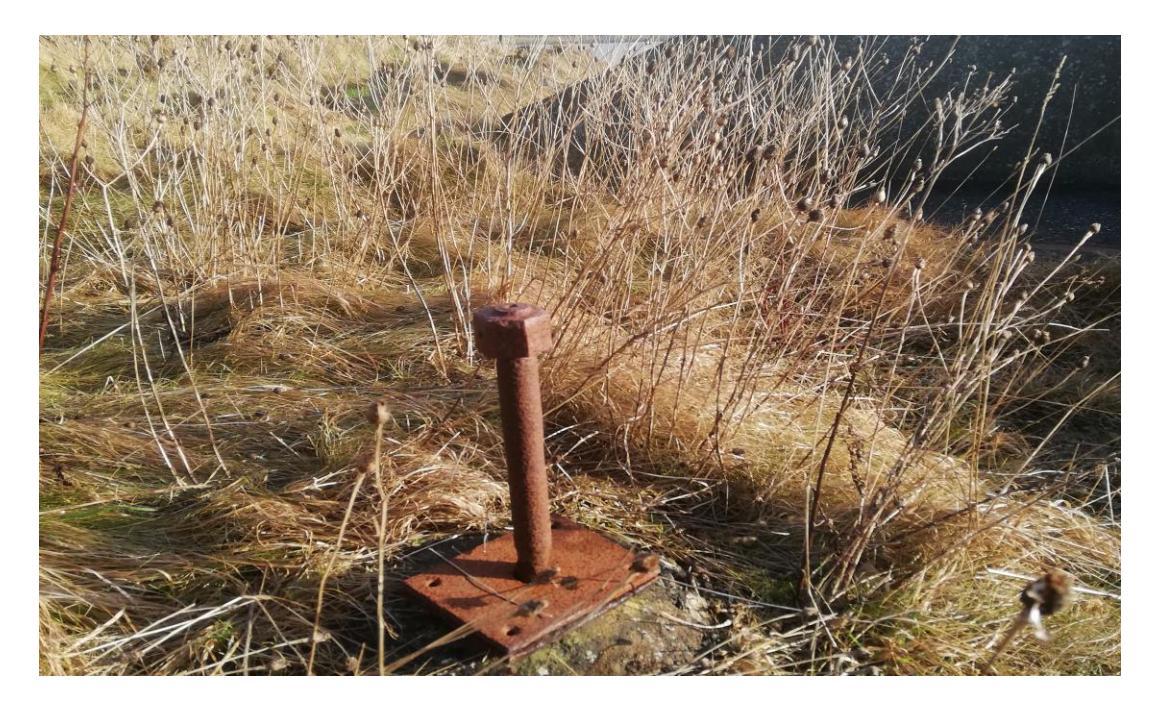
Fig 11 Close up of the central iron axle with a mounting plate

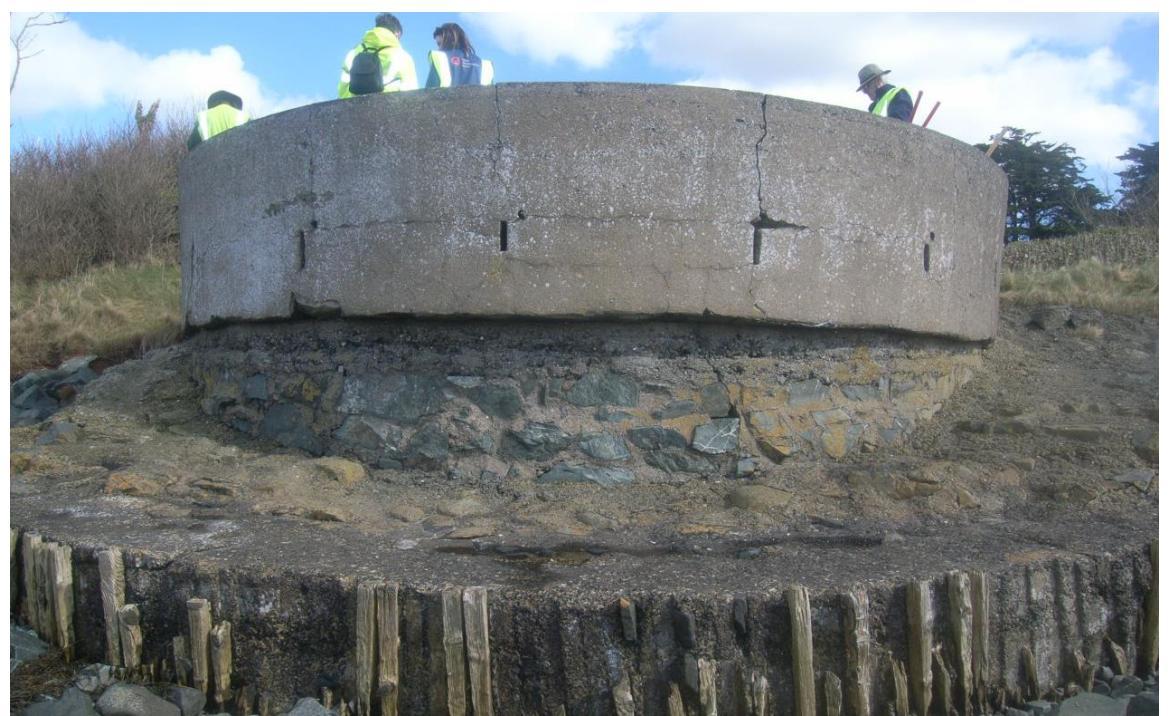
These photographs show the position of the summer house on the bank above the beach, the structure of the wall and the foundation base and the present condition of both.

Fig13 Summer house from the beach, the base, the protective wall and the foundation.

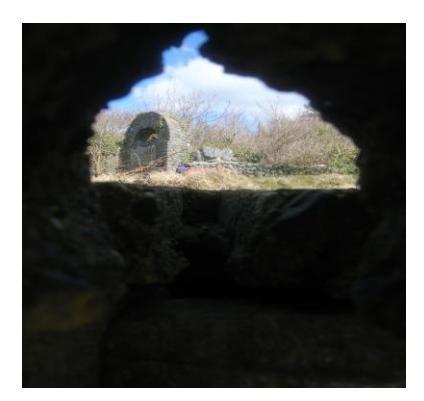
Fig15 Looking through the hole in the wall to the western arched gate of the swimming pool.

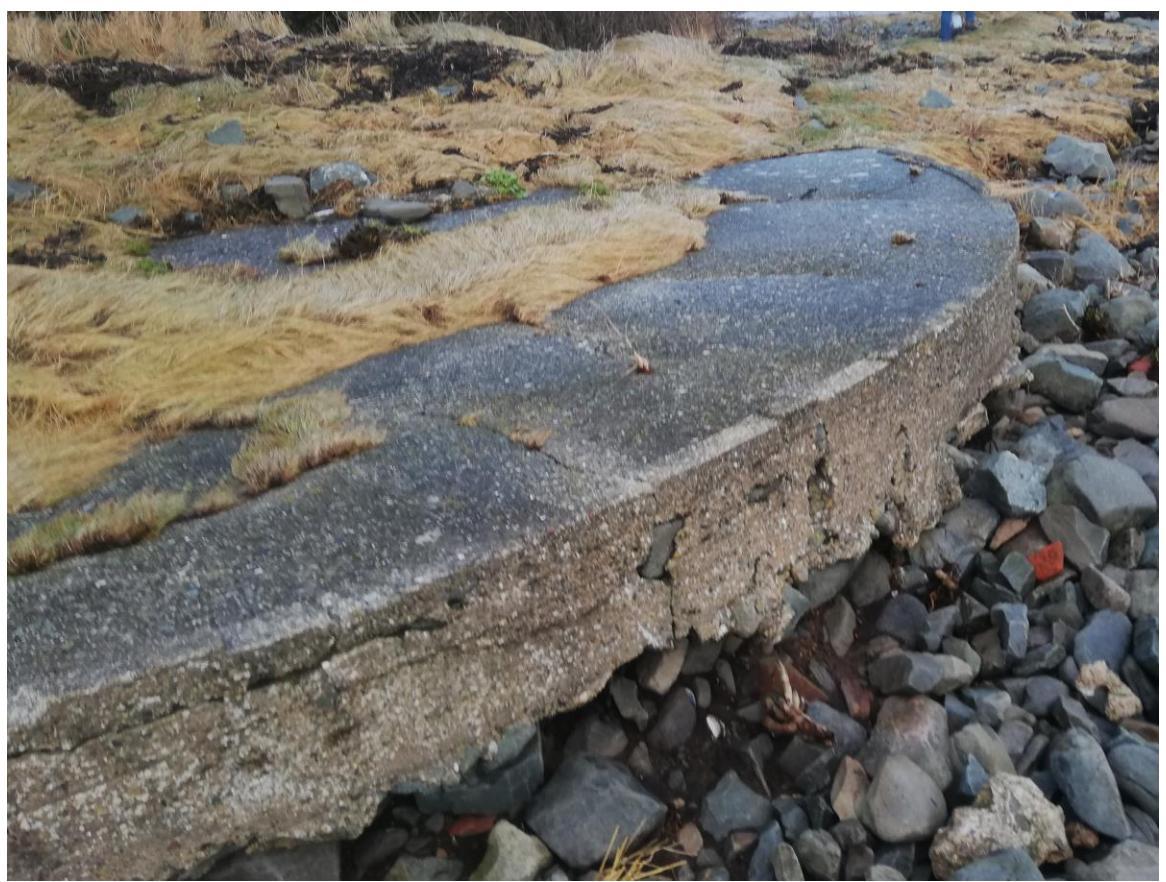
A few meters to the East of the revolving summer house there are the remains of another circular concrete base, the base of another possible summer house. None of the photos of the swimming pool complex show any building or structure on this base. Perhaps nothing was ever built on it, as it is very close to sea level so would often be submerged and covered in seaweed. It is also not in a good position for the afternoon summer sun. There is no sign of a metal rail or central axle so perhaps it was a static summer house, not a revolving one.

Fig 29 Circular concrete base of possible second summer house Note the sea weed on the grass on land ward side of the base
