Data Structure Report: No. 11.

Excavations at Mahee Castle, Co. Down
AE/02/79

Data Structure Report: Mahee Castle, Mahee Island, County Down

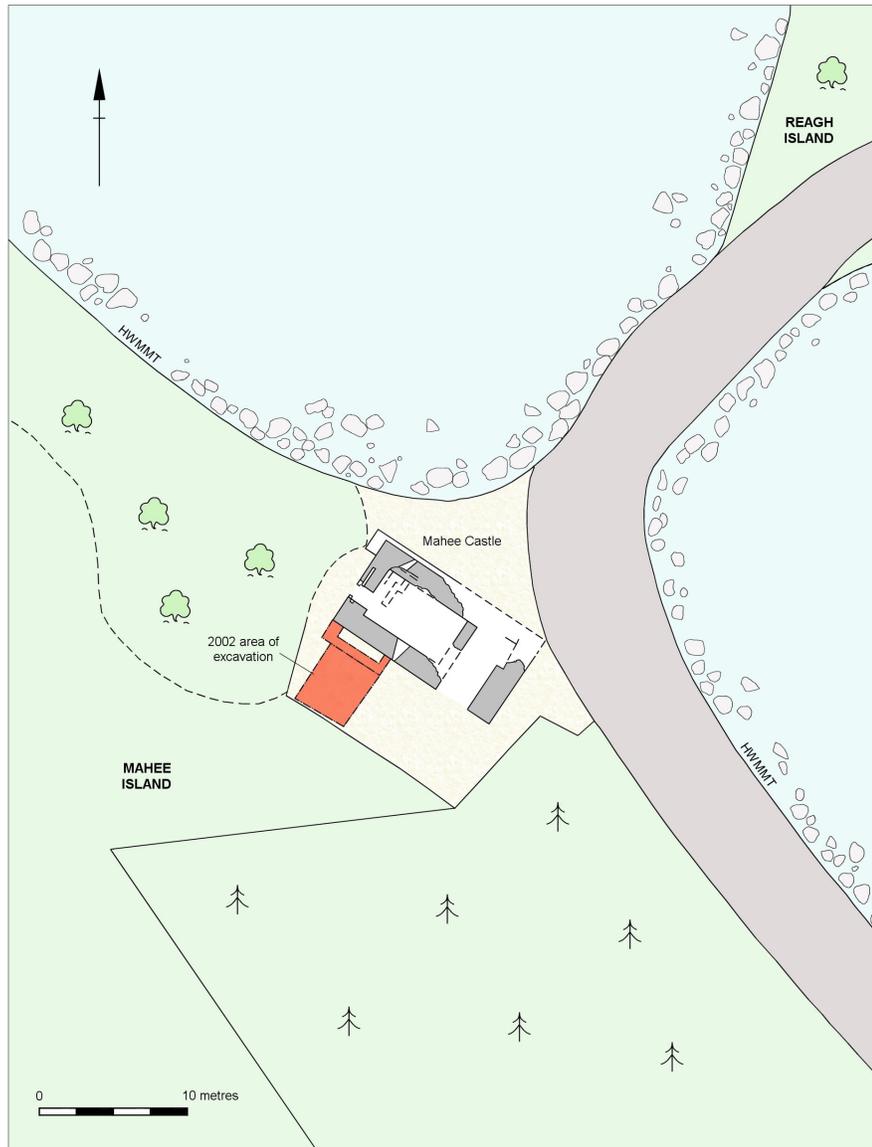
Figure Two: Mahee Castle showing location of 2002 area of excavation
(plan of tower house after *Archaeological Survey of County Down, 1966, p244*) (Scale 1:250)

- 3.1.3 The block of upstanding deposits was excavated, in plan, as a single area. Excavation was undertaken by hand and the context record for the site was created using the standard context recording method. Large scale plans of the site (scale 1:50) were prepared prior to excavation showing the position of the 2002 excavations in relation to the tower house, revetment wall and surrounding features. Site plans (scale 1:10) were completed of all the significant stratigraphic levels uncovered during the course of the excavations. Section drawings (scale 1:10) of the fills of all negative features as well as the northwestern edge of the excavation were undertaken. An elevation (scale 1:20) was also completed of the northeast facing side of the revetment wall (for details of the field illustrations see Appendix Four). In addition to the field drawings, the principal site records consisted of photography (see Appendix Three), context sheets augmented by a supervisor's notebook, as well as separate registers of small finds (Appendix Five) and samples (Appendix Seven). The unique site code used to identify the records generated during the excavation was MAI 02.

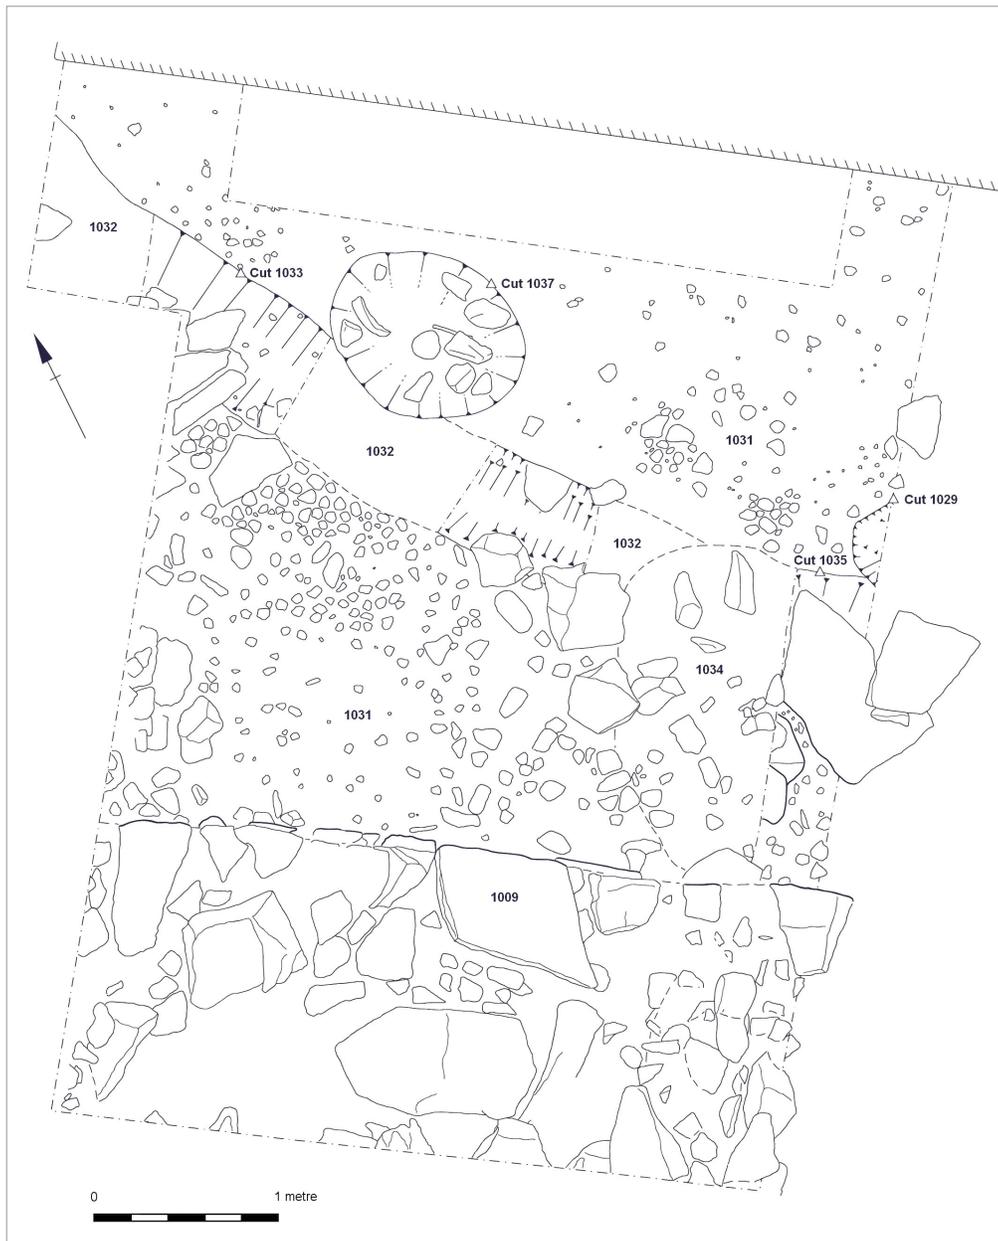
Figure Three: Plan of 2002 area of excavation showing revetment wall (Context No. 1009), pits (Context Nos. 1029, 1035 and 1037), drain (Context No. 1033) and roughly cobbled surface (Context No. 1031)

- 3.2.17 The second small pit (Context No.1037) was an oval-shaped feature with shallow sides, situated across the northeastern edge of the excavation area. It was partly excavated during Ó Baoill's 2001 season at the site. The pit extended north-south c.1.10 metres, east-west c.0.90 metres and had a maximum depth of c.0.20 metres. It was filled a dark brown, sandy clay loam (Context No.1036) and its base was filled with several large sub-angular stones. The purpose or function of this pit is uncertain.

- 3.2.18 The large pit (Context No.1035), that was cut by one of the small pits (Context No.1029), was a deep, apparently sub-circular shaped feature located across the southeastern edge of excavation. It was partly excavated during Ó Baoill's 2001 excavations. The pit was filled with a deposit of large sub-rounded to sub-angular stones and boulders set in a loose, charcoal flecked, dark brown, sandy clay loam matrix (Context No.1034). The fill

3.2.19 As noted above, the large pit (Context No.1035) and one of the smaller pits (Context No.1037) cut the fill (Context No.1032) of a linear drain (Context No.1033) which ran approximately south-east to north-west across the entire excavation area getting closer to the back wall of the tower house towards the castle's western corner (Plates Ten and Eleven). The drain (Context No.1033) has steep sides, a U-shaped profile, is c.0.50 – 0.60 metres wide and c.0.45 metres deep. The drain appears to be lined with large stones at certain points along its length; however, these stones are naturally occurring inclusions within the underlying boulder clay (Context Nos.1010, 1014 and 1025) rather than a deliberately created slab lining to the drain. The drain is filled with a firm, dark brown, charcoal flecked, silty clay loam which was only excavated in two cuttings. Excavation suggested that the fill of this drain (Context No.1032) accumulated relatively slowly suggesting that the revetment wall (Context 1009) is a secondary feature which post-dates the initial construction of the tower house, possibly by a significant period. The drain (Context No.1033) cuts through a now incomplete, roughly metalled surface (Context No.1031) impressed directly into the truncated surface (Context No.1038) of the boulder clay (Context Nos.1010, 1014 and 1025). The roughly metalled surface (Context No.1031) is made up of a variety of sub-angular stones whose flat sides have been arranged uppermost. The maximum dimension of the stones range from 0.07 to 0.15 metres in length. The metalled surface is presumably contemporary with the initial construction of the tower house. In line with conditions of Scheduled Monument Consent the roughly metalled surface (Context No.1031) was not excavated but preserved *in situ*.

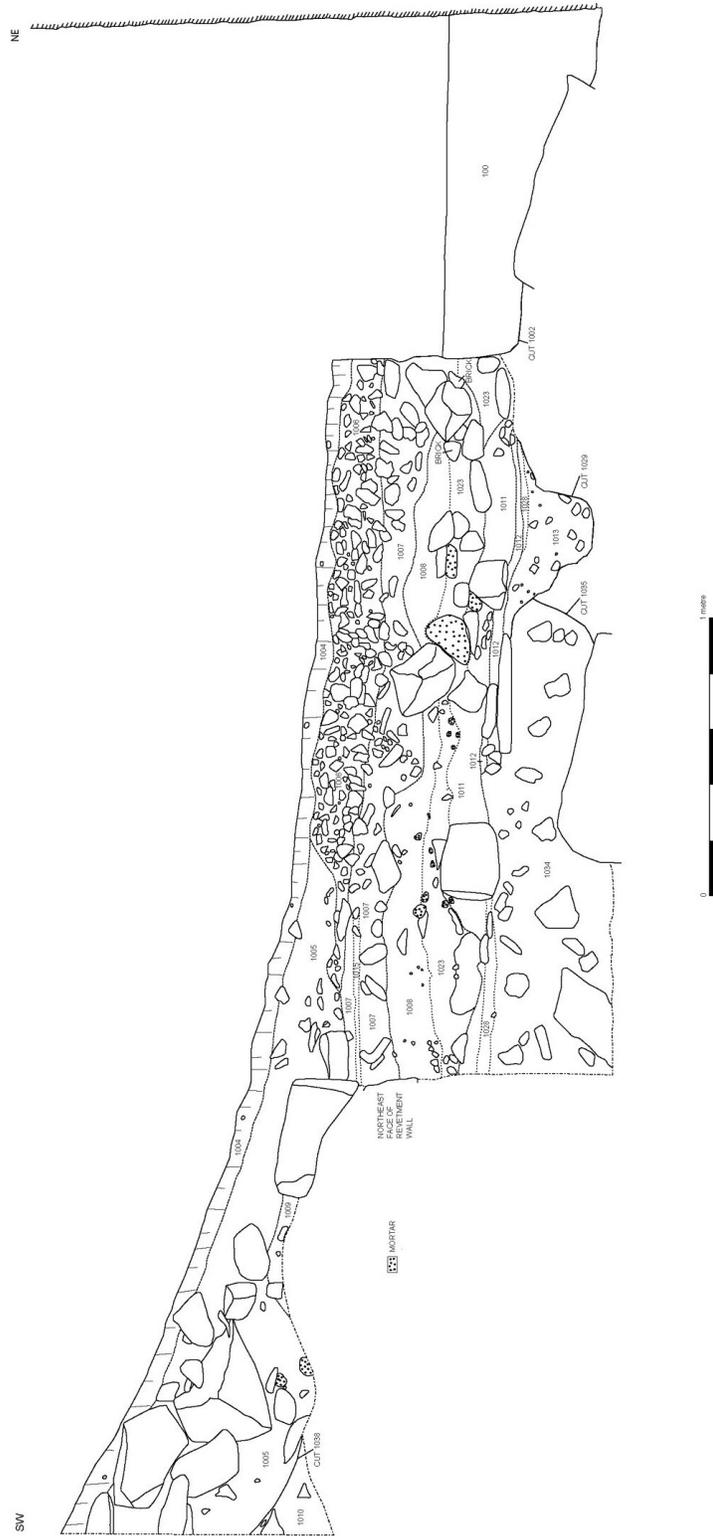
Figure Four: Southeast facing section of 2002 area of excavation

- 3.1.2 Excavating the upstanding block of deposits meant that the northeast and southeast facing sections of the excavation, which were defined by the edges of the 2001 excavation trenches, would be destroyed, rather than exposed, as the excavation progressed. Consequently, prior to excavating the upstanding block of deposits, the partially backfilled 2001 excavation trenches immediately adjacent to the block's northeastern and southeastern edges were re-excavated. Clearing back an area c.0.7 metres wide around the block of deposits facilitated access to the site and enabled both the northeast and southeast facing sections to be drawn prior to excavation. As the excavation progressed corrections to these section drawings were made on sheets of drawing film that were laid over the original drawings.

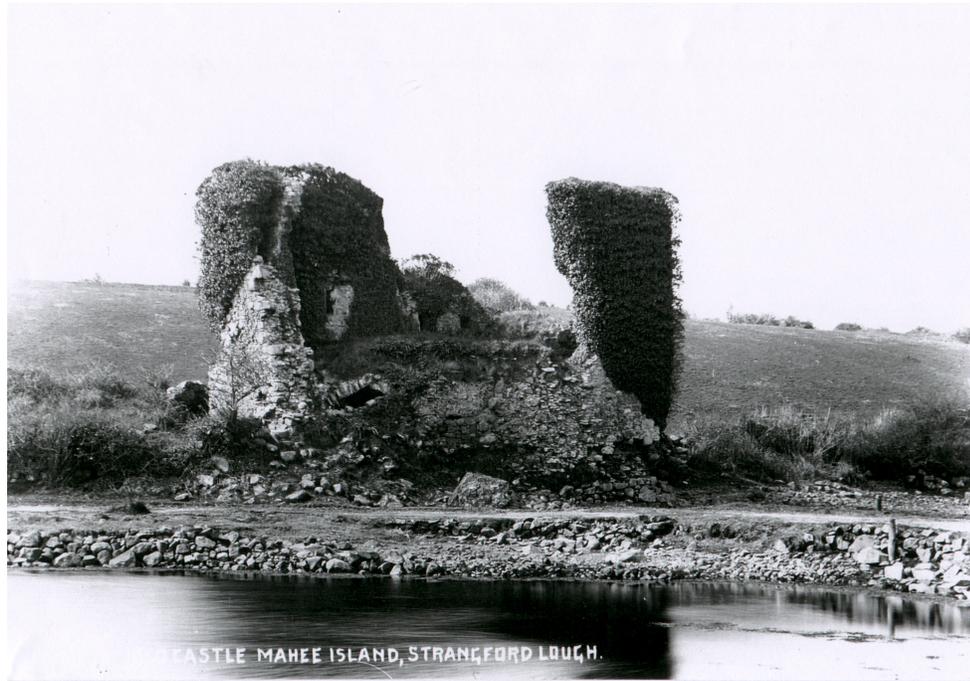
Plate One: Mahee Castle c.1900 (looking southwest) (from the Green Collection WAG 880).

2.5.3 The early photographs all show preferential robbing of stone from both the corners and the northeastern side of the castle. Presumably the squared stones from the corners of the tower house were taken for use in local buildings, whilst the stone from the northeastern side of the castle was used for the construction of the adjacent nineteenth century causeway to Reagh Island. Several of the photographs also show that the area between the southwestern wall which forms the back of the tower house and the revetment wall was

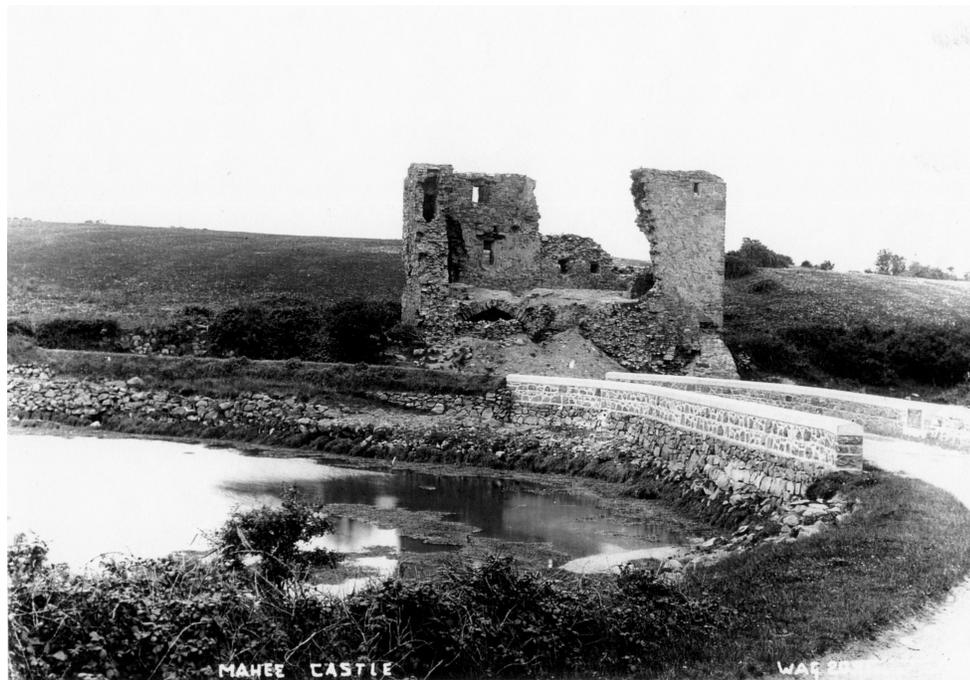
Plate Two: Mahee Castle during 1923 restoration (looking southwest) (from the Green Collection WAG 2091).

- 2.6.2 Comparing and contrasting photographs of Mahee Castle taken both prior to and during the 1923 restoration work verifies the accuracy of Lawlor's account of his works. Earlier images of the castle confirms that its northern corner had been undermined, presumably as a result of tidal erosion exacerbated by the construction of the causeway during the nineteenth century (for example see Plate One). Images taken during Lawlor's restoration work (Plates Two and Three) show that a buttress was inserted under the northern corner. More recent photographs of Mahee Castle, taken prior to the current phase of restoration work, indicate that the line of the buttress was extended as a base batter across the northernmost part of the northeastern side of the tower house (Plate Four). The photographs taken during Lawlor's restoration work (Plates Two and Three) show that the fresh mortar used on the buttress was distinctly lighter in colour than that on the surviving parts of the tower house's original masonry. However, the new mortar subsequently weathered and the buttress and base batter were mistakenly identified as original features by the Archaeological Survey of County Down (1966, 244). This misidentification is

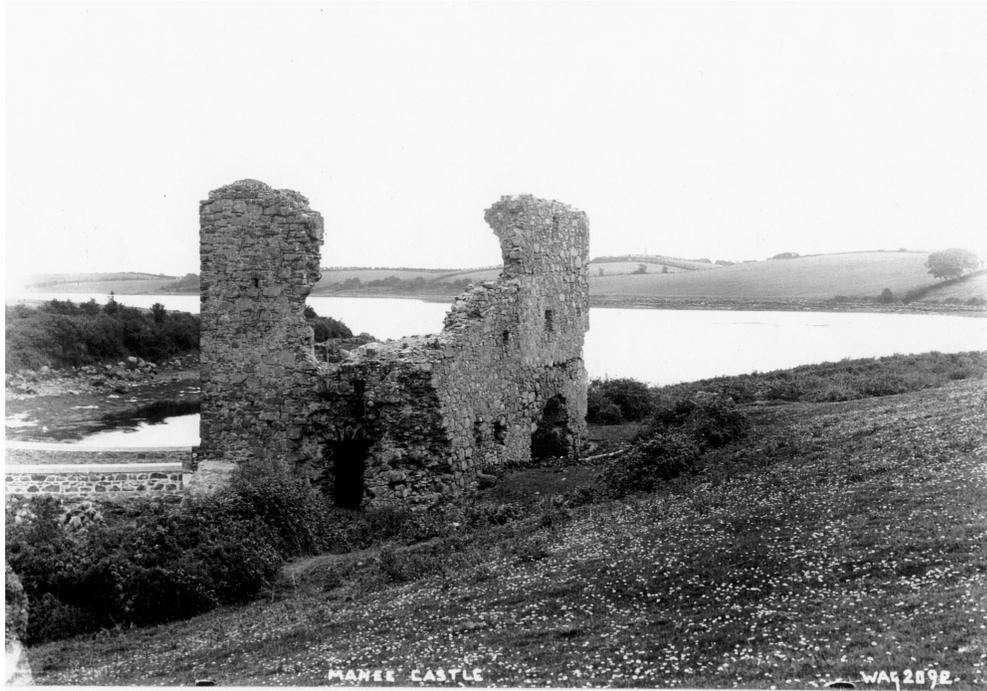
Plate Three: Mahee Castle during 1923 restoration (looking east) (from the Green Collection WAG 2092).

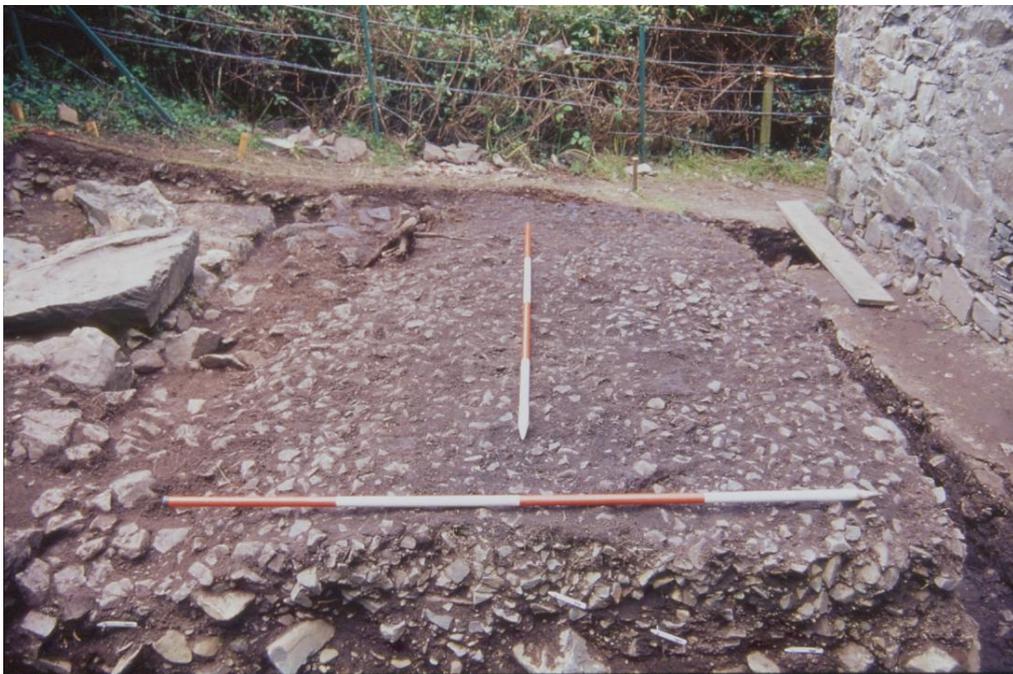
Plate Six: Levelling deposit (Context No.1006) prior to excavation (looking northwest).

3.2.4 Underlying the topsoil (Context No.1004) was a deposit of loose, charcoal flecked, brown loamy hillwash (Context No.1005) which extended from the southwestern edge of excavation in a northeasterly direction for a maximum distance of c.2.30 metres. This hillwash deposit (Context No.1005) physically overlay the top of the revetment wall (Context No.1009) but also included localized spreads of tumbled stone from the revetment wall suggesting that some damage had occurred to the wall as the deposit accumulated. Underlying the hillwash (Context No.1005) was a dump of uniform small angular stones in a loose, dark brown, loam matrix (Context No.1006) (Plate Six). This deposit extended

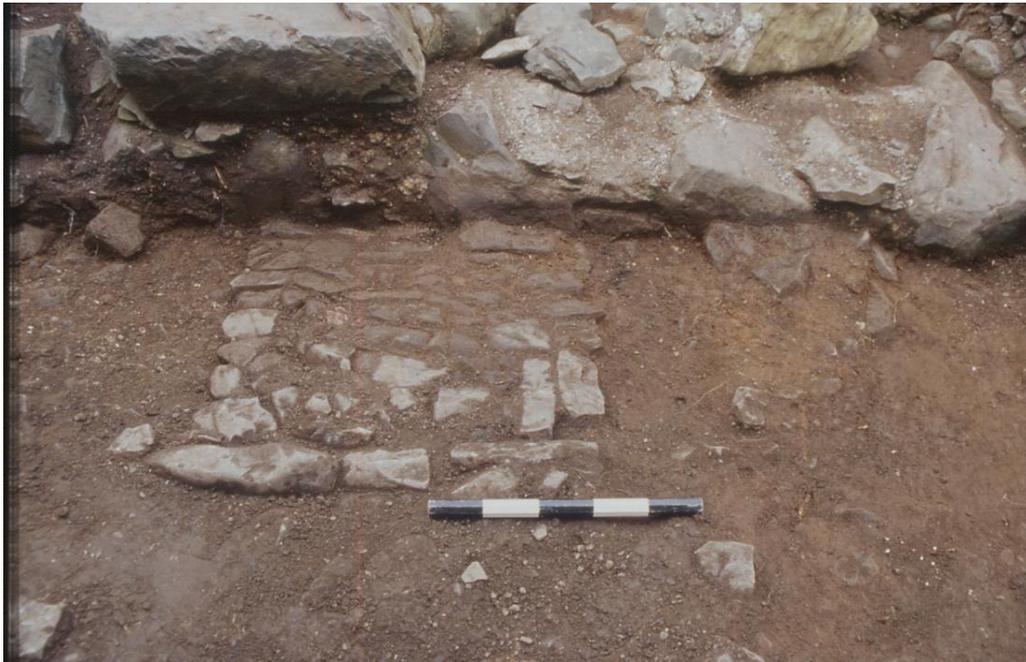
Plate Seven: rectangular-shaped stone setting (Context No.1019) and adjacent deposit of burnt or oxidised boulder clay (Context No.1020) prior to excavation (looking southwest).

- 3.2.8 Located c.0.30 metres to the northwest of the stone setting (Context No.1019) was a sub-triangular shaped spread of burnt or oxidised, compact, stoney orange clay (Context 1020). This layer, of apparently redeposited boulder clay, physically butted against the revetment wall (Context No.1009), was 0.07 - 0.09 metres deep, had a maximum width of 0.36 metres and extended 0.87 metres in a northeasterly direction.

- 3.2.9 The function of both the rectangular-shaped stone setting (Context No.1019) and the adjacent deposit of burnt or oxidised boulder clay (Context No.1020) was not obvious; however, it is not unreasonable to assume that they were related features. They overlie the sequence of deposits associated with the primary tumble and ruin of the tower house, demonstrating that they post-date the site's occupation, abandonment and ruination. It is possible that the small rectangular-shaped stone setting formed the base of a hearth; however, no evidence of burning directly associated with the stone setting was observed. Another possibility is that the stone setting formed either a pad for an upright structural timber or the base of a wooden partition used for stalling animals. That no comparable features were uncovered during the 2002 excavations suggests that the stone setting is unlikely to have been part of a large building or structure. The features may also be associated with the preparation of either limewash or lime mortar which appears to have been used during an episode of repair work dating to the Belfast Naturalist Field Club's excursion to Mahee Island in 1887.

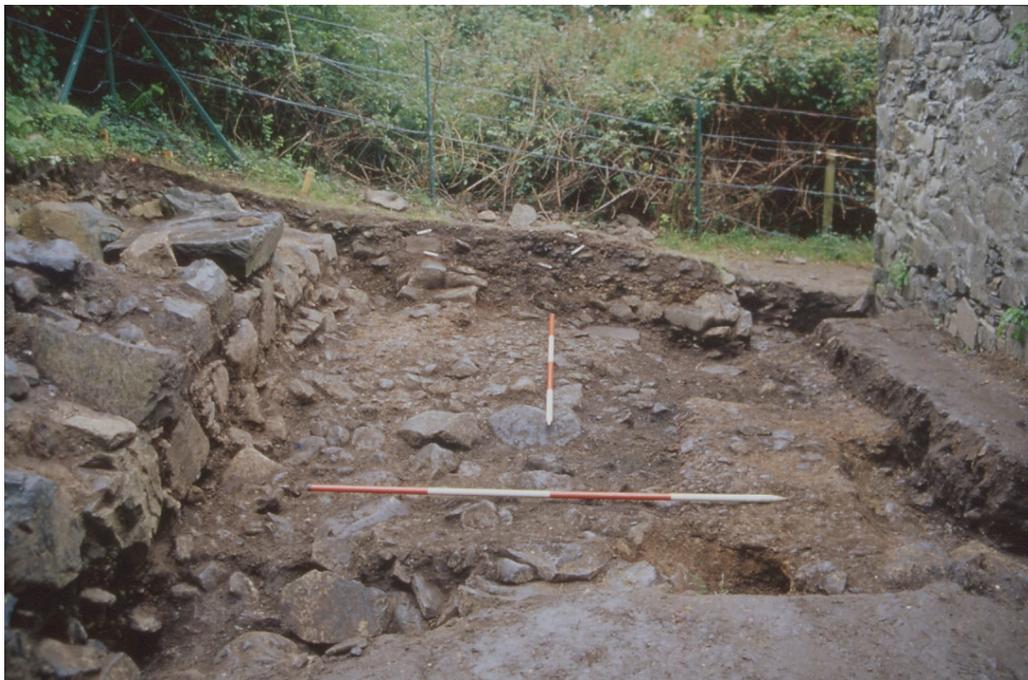
Plate Eight: Area of excavation following removal of charcoal-rich loamy deposit (Context No.1028) (looking northwest). The photograph also shows the revetment wall (Context No.1009), three pits (Context Nos.1029, 1035 and 1037) and drain (Context No.1033) prior to their excavation.

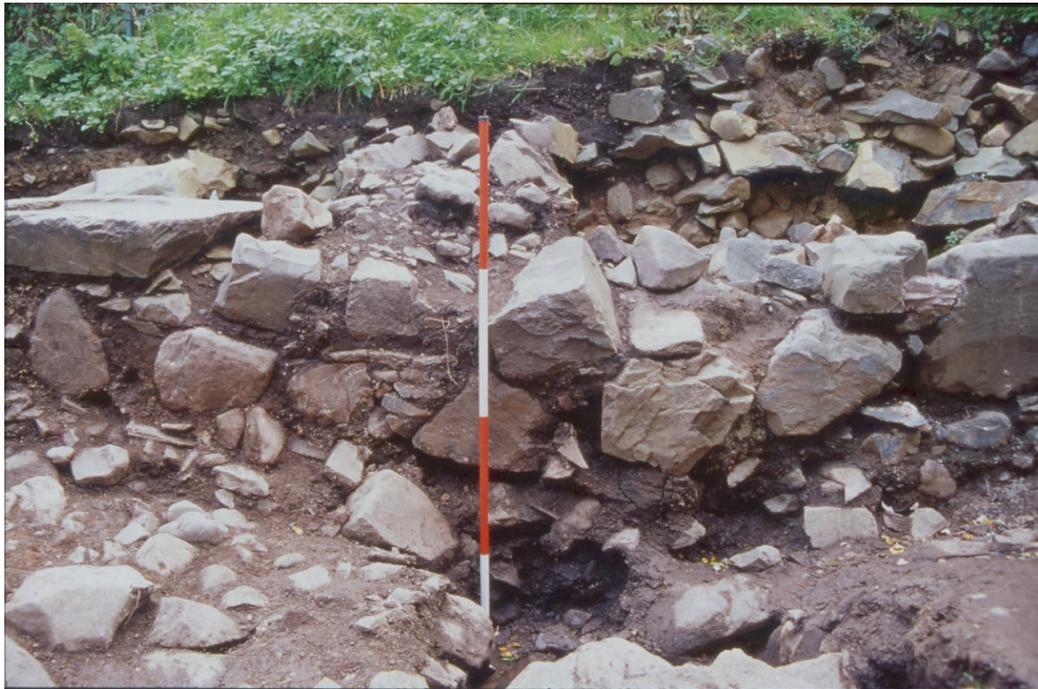
Plate Nine: Section of revetment wall (Context No.1009) which has slumped into the settled fill of the partially excavated large pit (Context No.1035) (looking southwest).

(Context No.1034) appears to have been rapidly deposited in order to fill the pit and enable the revetment wall (Context No.1009) to be built across it. The large stones and boulders which make up the bulk of the fill were presumably selected because they could have been used to fill the pit quickly. Despite being rapidly deposited, the fill (Context No.1034) contained a large number of finds (especially animal bones) suggesting that, in addition to the large stones, the pit may have been filled with debris from a midden. The fill (Context No.1034) was only partially excavated because it continued below the water table and extended under the revetment wall (Context No.1009) and further excavation would have risked undermining the wall. The part of the pit which was exposed during the 2002 excavations has a maximum diameter of c.1.80 metres. It was excavated to a depth of c.0.40 metres before digging was abandoned. The original purpose of the pit is uncertain.

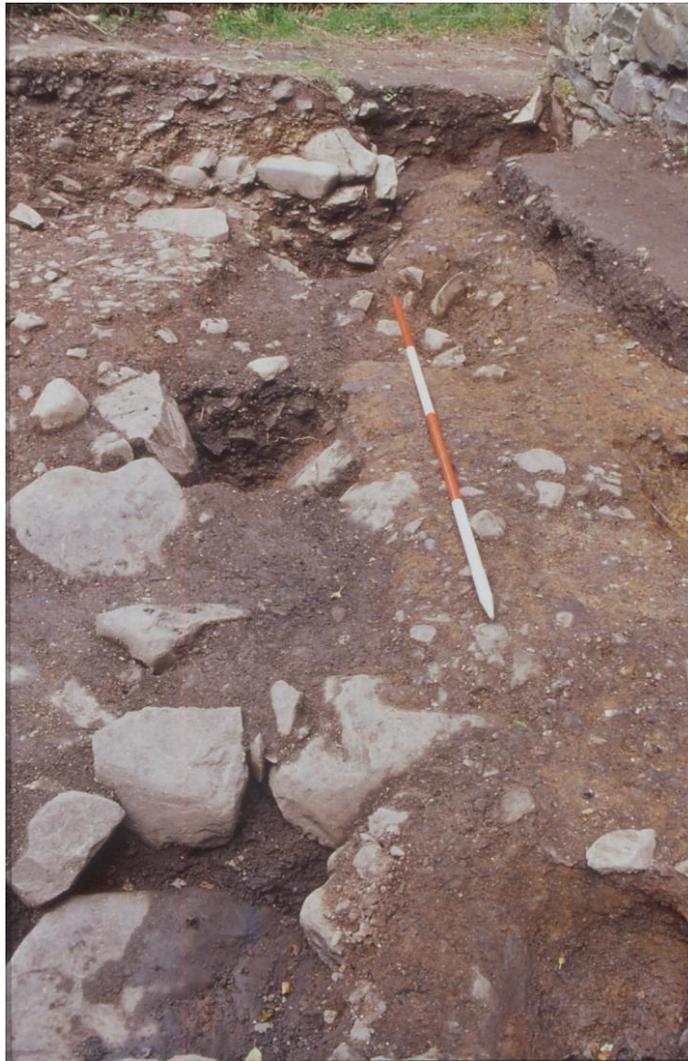
Plate Eleven: Occupation features following excavation (looking northwest). Photograph shows part of the large pit (Context No.1035) (*foreground left*), part of the small pit (Context No.1029) (*foreground right*), the shallow pit (Context No.1037) (*middle ground centre*) and the linear drain (Context No.1033) (*excavated in two separate cuttings*).
