**Inishargy House, Kircubbin County Down**

Excavation and monitoring carried out  
on behalf of NIEA

**CAF DSR No. 94**

Excavation Licence No: **AE/12/149**

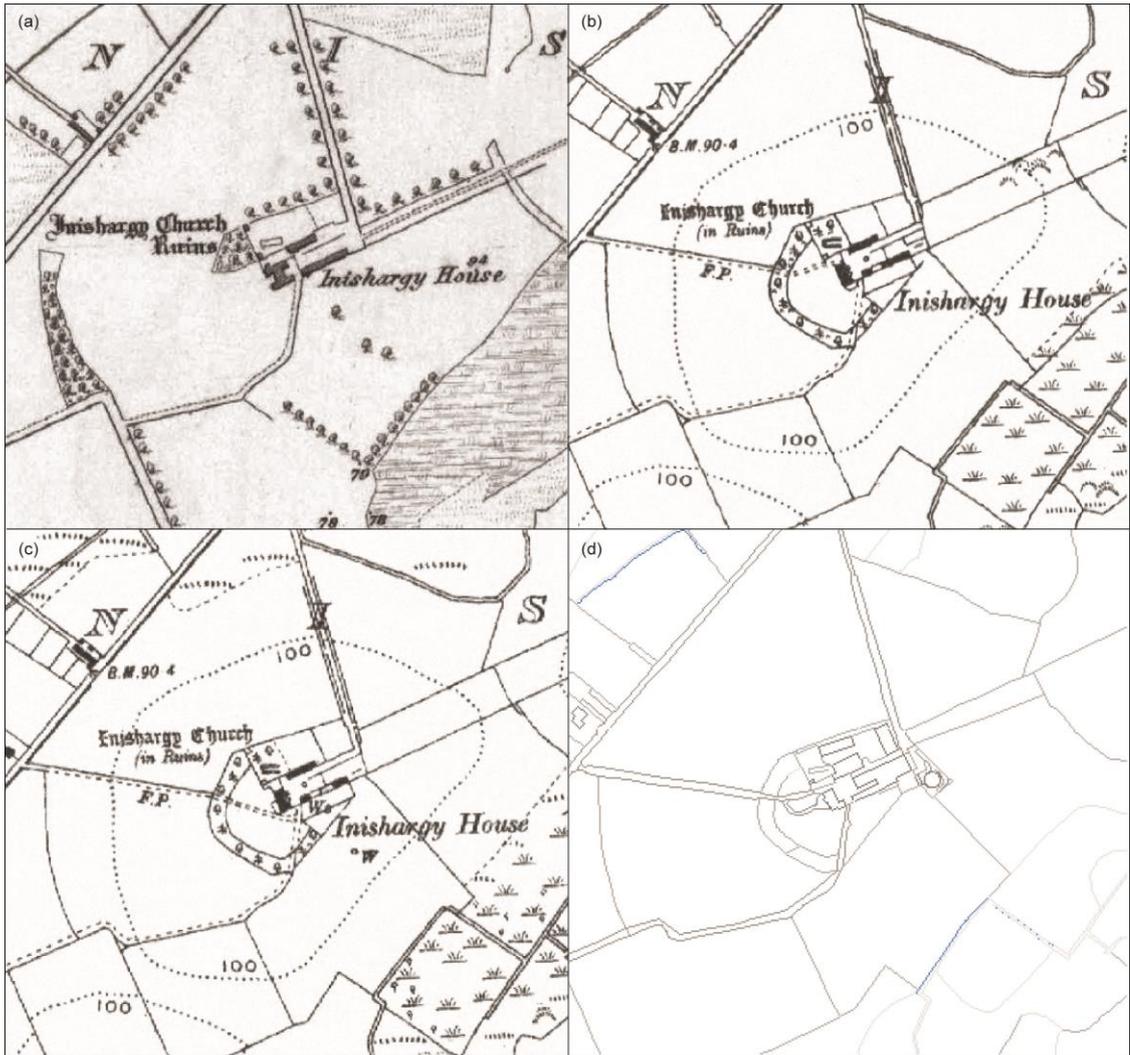
Figure 2: Comparison of extracts from 6-inch Ordnance survey maps of Inishargy (NIEA & LPS, 2006)

- (a) First edition Ordnance survey 1829-1835
- (b) Third edition Ordnance survey 1857-1932
- (c) Fourth edition Ordnance survey 1901-1957
- (d) Current digital Ordnance survey data (Copyright NIEA & LPS, 2006)

Three entrances to the site coming from the north, east and south can be noted on the first edition Ordnance Survey map of 1835; the northern entrance appears substantial and tree-lined and enters the yard on the eastern side. A wide straight entranceway with trees lining its northern edge runs directly from the eastern end of the yard and centrally in line with the house (in an east-northeast to south-southwest direction). A winding laneway exits the site at the south, between the yard buildings and the house before curving round to join the road to the southwest (Figure 2a). From the third edition Ordnance Survey map of 1932 and onwards three entranceways are clearly shown although the eastern entrance is gone and a new laneway approaches from the road to the west. The western laneway cuts through the enclosure and passes between the church ruins and the house before entering the yard (Figure 2b). The fourth edition map of 1957 shows it passing in front of the house and joining the southern laneway before it enters the yard (Figure 2c). However it appears that by present day, it has been reverted back to its original position, passing between the house and the church ruins (Figure 2d).

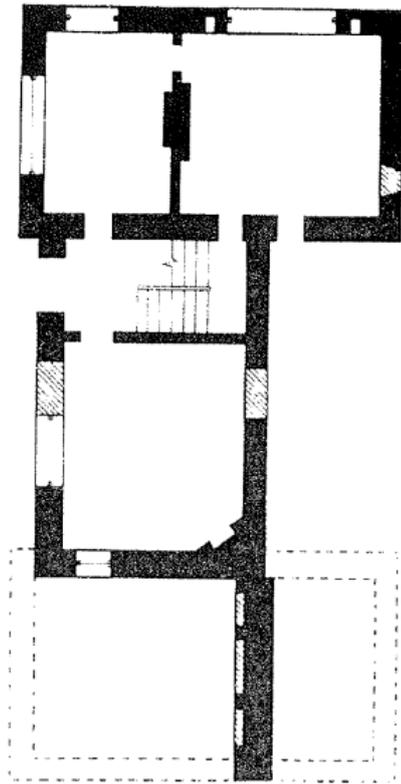
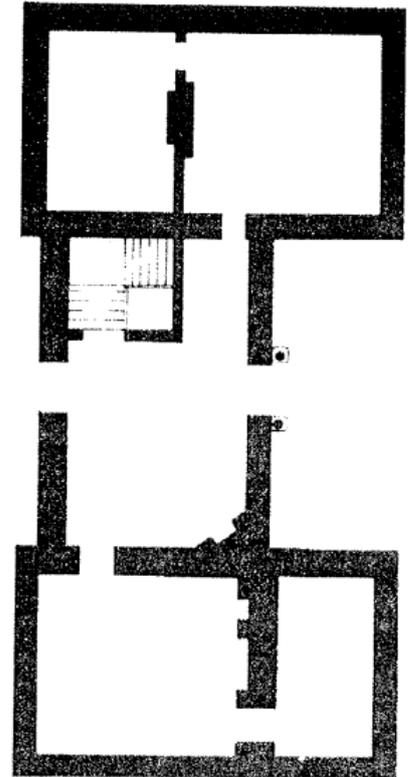
Plan of what remains of the old fabric.

Conjectural plan of old house

Figure 3: Ground plan of Inishargy House (Robinson & Oram 1983)

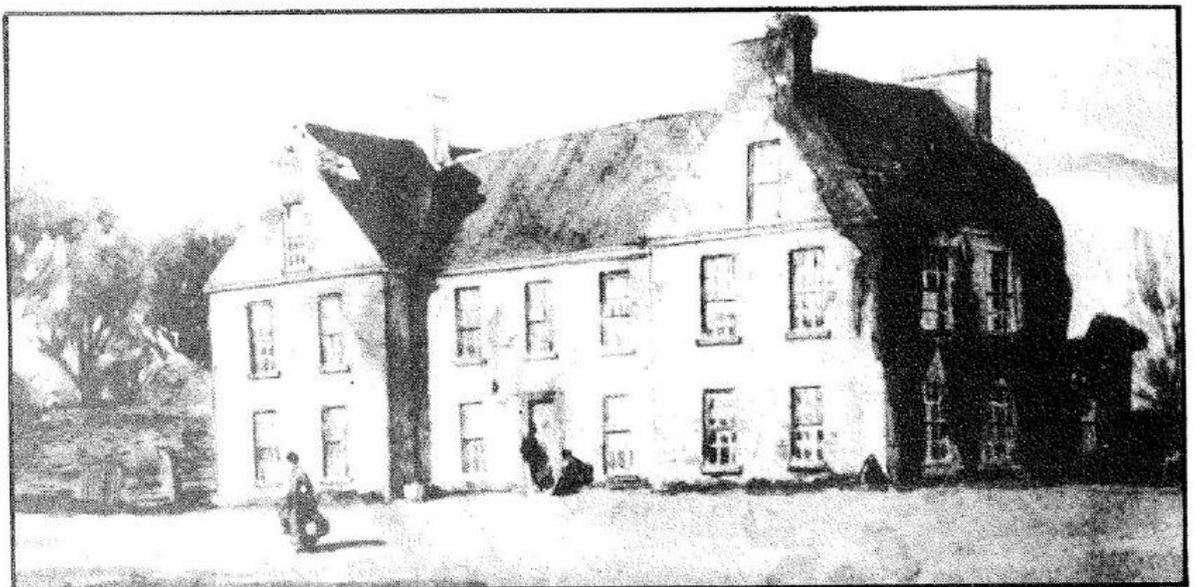
Figure 4: Illustration of Inishargy House before modernisation, looking northeast and showing the southern wing in ruins (Robinson & Oram 1983)

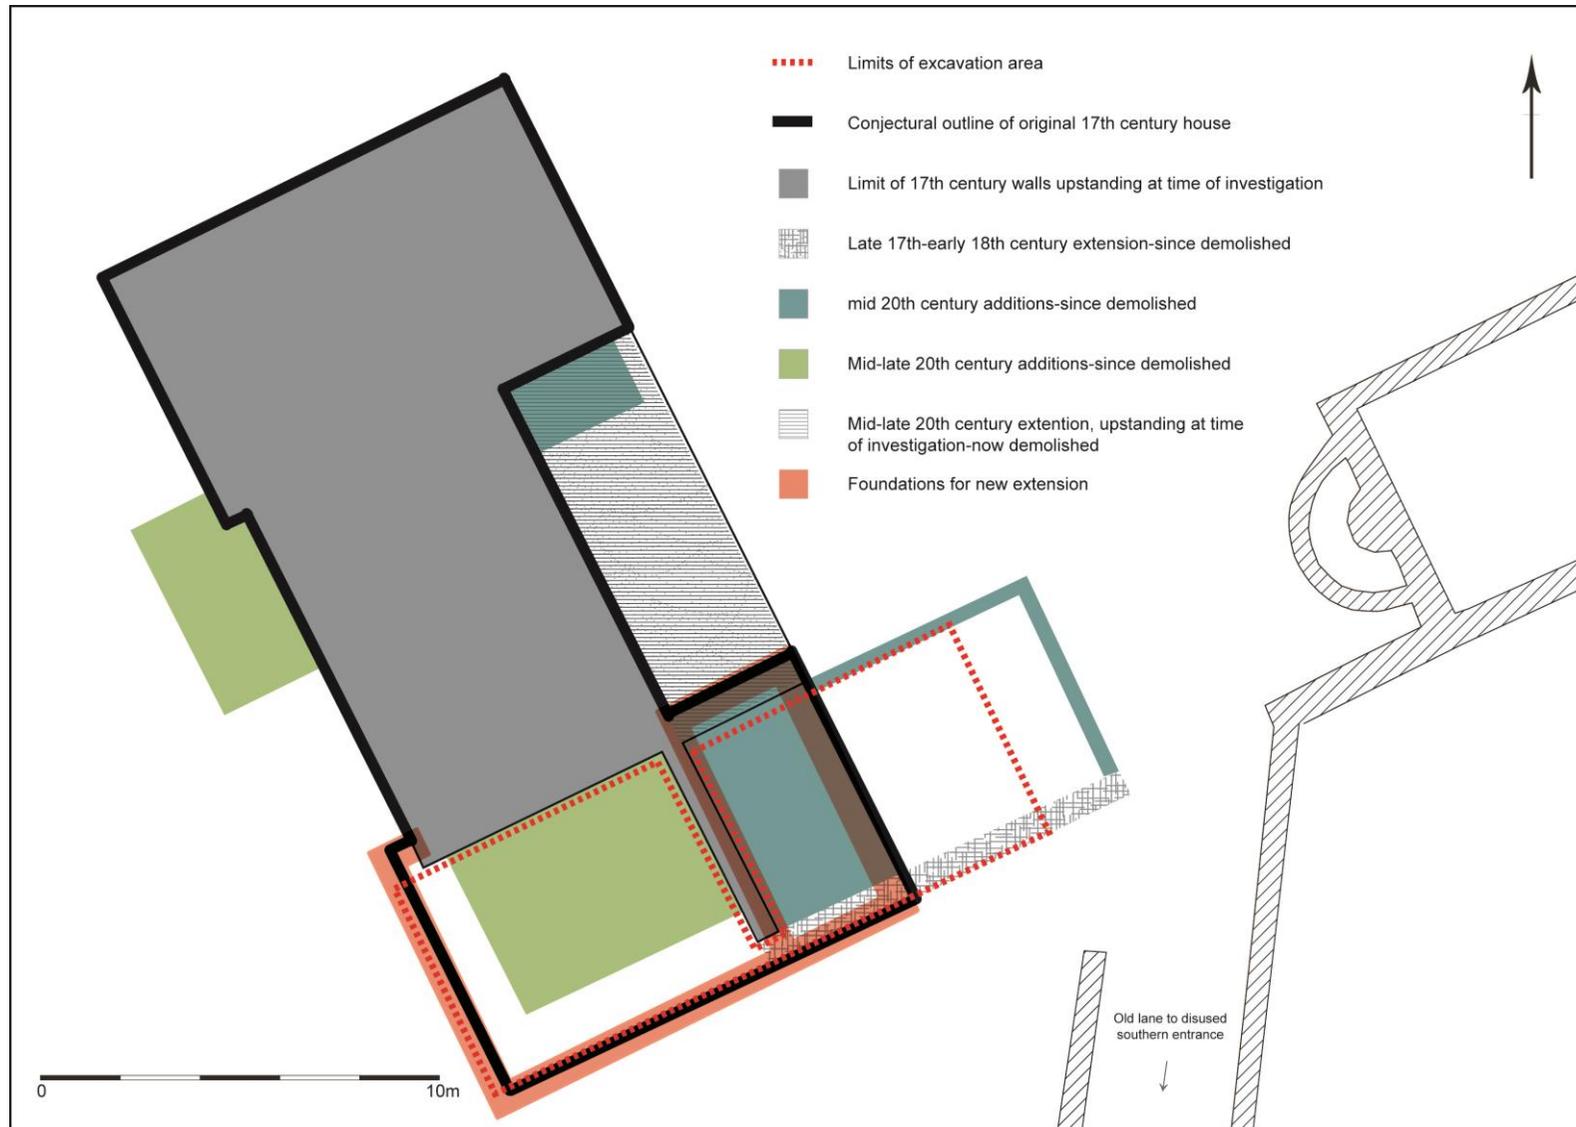
Figure 5: Summary phasing of alterations to Inishargy House, also showing the limit of the excavation area and outline of new foundations

## **5.0 Summary phasing of Inishargy House (Figure 5)**

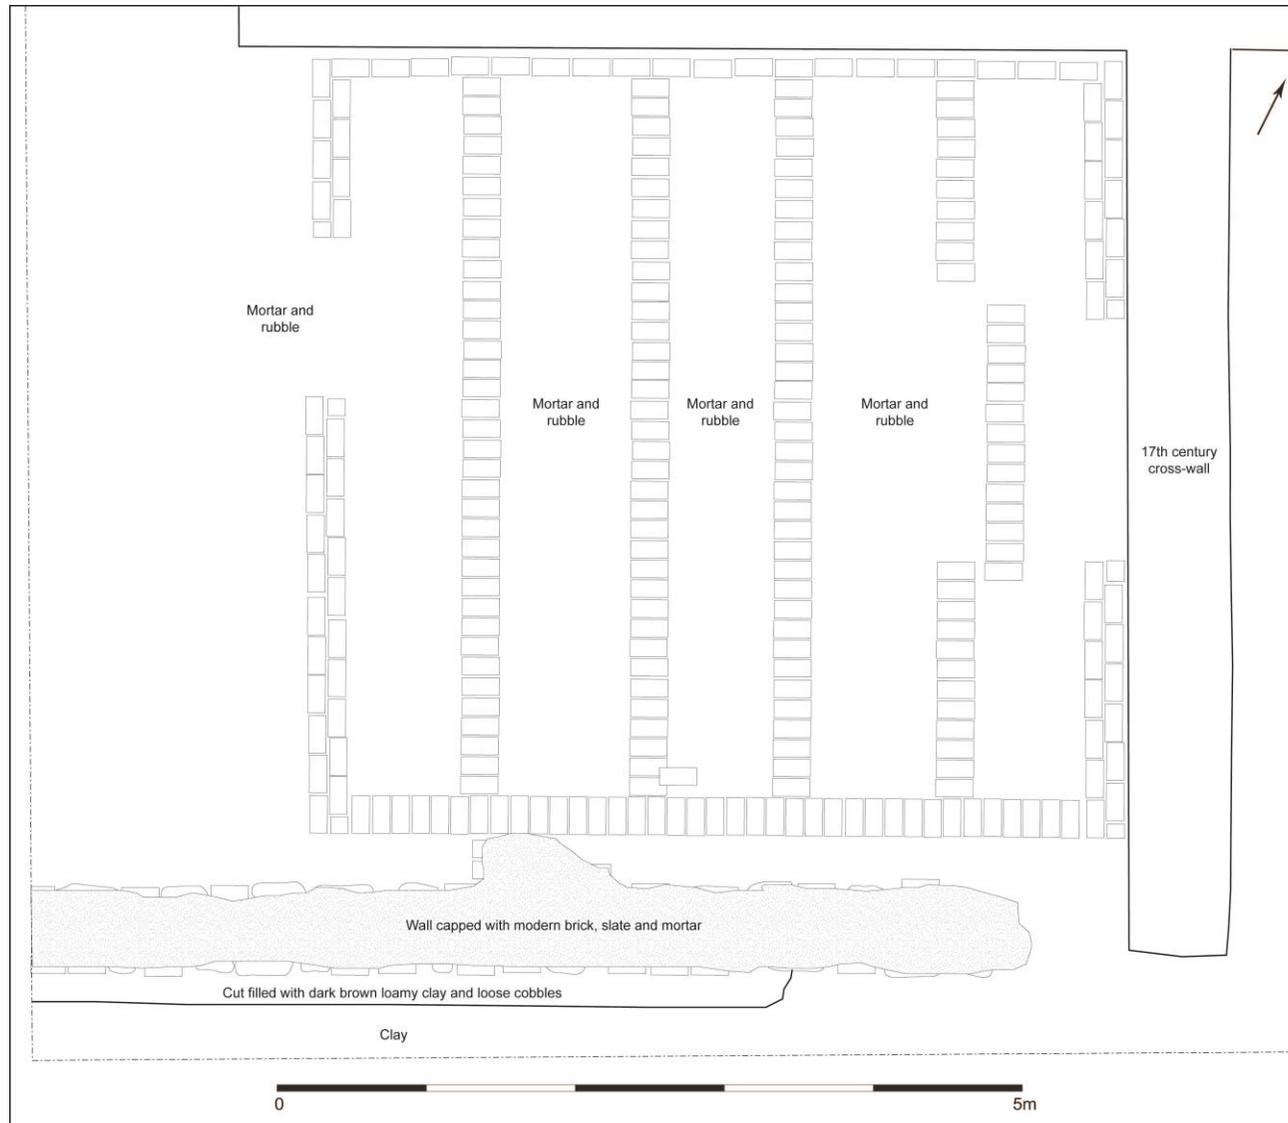
Figure 6: Area 1, with additions as uncovered during monitoring of foundation trenches

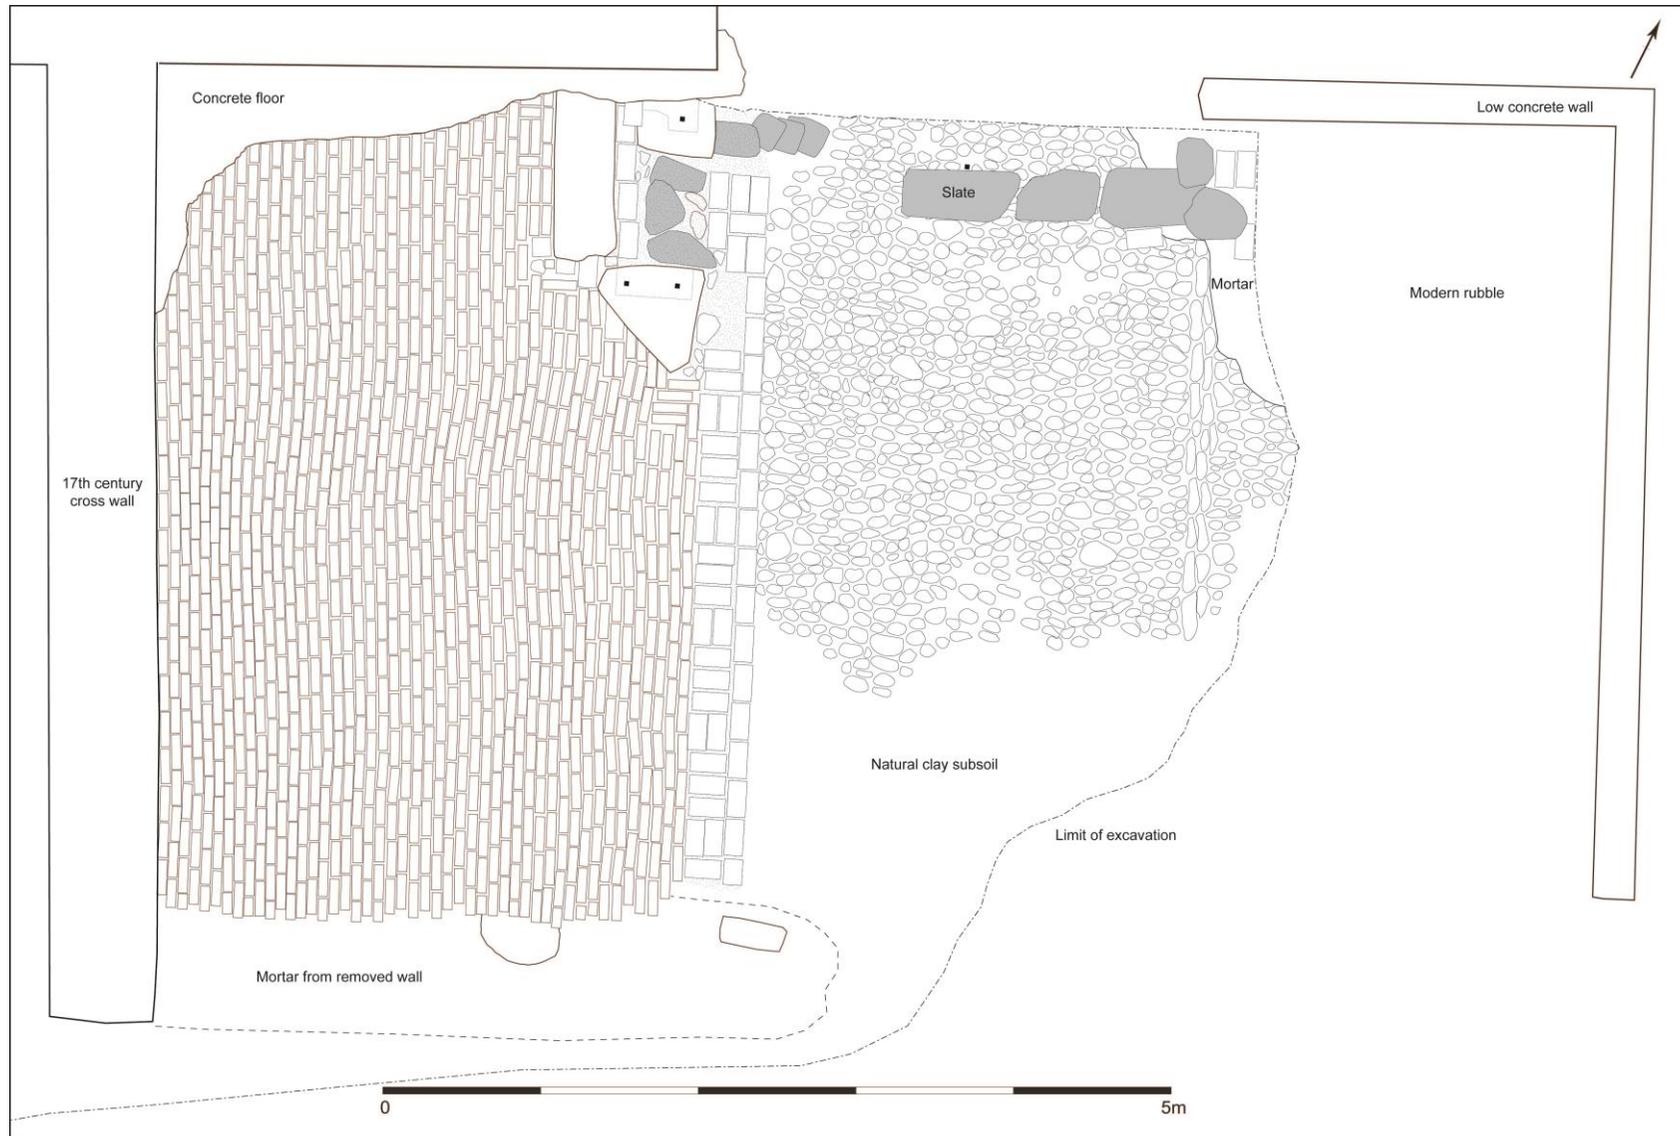
Figure 7: Area 2, east of the 17<sup>th</sup> century cross wall

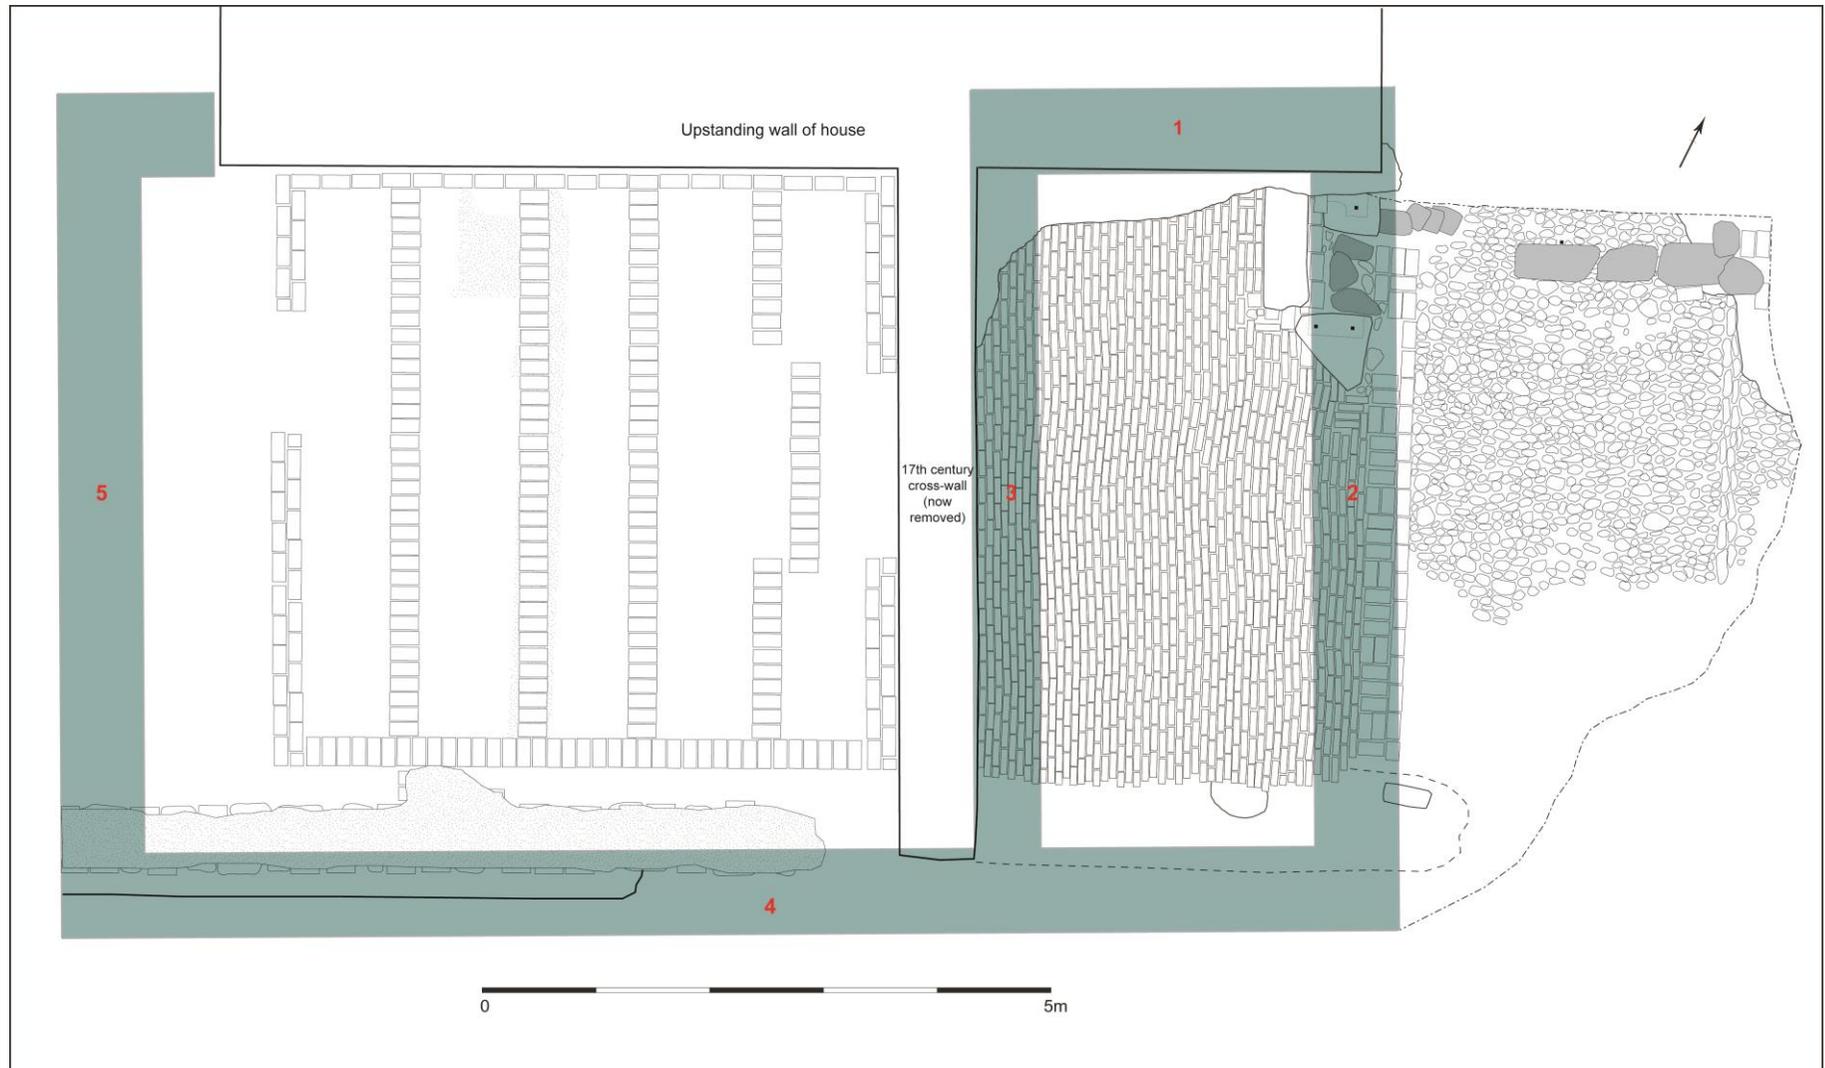
Figure 8: Plan of foundations for new extension overlying earlier structural remains. Features lying within new foundation limits (marked in green) have since been removed. The cross wall was also removed (prior to excavation of the foundations). Foundation cuttings numbered 1-5 according to discussion given in Section 6.4

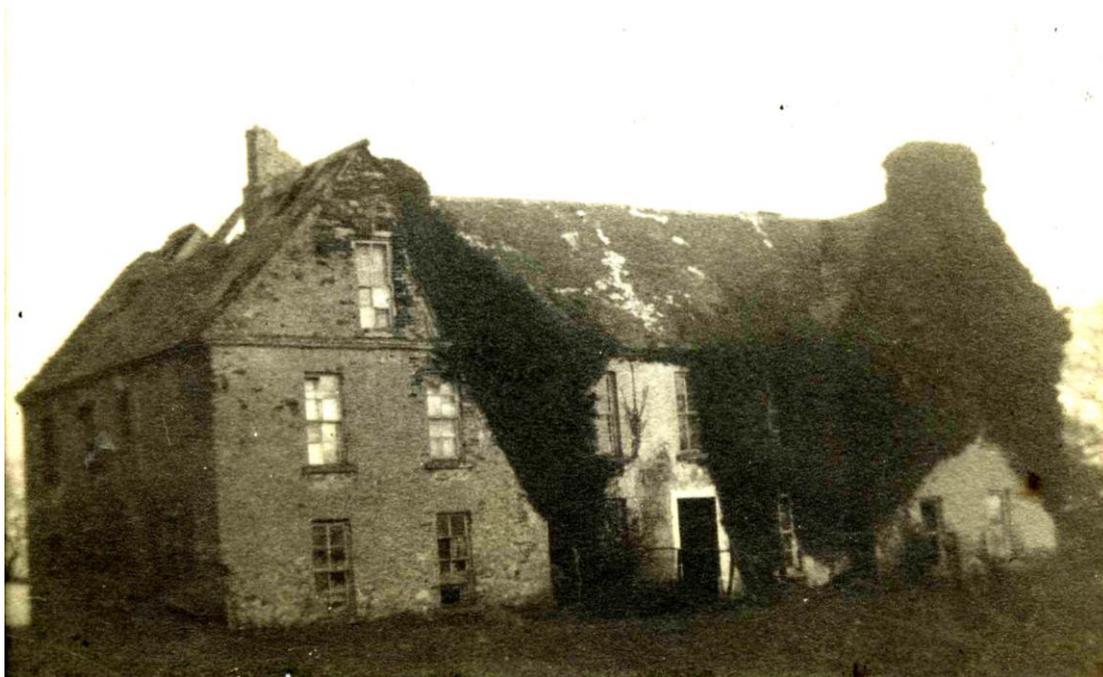
Plate 1 East facing view of Inishargy House as it stood when purchased by current owners in the early 20<sup>th</sup> century (photo: landowner's personal collection)

The sash windows were replaced or repaired with larger panes of four over four (Plate 1).

The house becomes uninhabited and falls into a state of disrepair. The house is then bought by the current owners (The Coulters), (Plate 1).

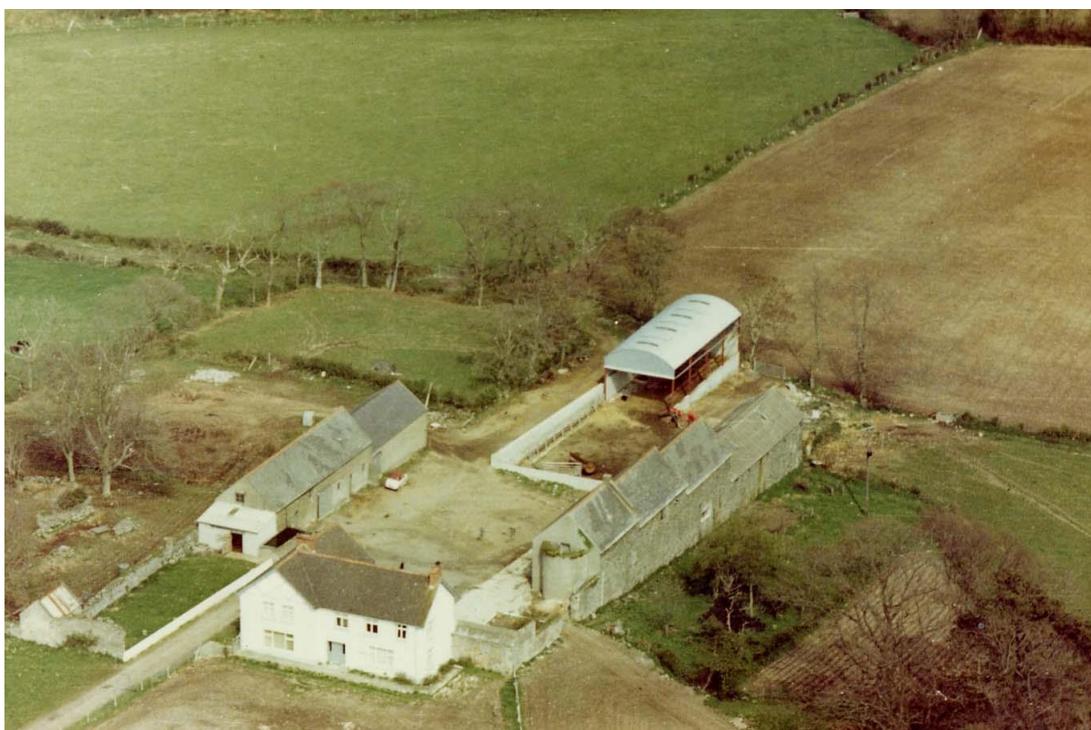
Plate 2 Aerial view of Inishargy House, yard and out-buildings, looking northeast, dated 1966. Church ruins visible on the left (photo: landowner's personal collection)

- 3.3 To the current rear of the house (its east face) are a series of stone buildings sited around a yard of poured concrete (Plate 2). These buildings now used as storage, farm buildings and workshops are likely to have been originally used as coach houses, stables and offices serving the 17<sup>th</sup>-18<sup>th</sup> century occupancy of the house. Attached to the range of out-buildings are the remains of what appears to be a stone tower with narrow lights which may be perceived as gun loops (Plate 5). It has been speculated that this may indicate the remains of a bawn at the site (Robinson and Oram 1983, 26). However, its central location in the gable wall of an out-building and the turning of the stair in an-anti clockwise direction, which would not be of particular use in defence (Plates 5 & 6), suggest that it is a folly built alongside the house in the 17<sup>th</sup> century. It may also be worth noting that the stairs appear to be concrete or concrete covered (Plate 6).

- 3.4 The house as it stands is by all appearances modern with 20<sup>th</sup>-century windows and roof slates, plastic guttering, concrete-brick facing covered with modern render, and modern brick chimneys (Plates 2-4). However, beneath this it can be seen that it is composed of large rough stones and mortar (Plate 13). A free standing cross-wall (Plates 9-12) topped with a skim of concrete, which stood perpendicular to the southern wall of the house, contained in its western face, a number of brick arches blocked up with brick, stone and mortar (Plates 9 & 10). It is speculated that these arches represented the remains of two brick ovens and a fireplace. This wall was found to be structurally unsound with large cracks, holes and falling away in places and has since been removed (Plates 9-14).

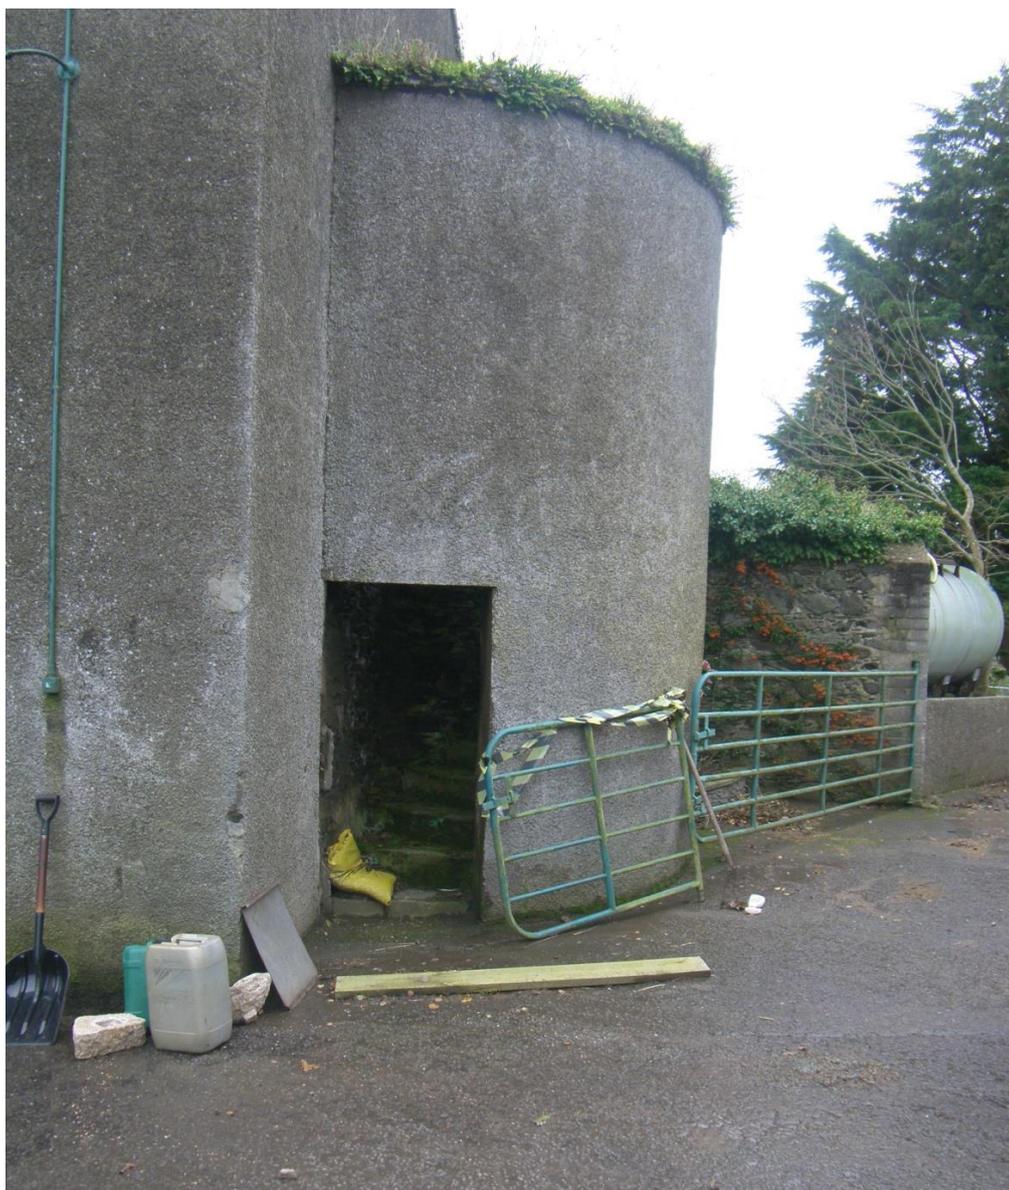
Plate 5 Southeast facing view of semicircular 'tower'

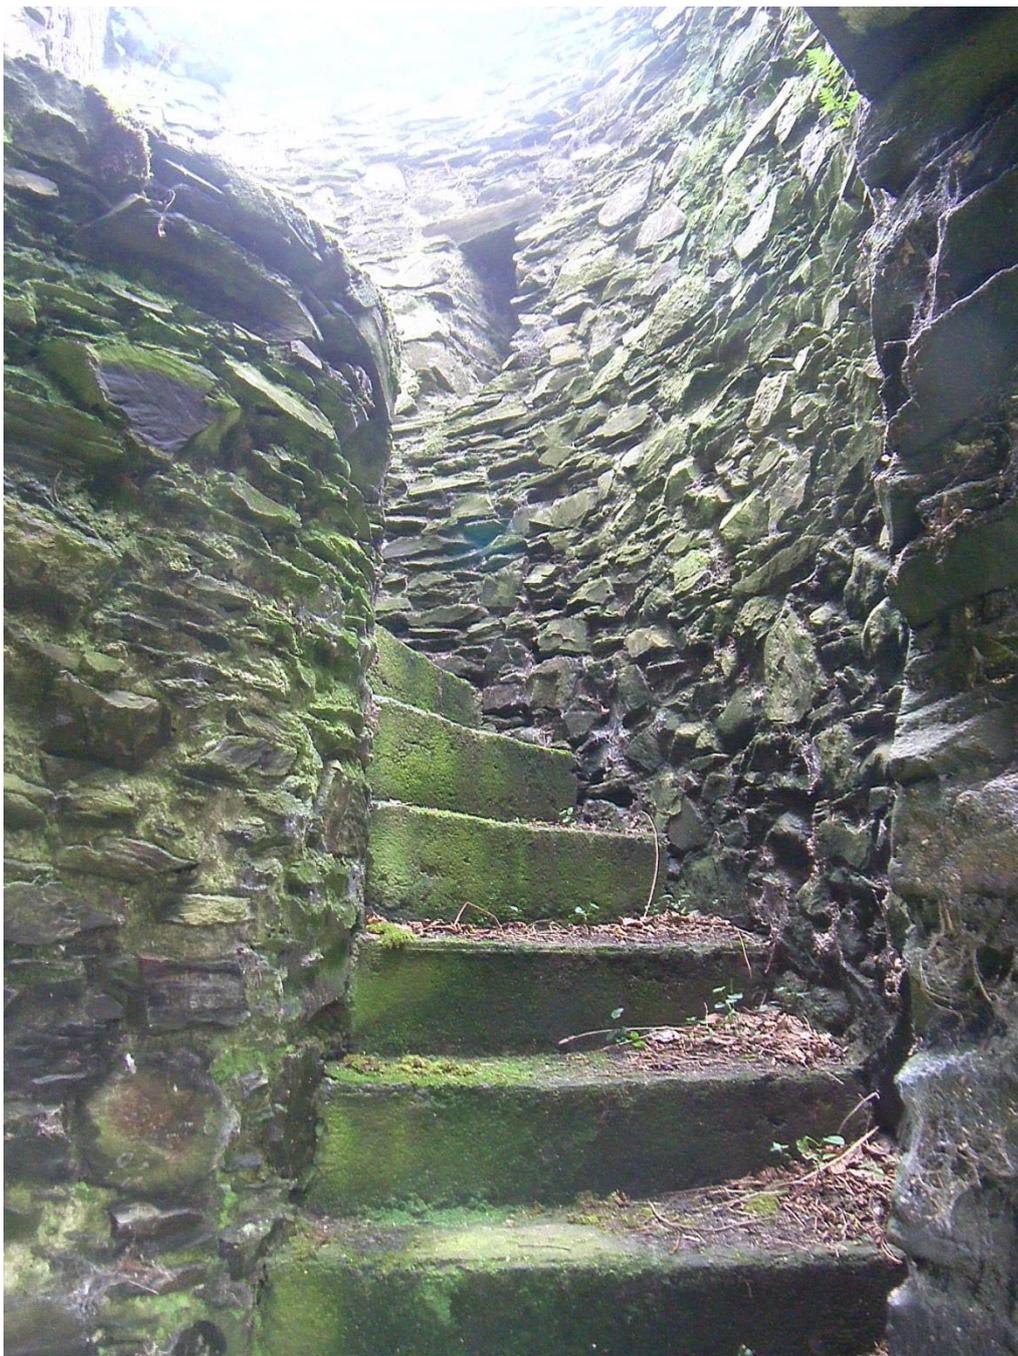
Plate 6      Stairs and 'gun-loop' in the semicircular 'tower'

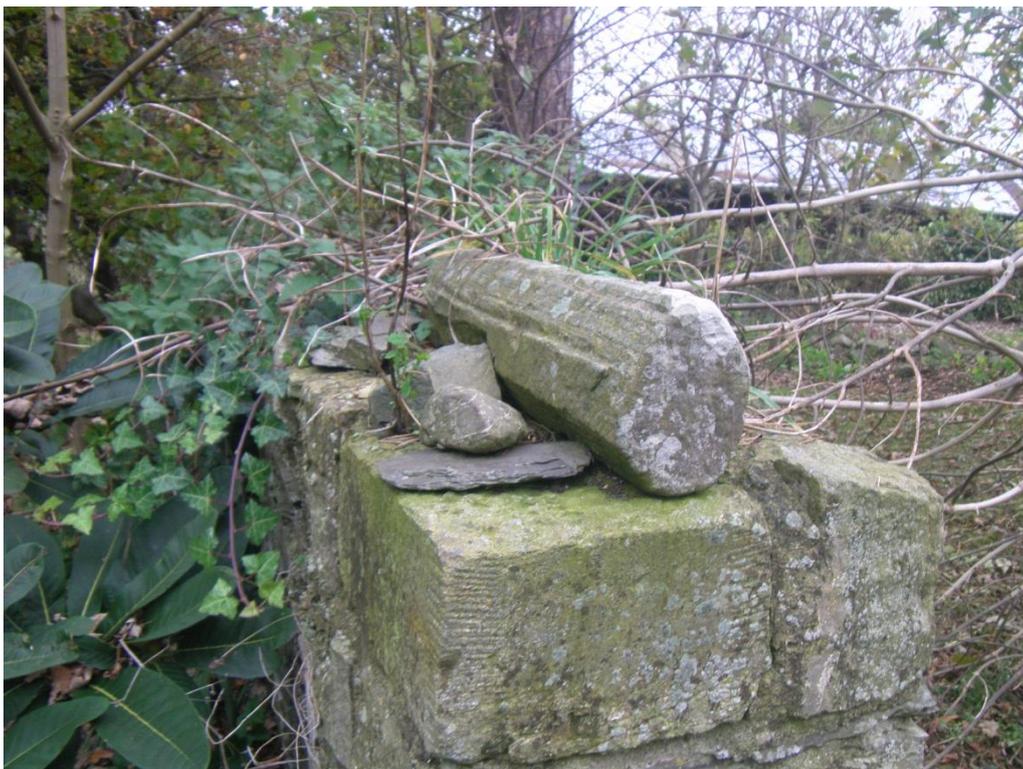
Plate 7 Stone mouldings and reused cut stone in the vicinity of Inishargy House

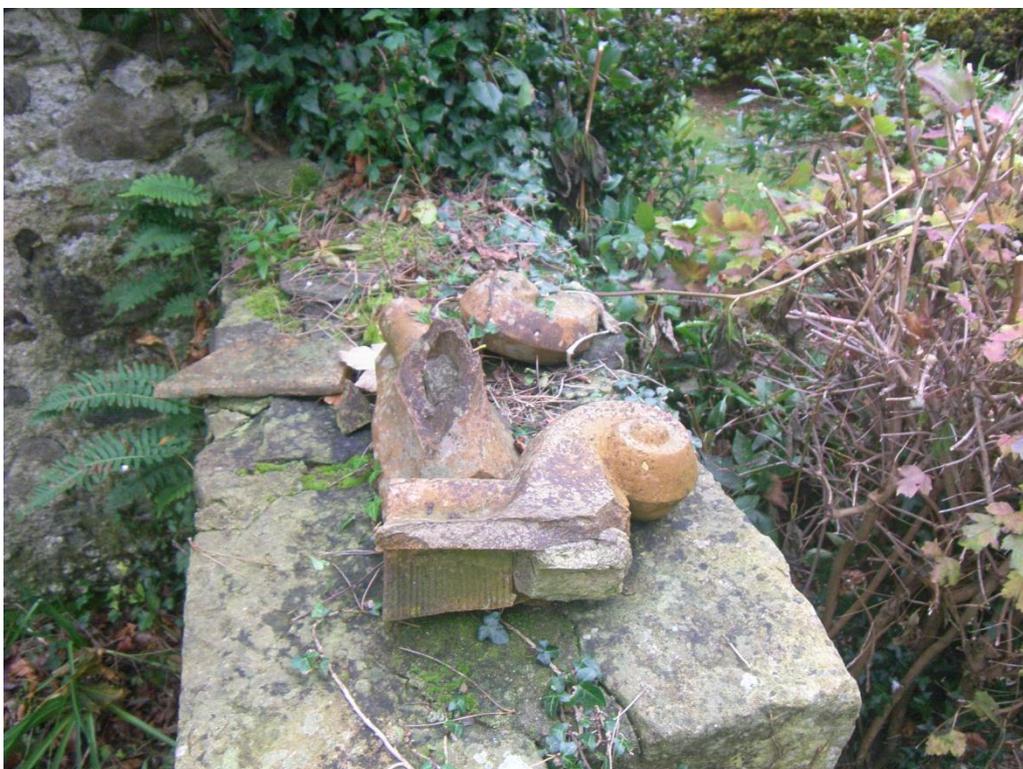
Plate 8 Stone mouldings found lying in the vicinity of Inishargy House

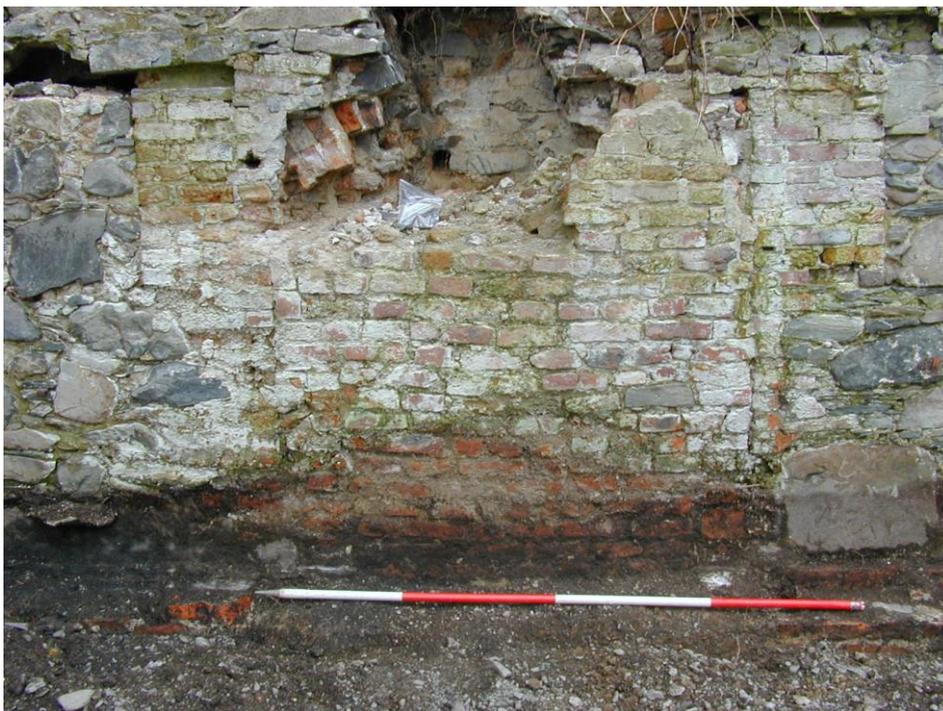
Plate 9 Northeast facing view of wall containing blocked up ovens and a fireplace

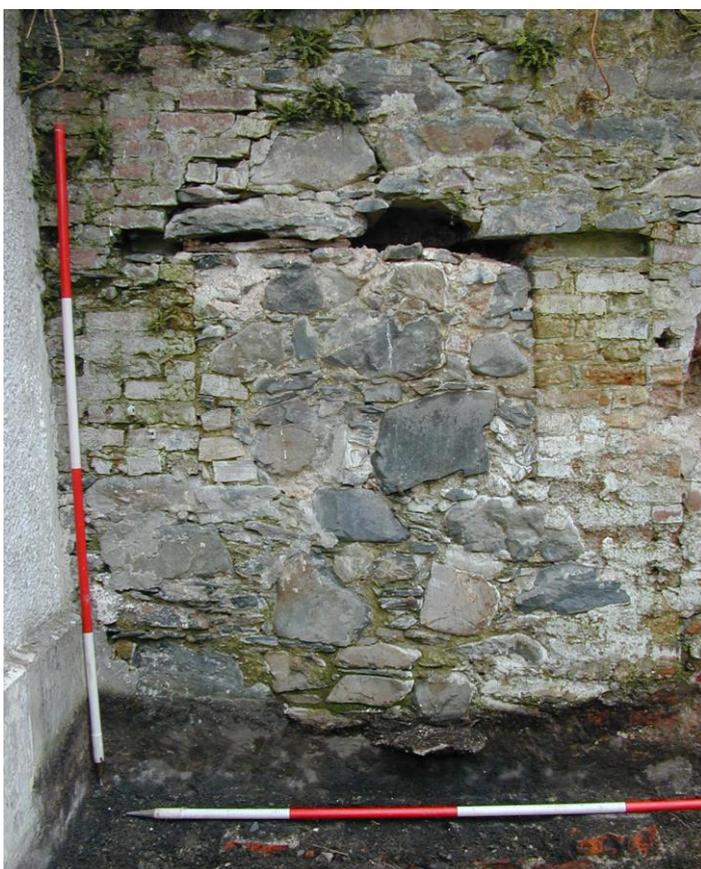
Plate 10 Northeast facing view of blocked up oven in 17<sup>th</sup> century cross wall

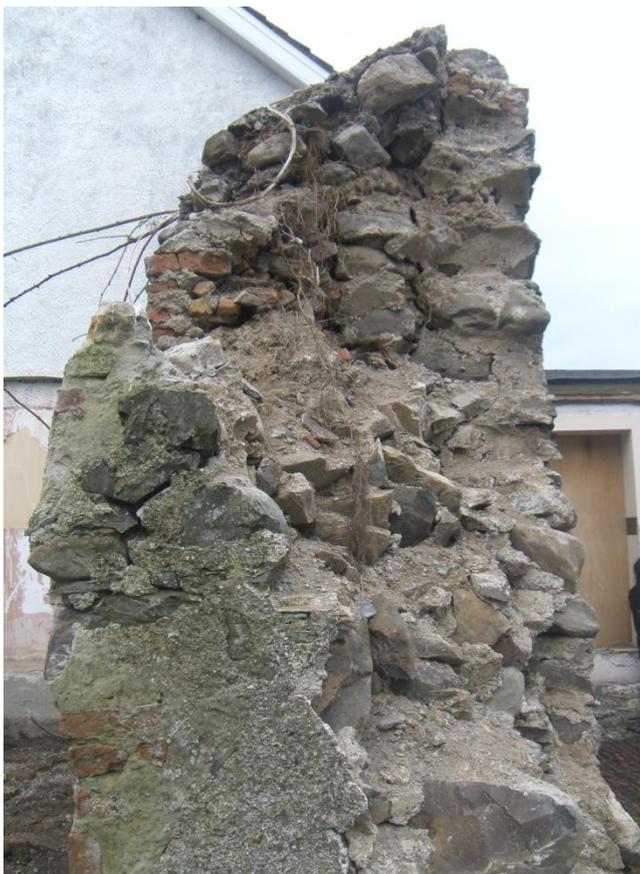
Plate 11 Northwest facing view of the top of the southern end of the 17<sup>th</sup> century cross wall

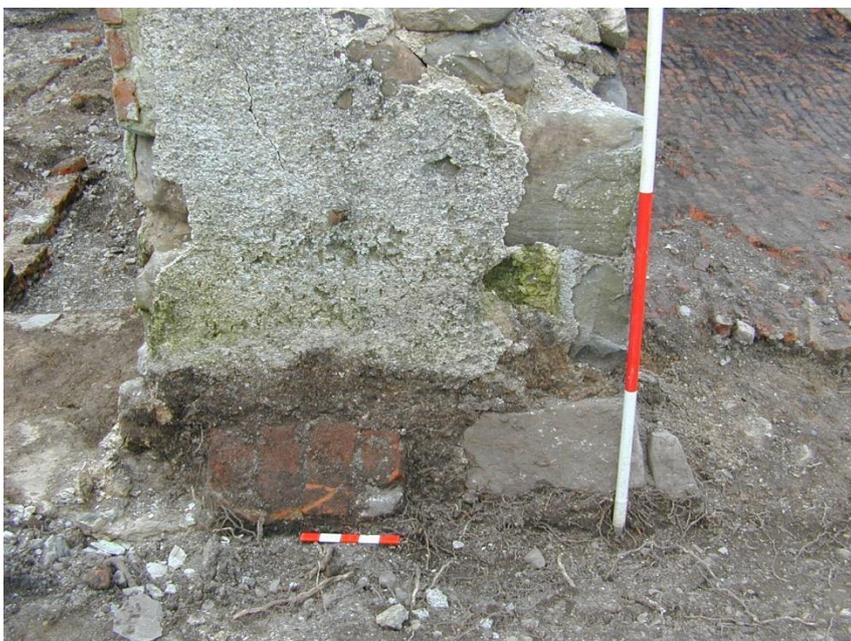
Plate 12 Northwest facing view of the base of the southern end of the 17<sup>th</sup> century cross wall

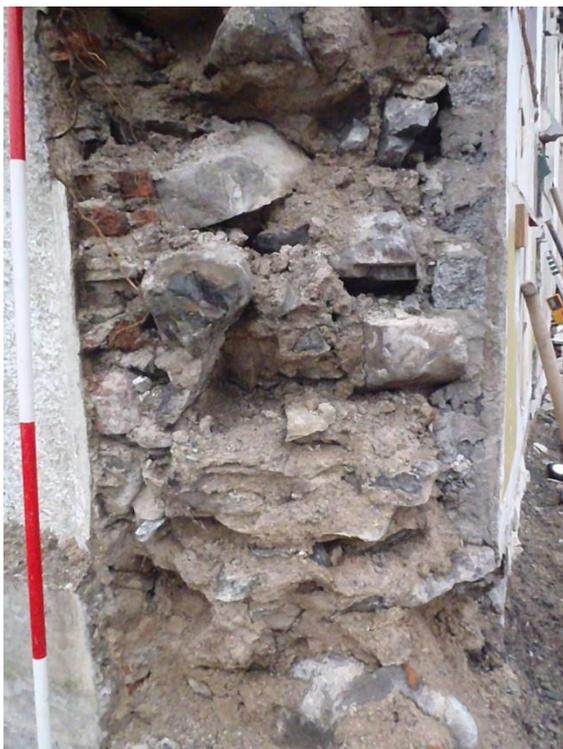
Plate 13 Northwest facing view of corner of Inishargy House post removal of the cross wall

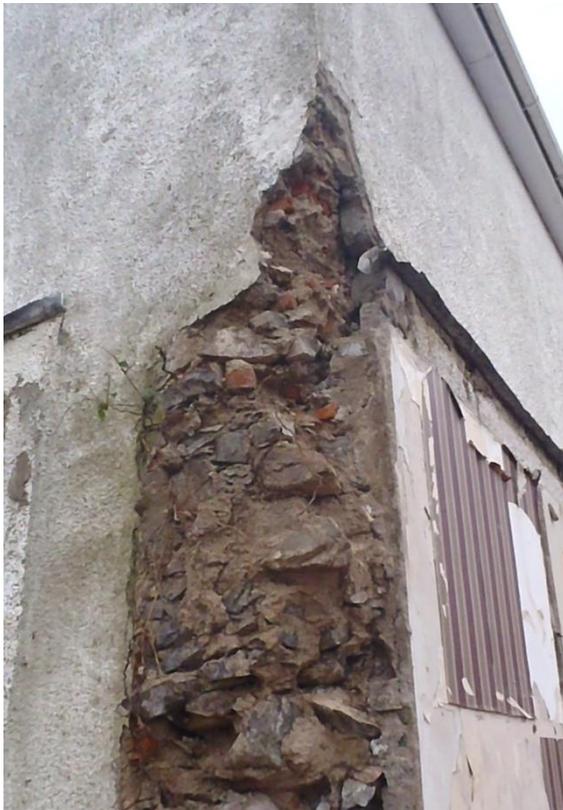
Plate 14 Northwest facing view of corner of Inishargy House post removal of the cross wall

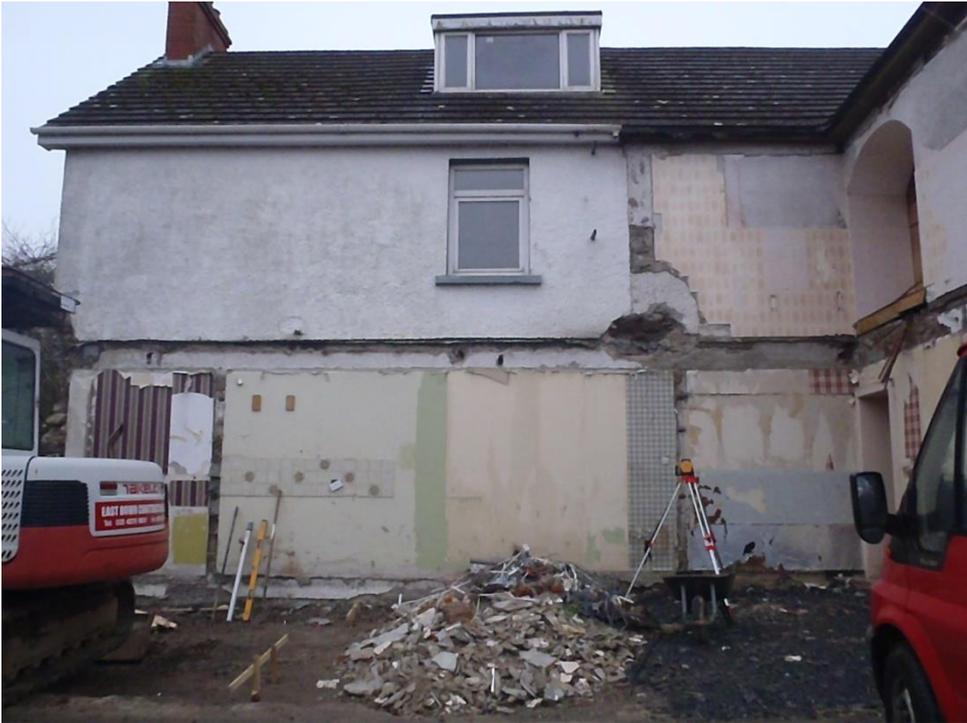
Plate 15 Southwest facing view of Inishargy House post removal of extensions

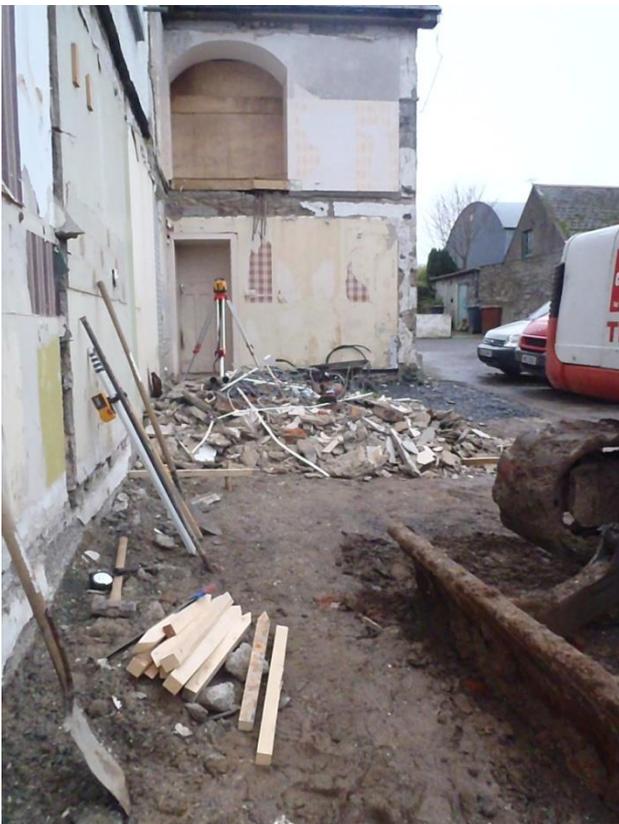
Plate 16 Northwest facing view of Inishargy House post removal of extensions

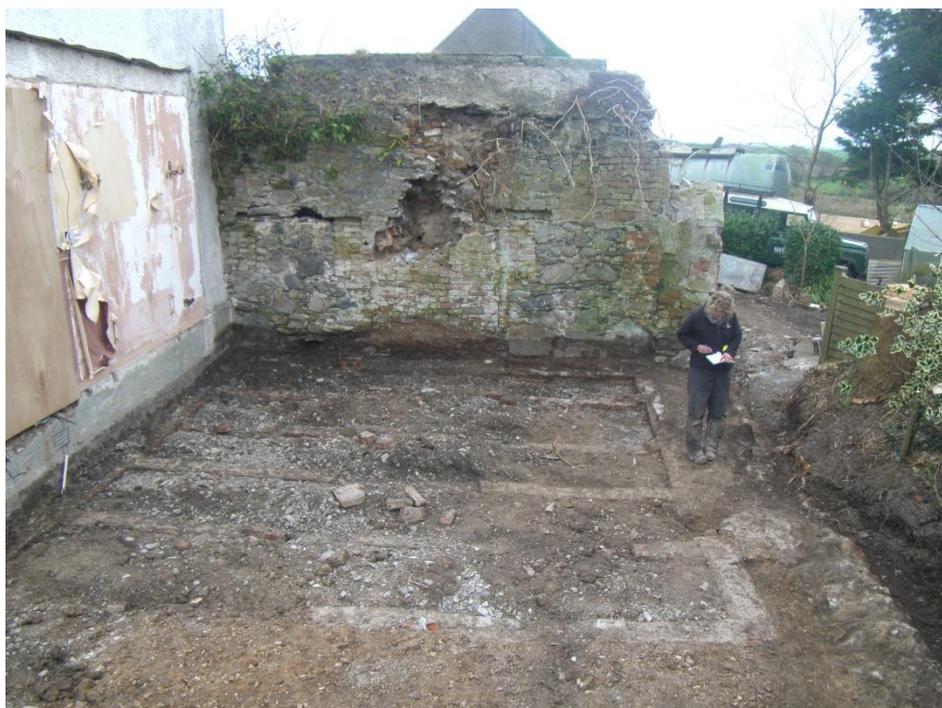
Plate 17 Northeast facing view of cross wall and brick walls uncovered during evaluation

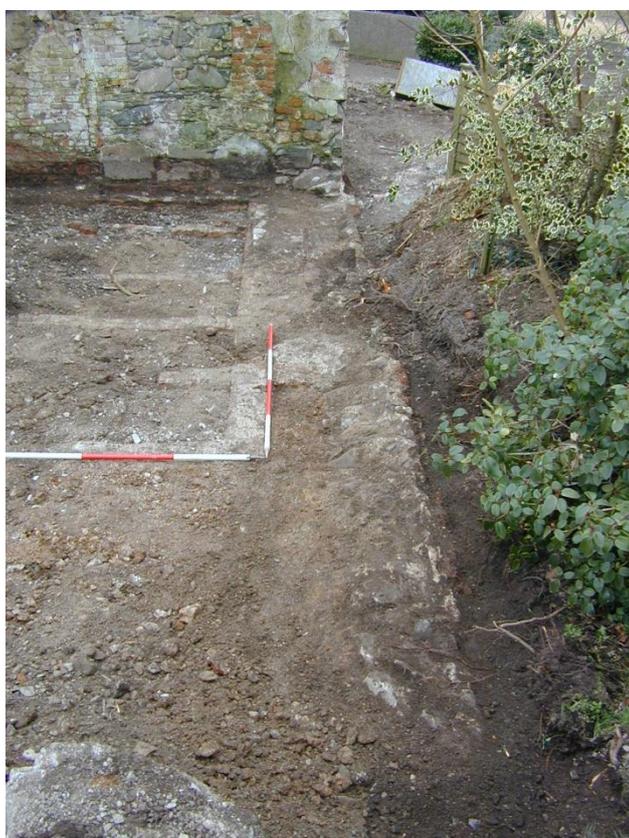
Plate 18 Northeast facing view of walls uncovered during evaluation
