**Inishargy House, Kircubbin County Down**

Excavation and monitoring carried out  
on behalf of NIEA

**CAF DSR No. 94**

Excavation Licence No: **AE/12/149**

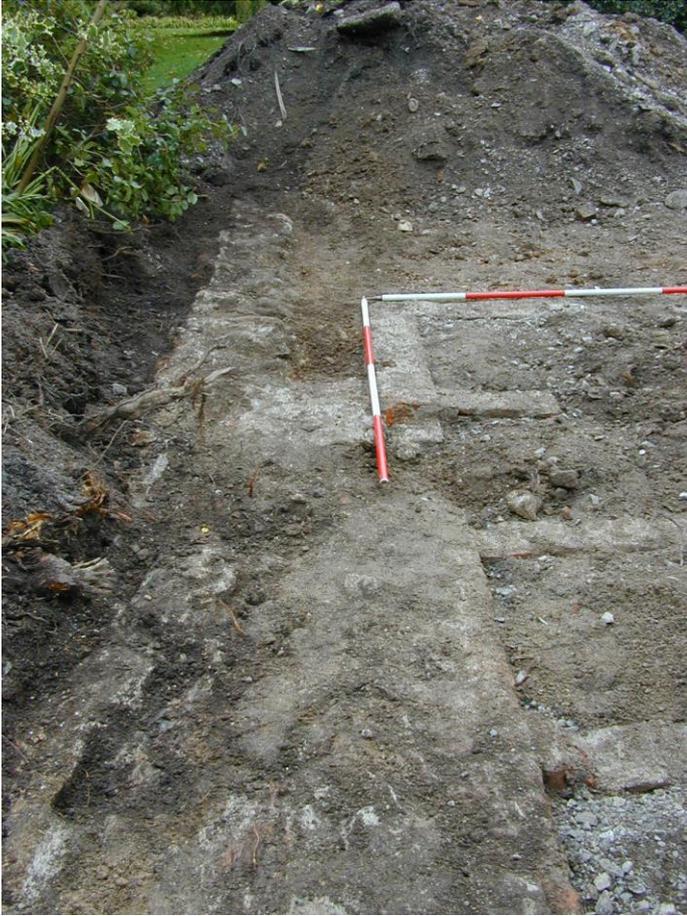
Plate 19 Southwest facing view of walls uncovered during evaluation

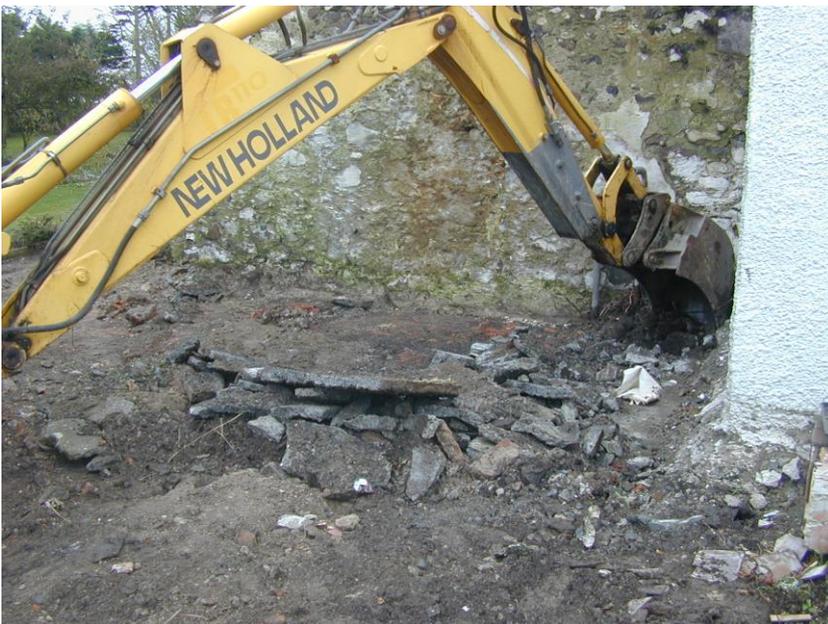
Plate 20 Southwest facing view of site mid-clearance of rubble and concrete flooring

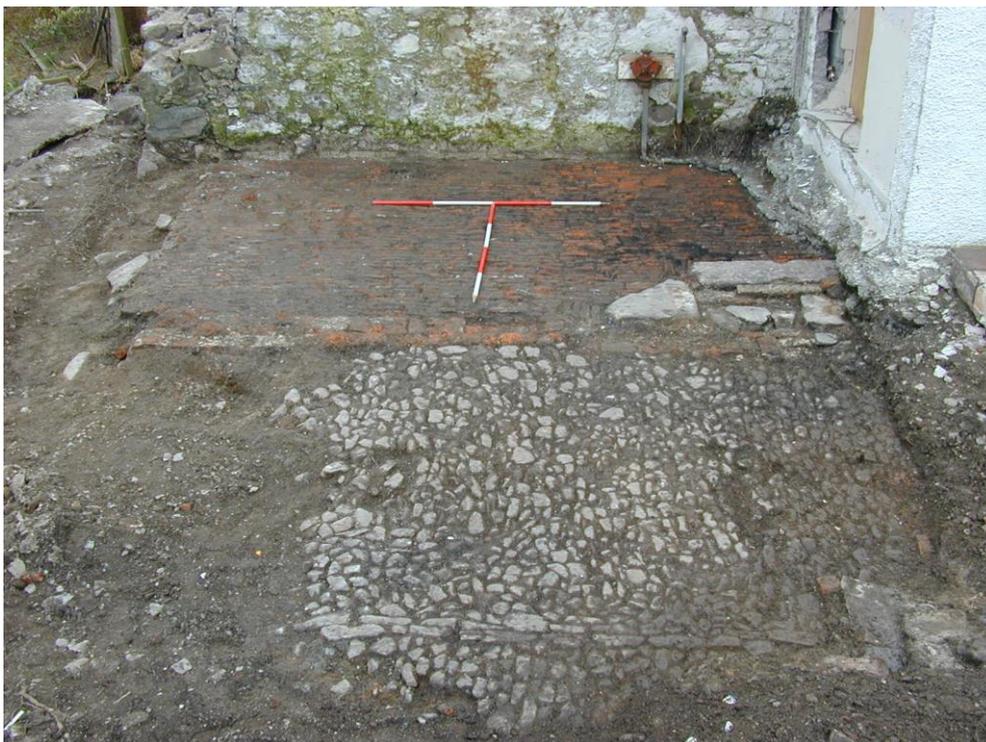
Plate 21 View from above and looking southwest of brick floor and cobbled surfacing

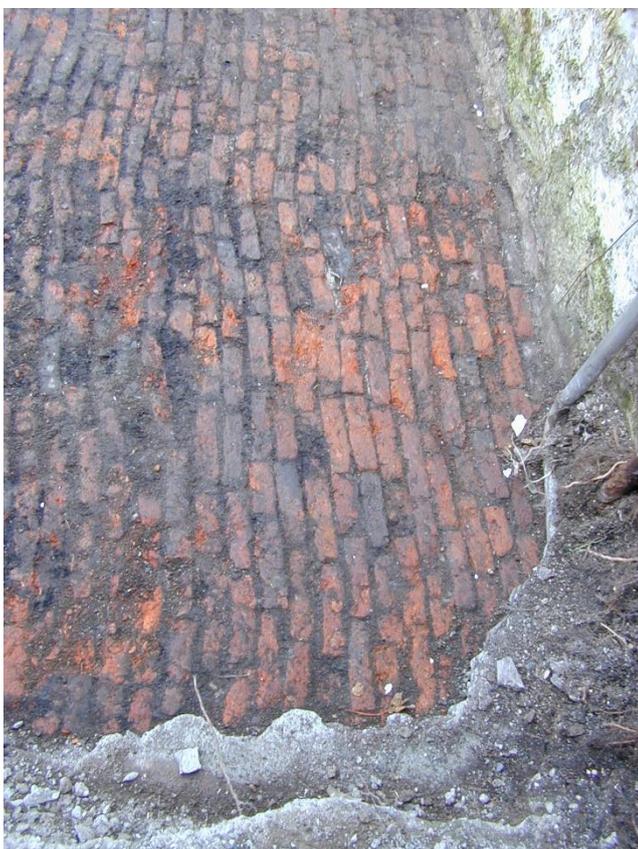
Plate 22 View from above of brick floor

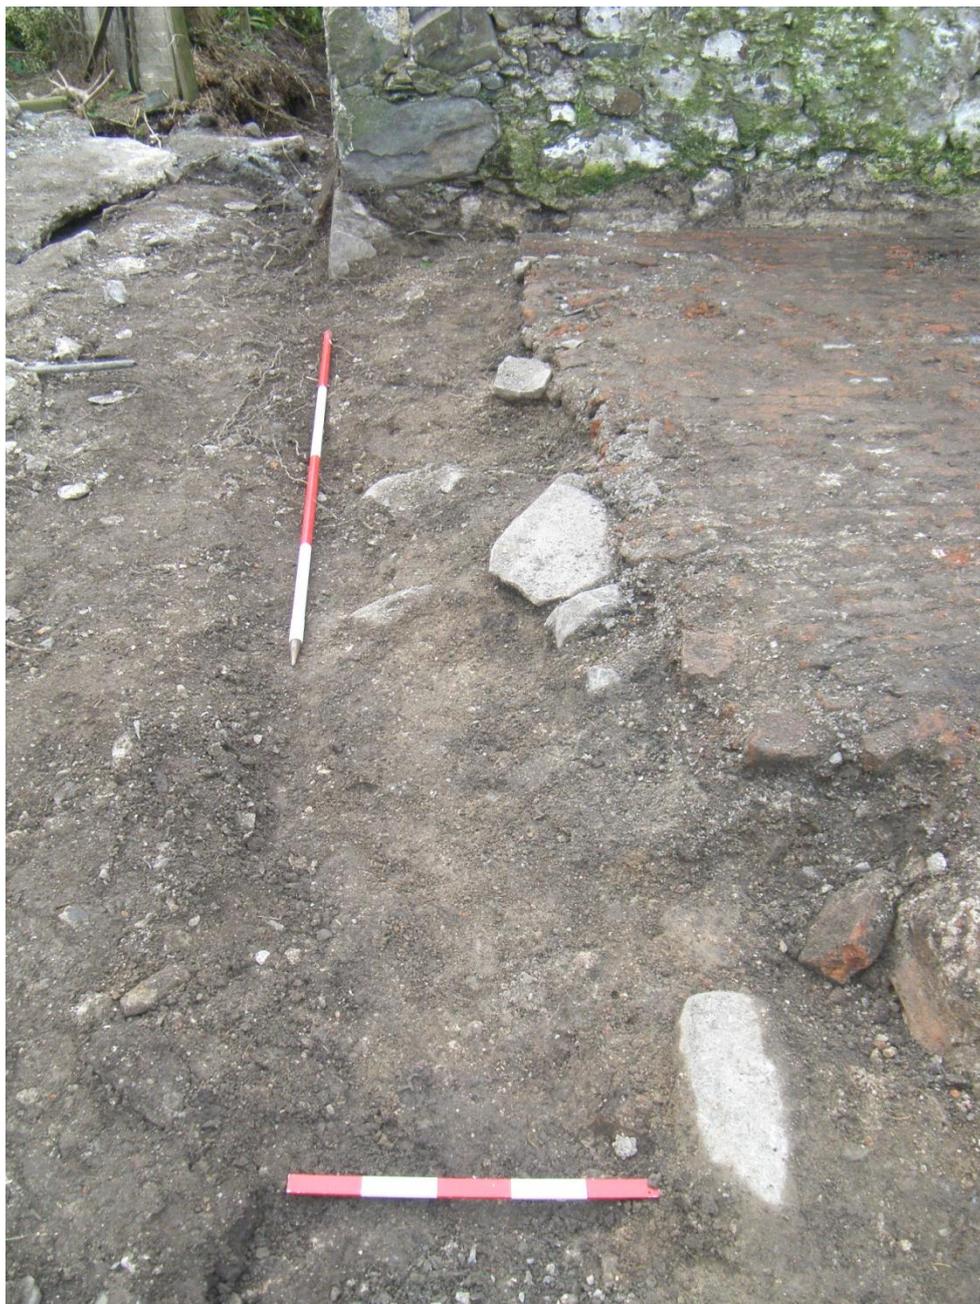
Plate 23 Southwest facing view along line of removed wall and edge of brick floor

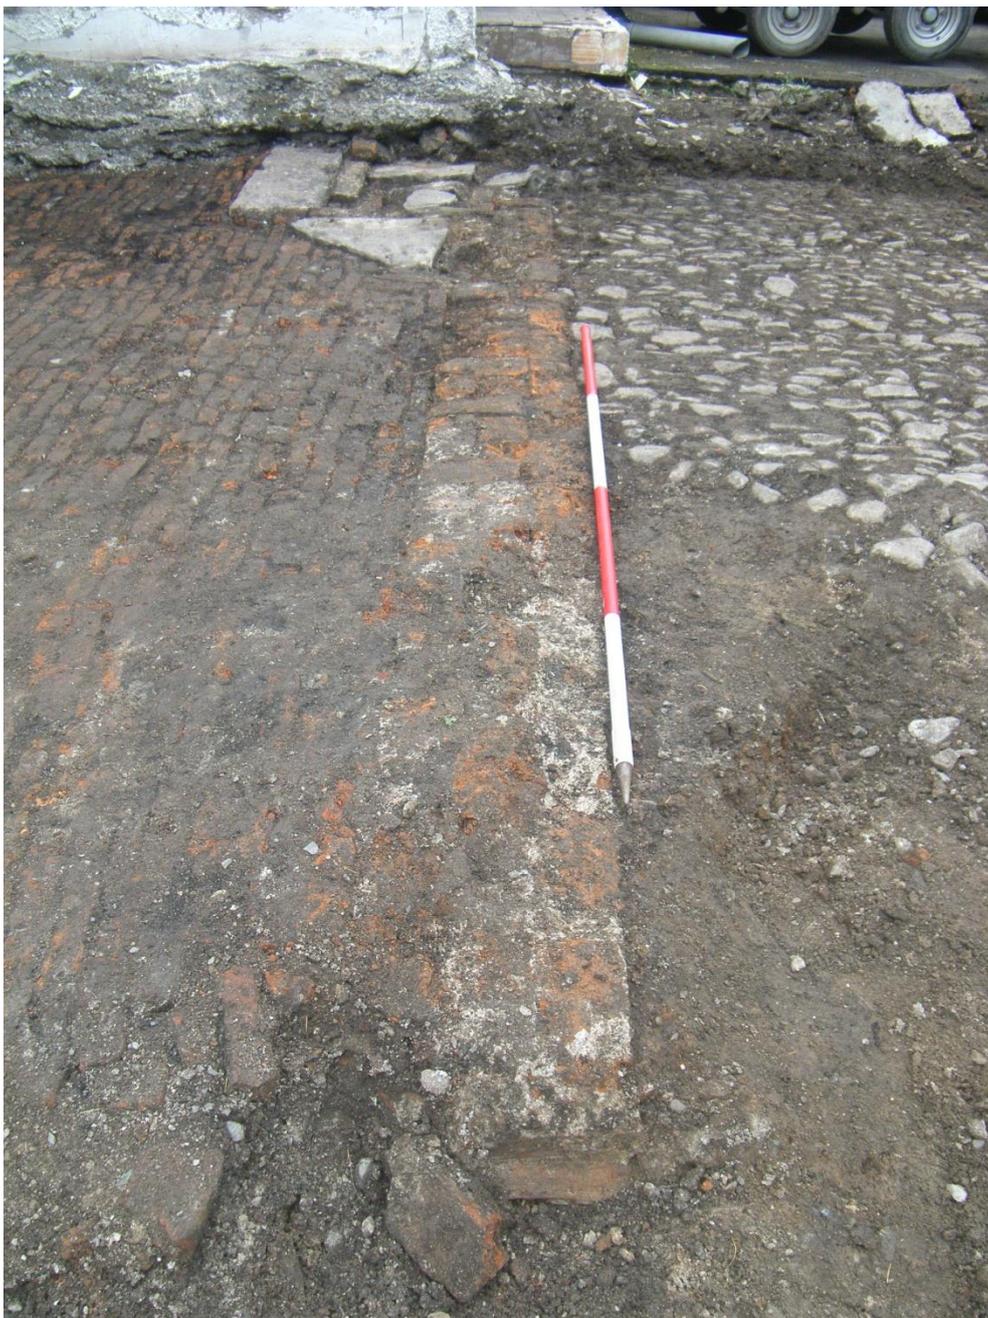
Plate 24 Northeast facing view along line of levelled brick wall

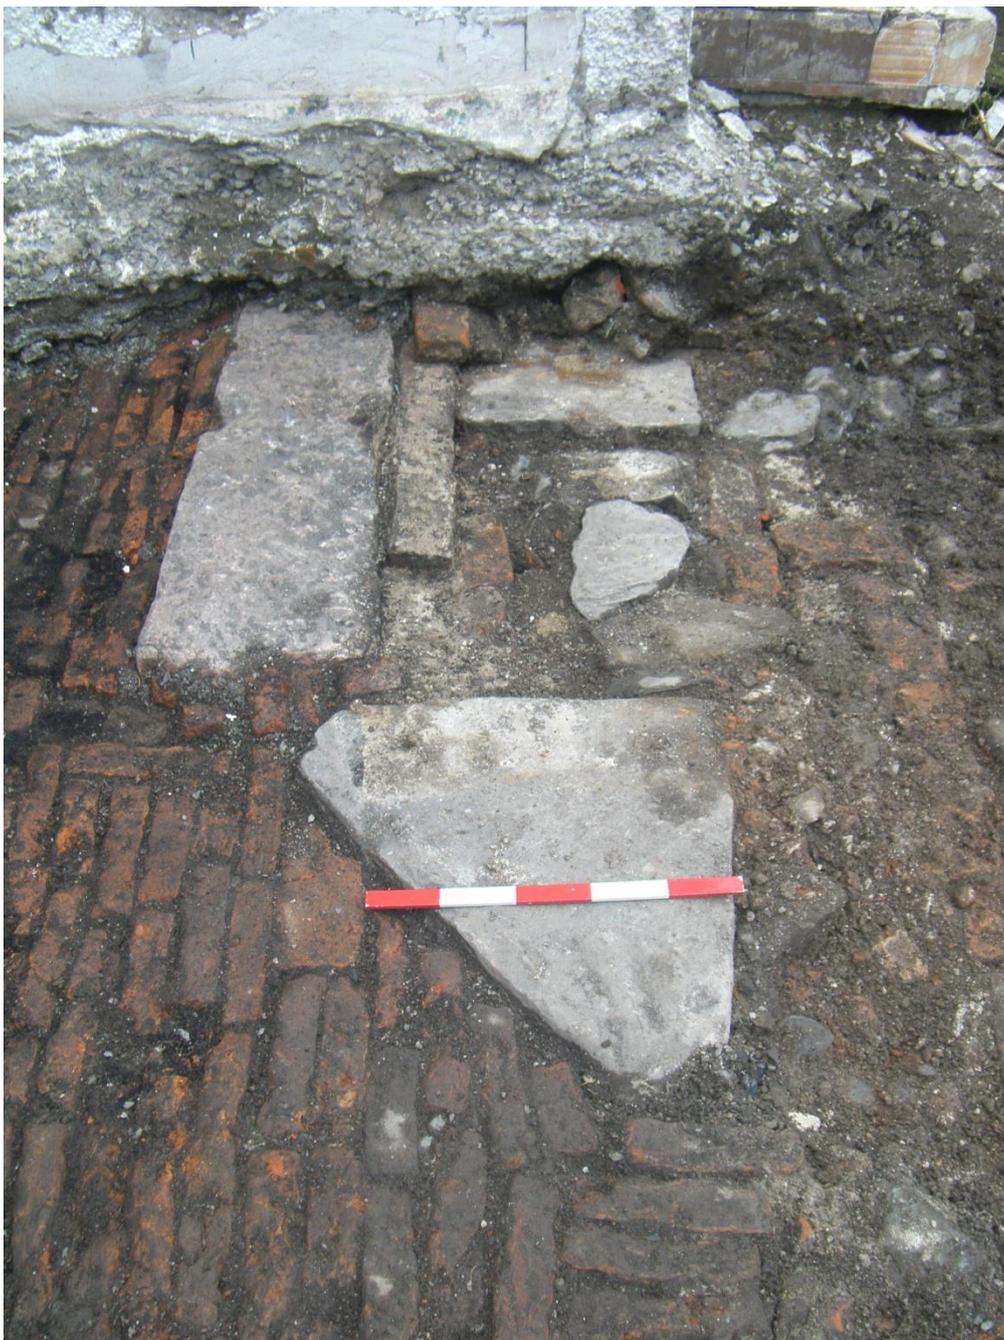
Plate 25 Northeast facing view of possible base of doorcase in brick floor

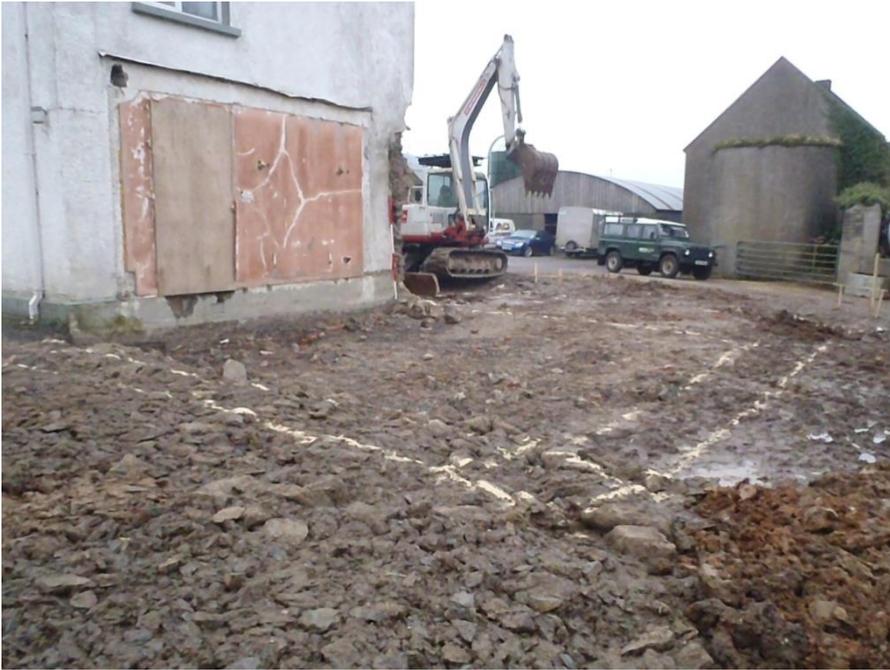
Plate 26 North facing view of site, pre-excitation of foundations

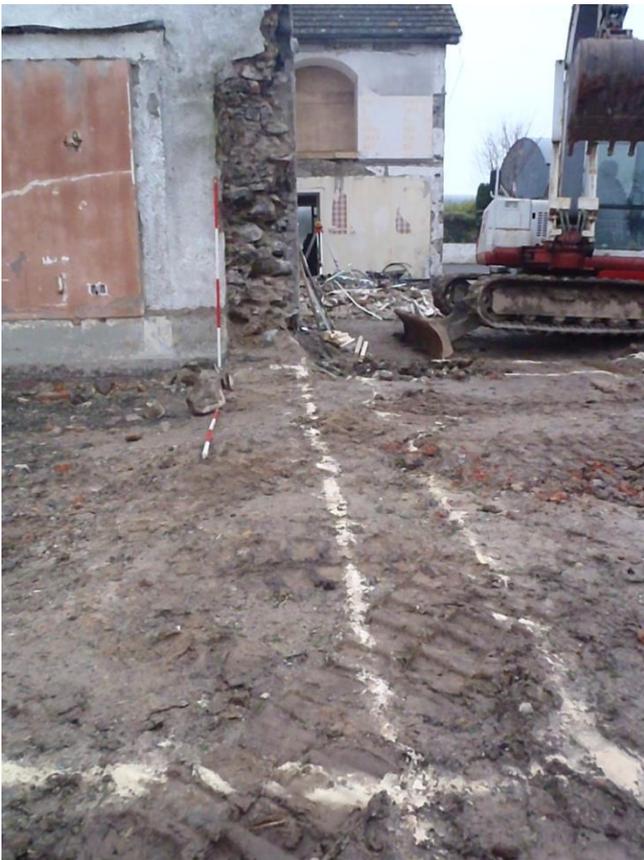
Plate 27 Northwest facing view of third foundation cut, pre-excitation, along the line of the now removed cross wall

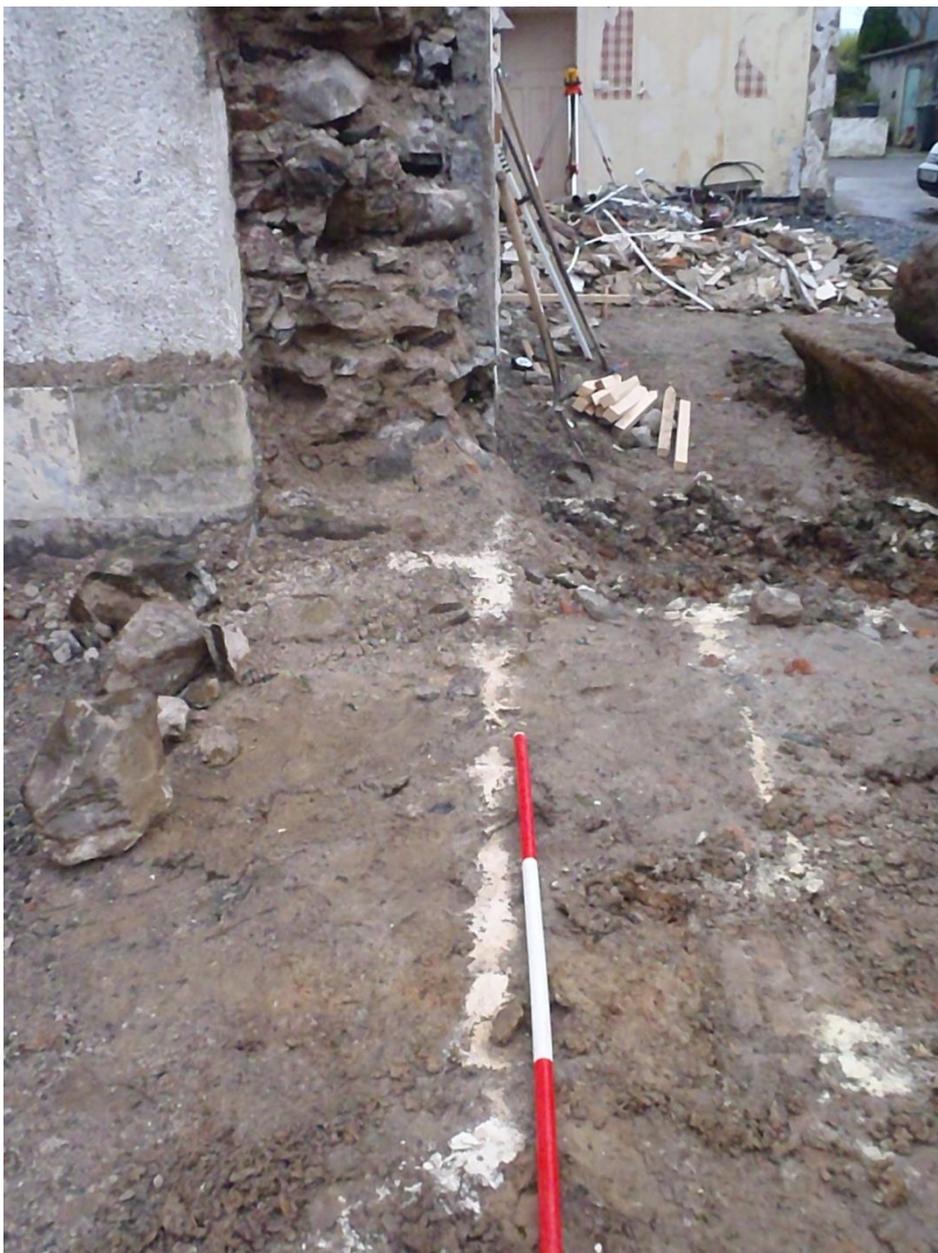
Plate 28 Northwest view of arbitrary edge of brick floor created by prior removal of original cross-wall, within the third foundation cut, pre-excavation of foundations.

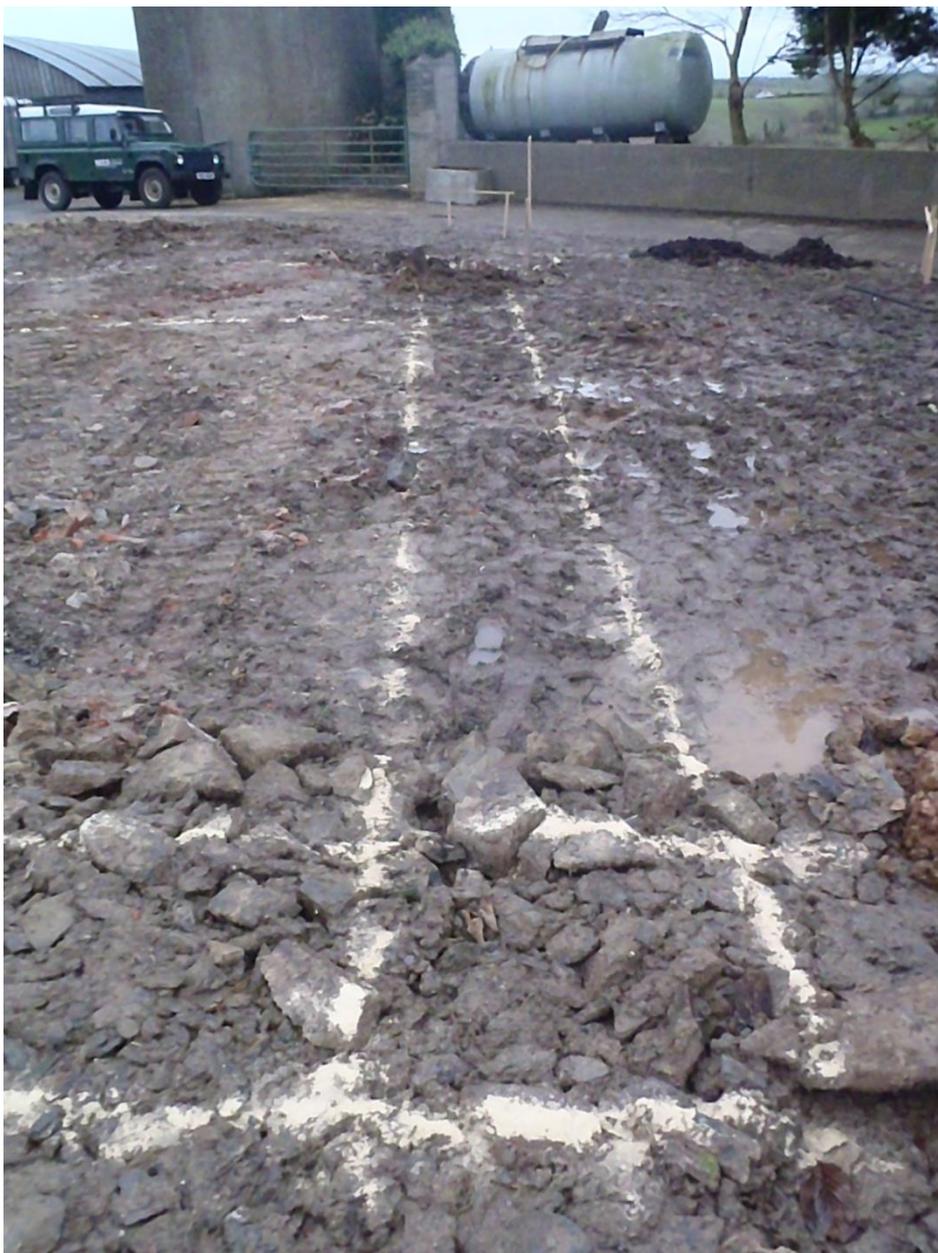
Plate 29 Northeast facing view of site pre-excitation of foundations

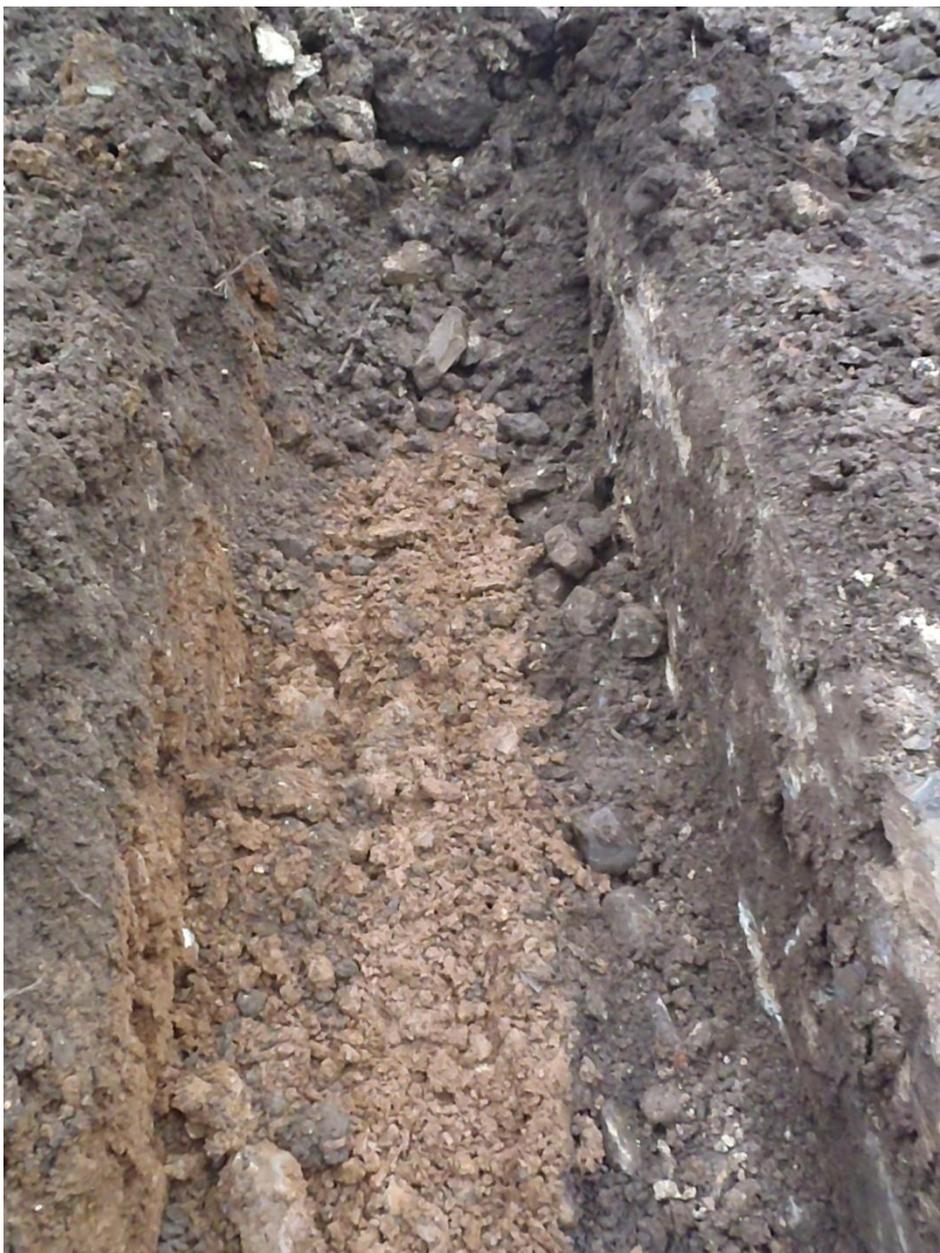
Plate 30 Southwest facing view of fourth foundation cut and uncovered wall, mid-excitation

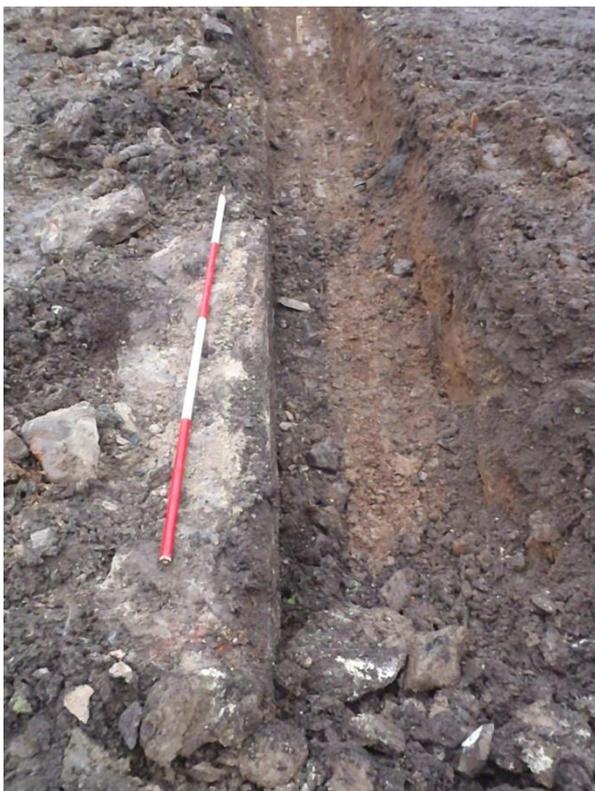
Plate 31 Northeast facing view of fourth foundation cut and uncovered wall, mid-excitation

- Plate 30 Southwest-facing view of fourth foundation cut and uncovered wall, mid-excavation
- Plate 31 Northeast-facing view of fourth foundation cut and uncovered wall, mid-excavation

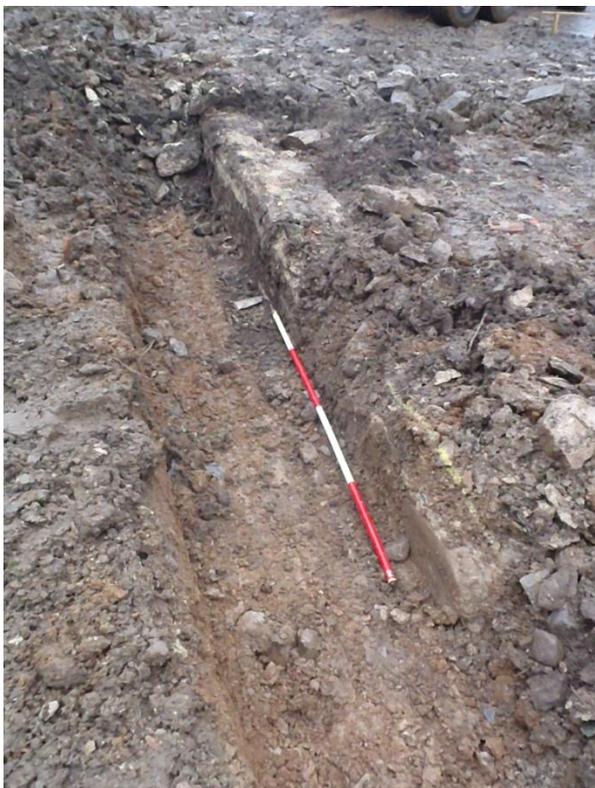
Plate 32 West facing view of fourth foundation cut and uncovered wall, mid excavation

- Plate 32 West-facing view of fourth foundation cut and uncovered wall, mid excavation
- Plate 33 Southwest-facing view of fourth foundation cut, post removal of intruding wall section

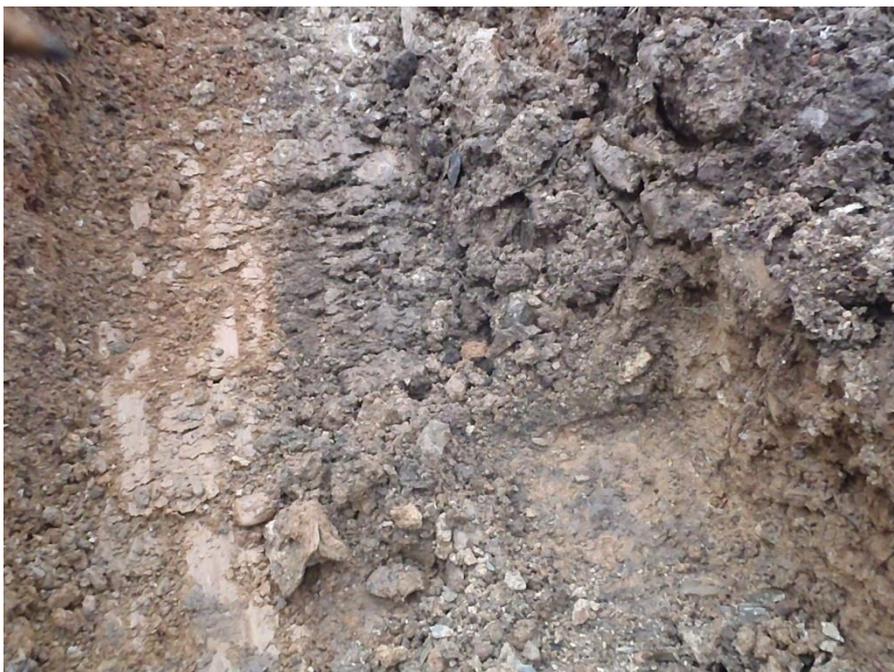
Plate 33 Southwest facing view of fourth foundation cut, post removal of section of wall which encroached on new extension foundations

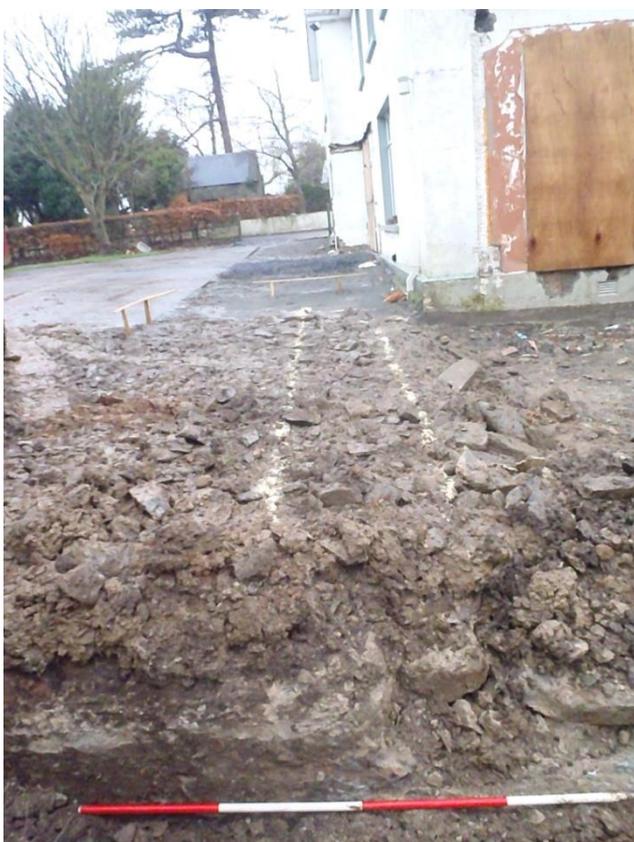
Plate 34 Northwest facing view along line of house and fifth foundation cut

- Plate 34 Northwest-facing view along line of house and fifth foundation cut

- 6.4.5 The fifth cutting was for the planned new southwest facing wall and its short return into the current front face of the upstanding house. Placement of the foundations appears to indicate that this new wall will sit marginally further west than the already existing northern wing of the house (Plate 34). Excavation of this trench revealed a demolition layer of mixed materials; concrete rubble, mortar, brick, stone, tarmac and road chippings. Removal of this revealed the natural orange clay subsoil of the site beneath. No further features or finds of archaeological significance were noted.
