**Excavations at Drumreagh, Bendooragh, Co. Antrim**

**CAF Data Structure Report No. 102**

**Data Structure Report: Drumreagh, Bendooragh, Co. Antrim**

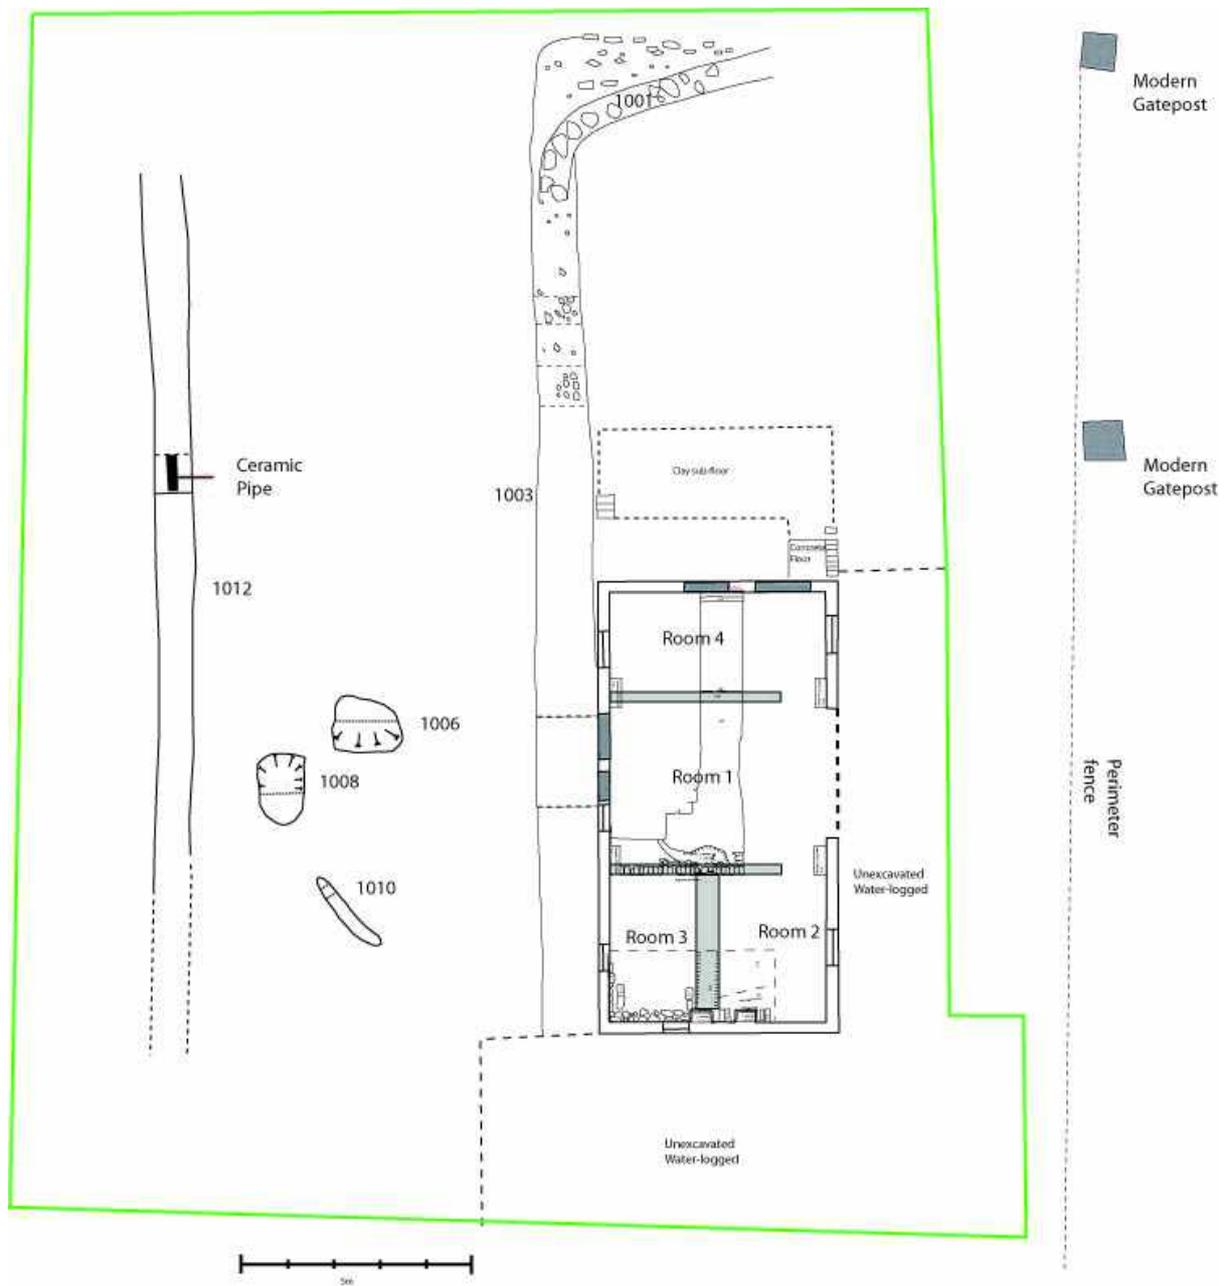
Figure 2 Detailed Location, general plan of excavation and external trenches

The interior of the building, as it currently stands, has a concrete floor. Four paired concrete block pillars, one set 2.8m from the west gable of the house and a second set 3.45m from the east gable (Figure 2), appear to bear most of the weight of the roof. The current roof is made from modern timbers supporting slate. While this roof and the concrete piers which support it are of very recent construction, it may have fossilised aspects of the earlier roof structure. As already mentioned the four concrete pillars along the side walls of the house effectively seem to have replaced wooden crucks. These concrete cruck replacements seem to be the primary supports of a modern variant of a traditional Collar-beam truss roof as defined by (McCourt 1972, 126-7). The two side purlins, supported by the gables are not made from a single piece of wood but are made from two separate pieces of timber jointed at the point where the collar beam tied the more westerly pair of concrete cruck replacements.

An area measuring 23m north-south by 28m east west was excavated at the side and rear of the house (Figure 2). The area had until recently been a hard-cored temporary parking place for the nearby church and had been stripped of topsoil in advance of construction of this temporary parking place. The area was re-stripped under archaeological supervision during the excavation. A number of features were uncovered.

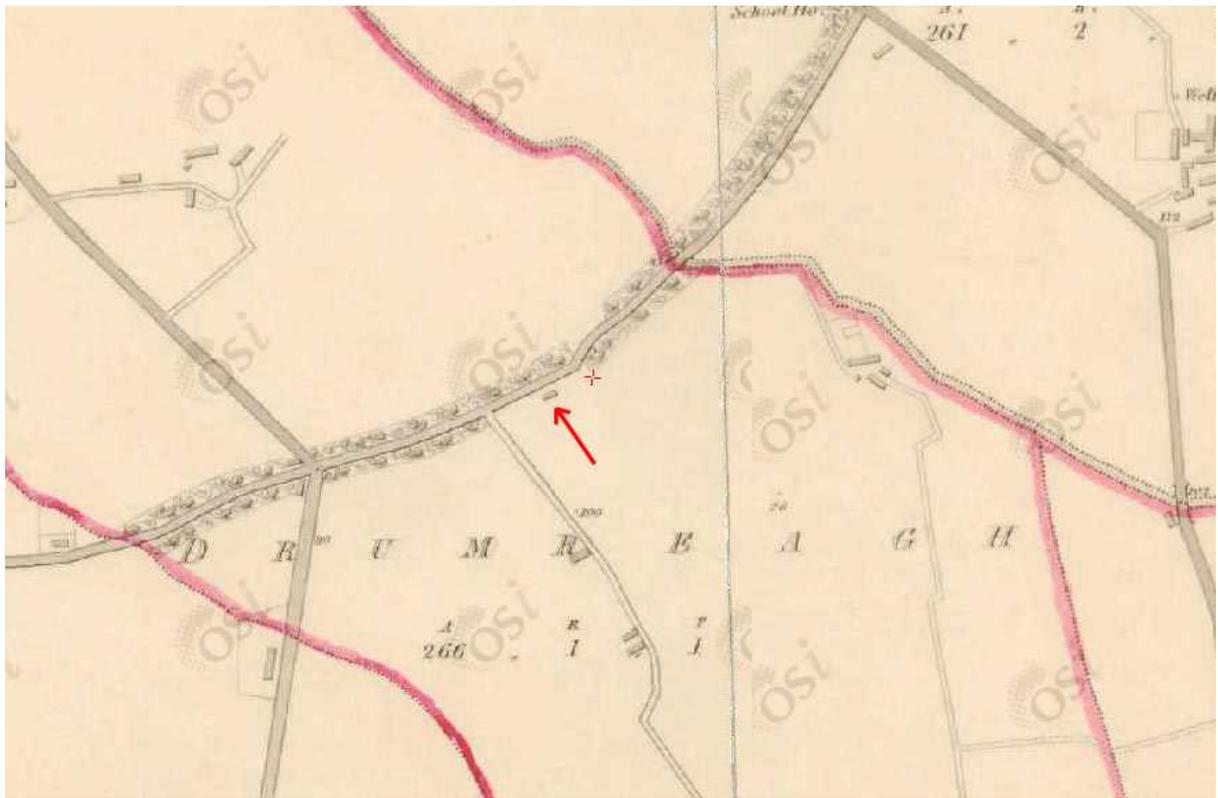
Figure 4: First edition Ordnance Survey Map of Drumreagh showing house- arrowed.

A building is depicted in the 1<sup>st</sup> Edition Ordnance Survey map (Figure 4), in the same location as the house we excavated. It appears however from the map to be slightly smaller than our structure (both slightly shorter and narrower), this may simply be the result of map makers inaccuracy, alternatively it could indicate that the existing structure is a later building or an extended version of an earlier building, neither of which possibilities seem to be supported by the results of the excavation.

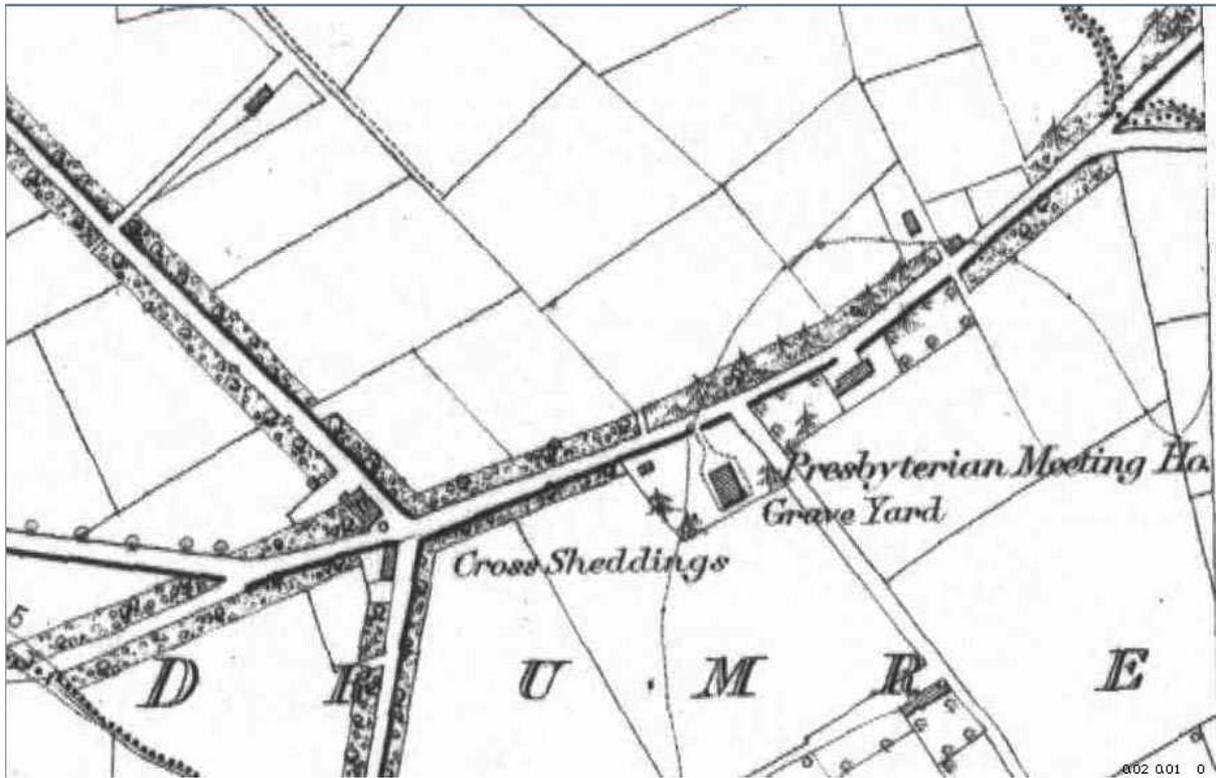
Figure 5: Second edition Ordnance Survey Map of Drumreagh showing with garden plots to east and west and possible annex.

The second edition Ordnance Survey Map (Figure 5), depicts a slightly larger structure with a hint of an annex at the west end. To the east and west of this structure there are two small rectangular enclosures which contain trees, broad leaf, in contrast to the conifer trees depicted in the newly constructed Presbyterian Meeting House and Grave Yard nearby. These may be orchards. The Second Edition maps were revised versions of the First Edition maps with more detail added, produced in the latter half of the 19<sup>th</sup> century, the area around Bendooragh.

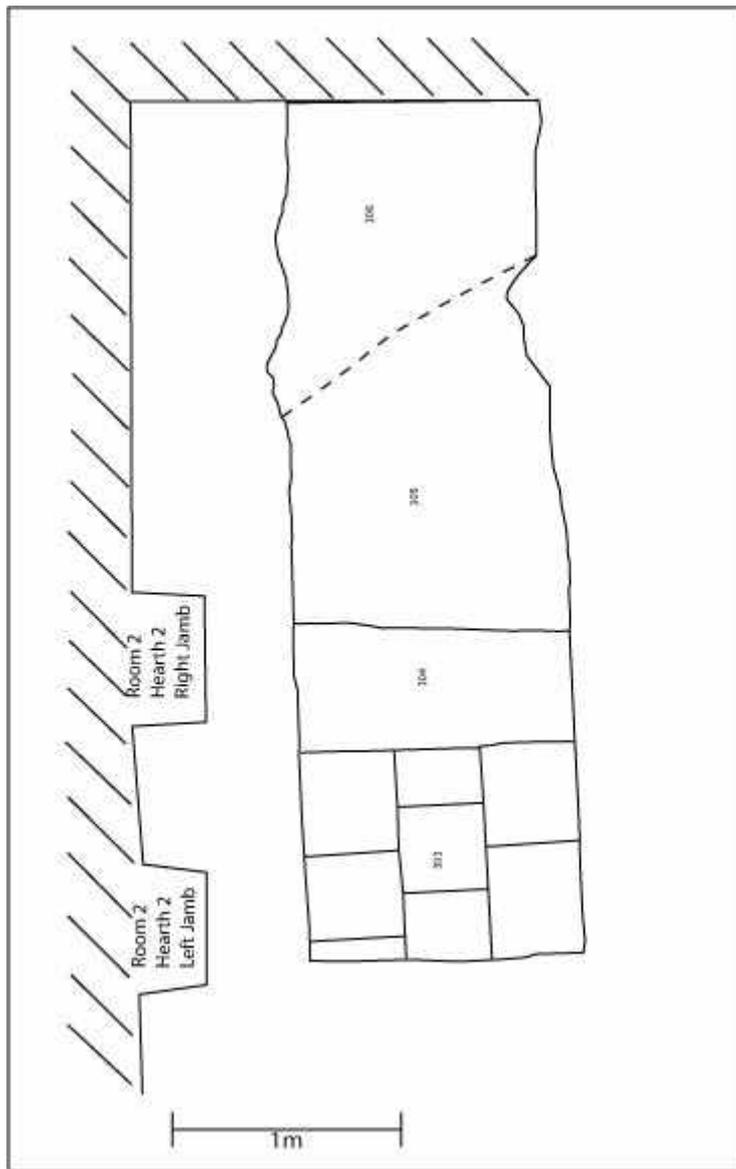
Figure 7: Trench 3 after removal of concrete

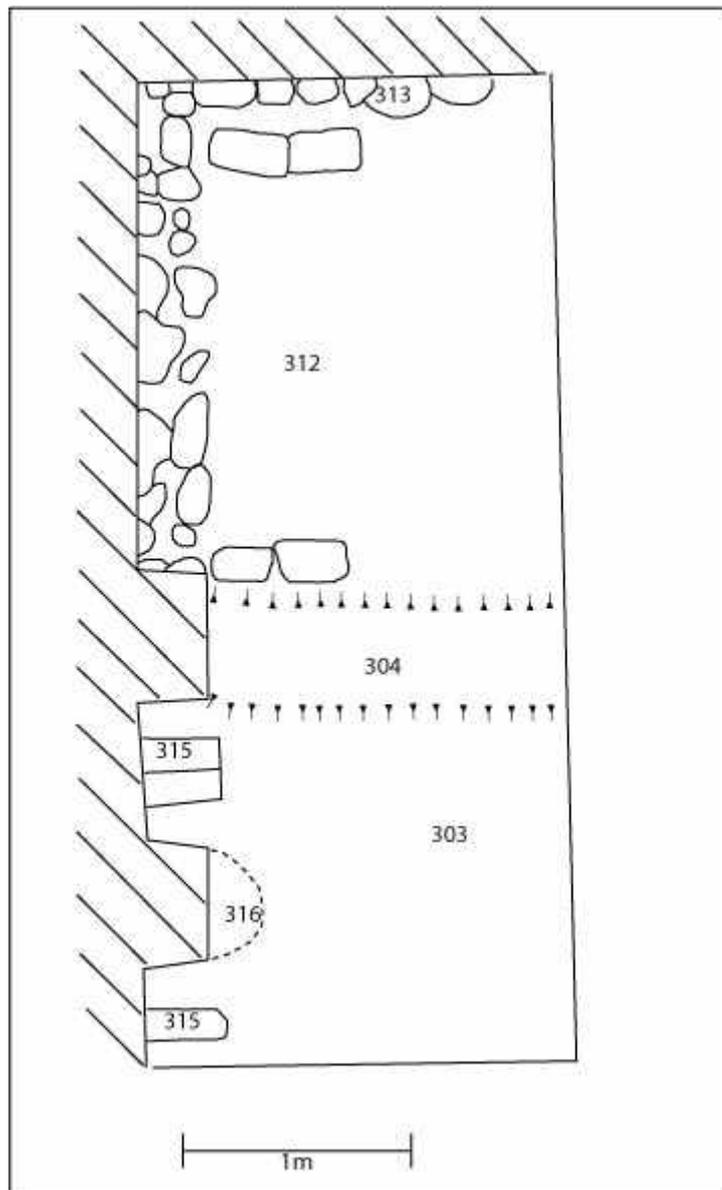
Figure 8: Trench 3 after being extended, showing mortar bedding for tile floor (303), berm of earth (304) possibly supporting internal partition, stone wall footing (313) early fireplace jambs (315) and fireplace derived soot (316) and subsoil (312)

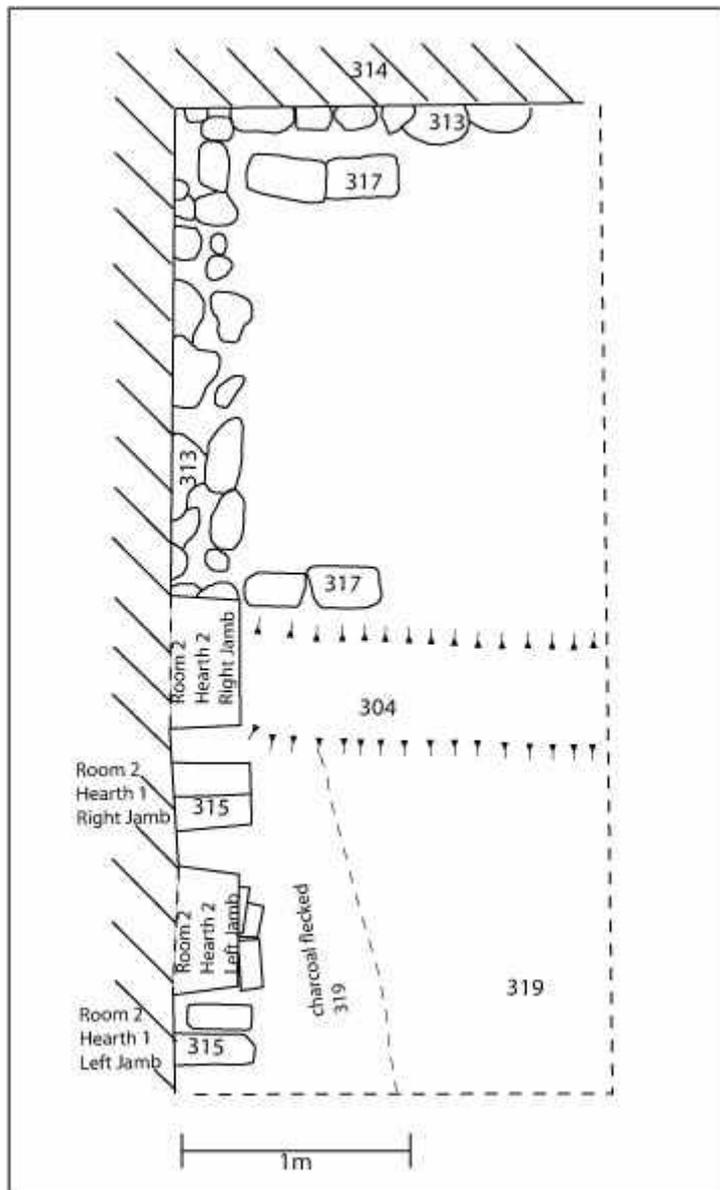
Figure 9: Trench 3 showing joists (317) for support of later wooden floor to south of trench, clay floor (319) in north of trench and brick jamb bases of earlier fireplace (315).

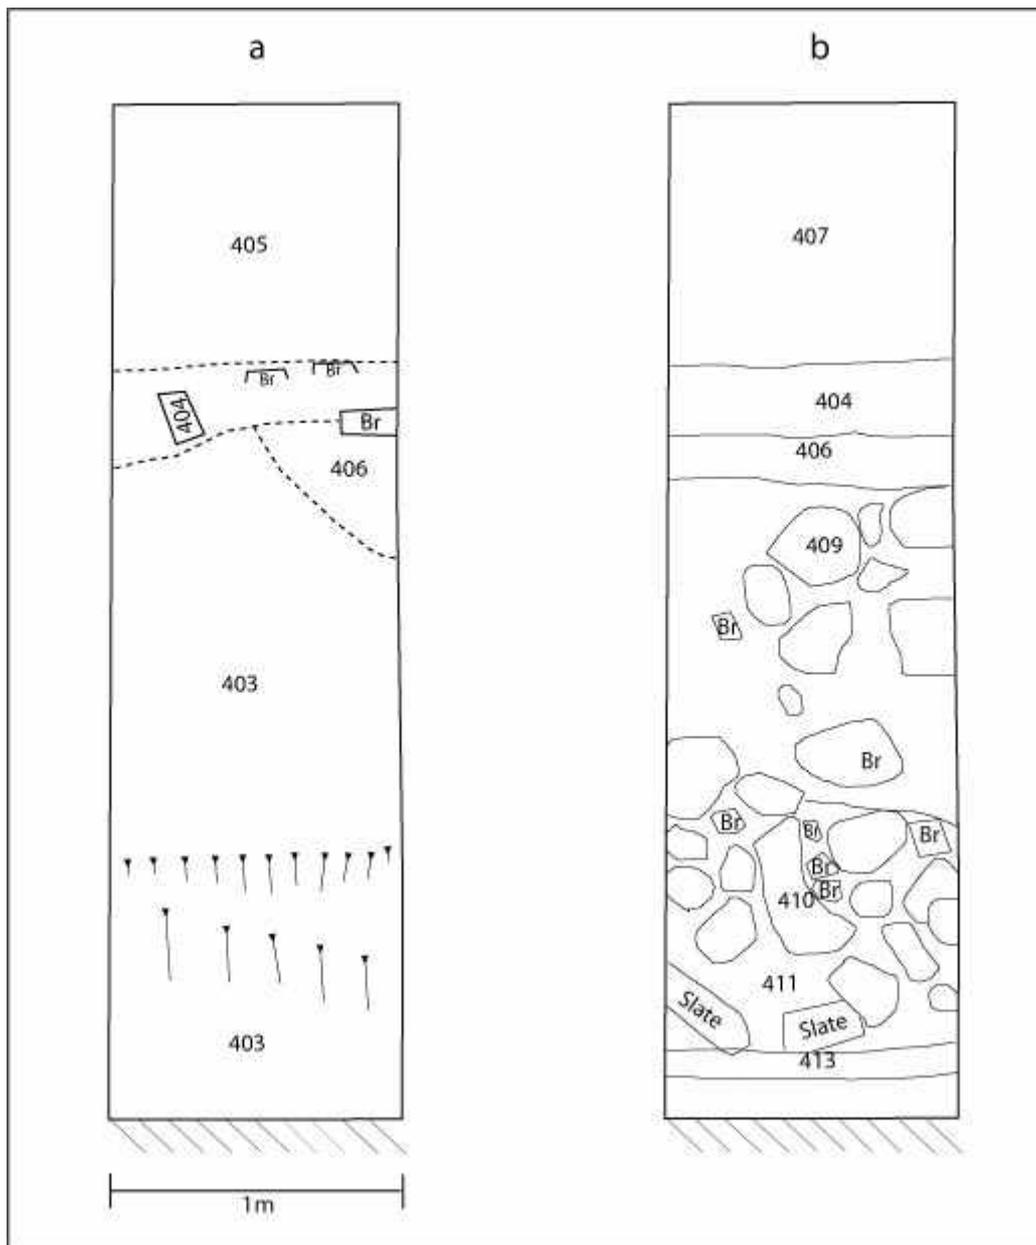
Figure 10a: Plan of initial layout of Trench 4 showing tile bedding mortar (405) and levelling layer (403) as well as top of internal wall (404) and void (406)

Figure 10b: Plan of initial layout of Trench 4 after removal of later levelling and flooring layers showing the beaten clay floor (407), the stones and mortar rubble infill (409 and 410) above the remnants of the wooden floor (411) and the joists supporting this floor (413).

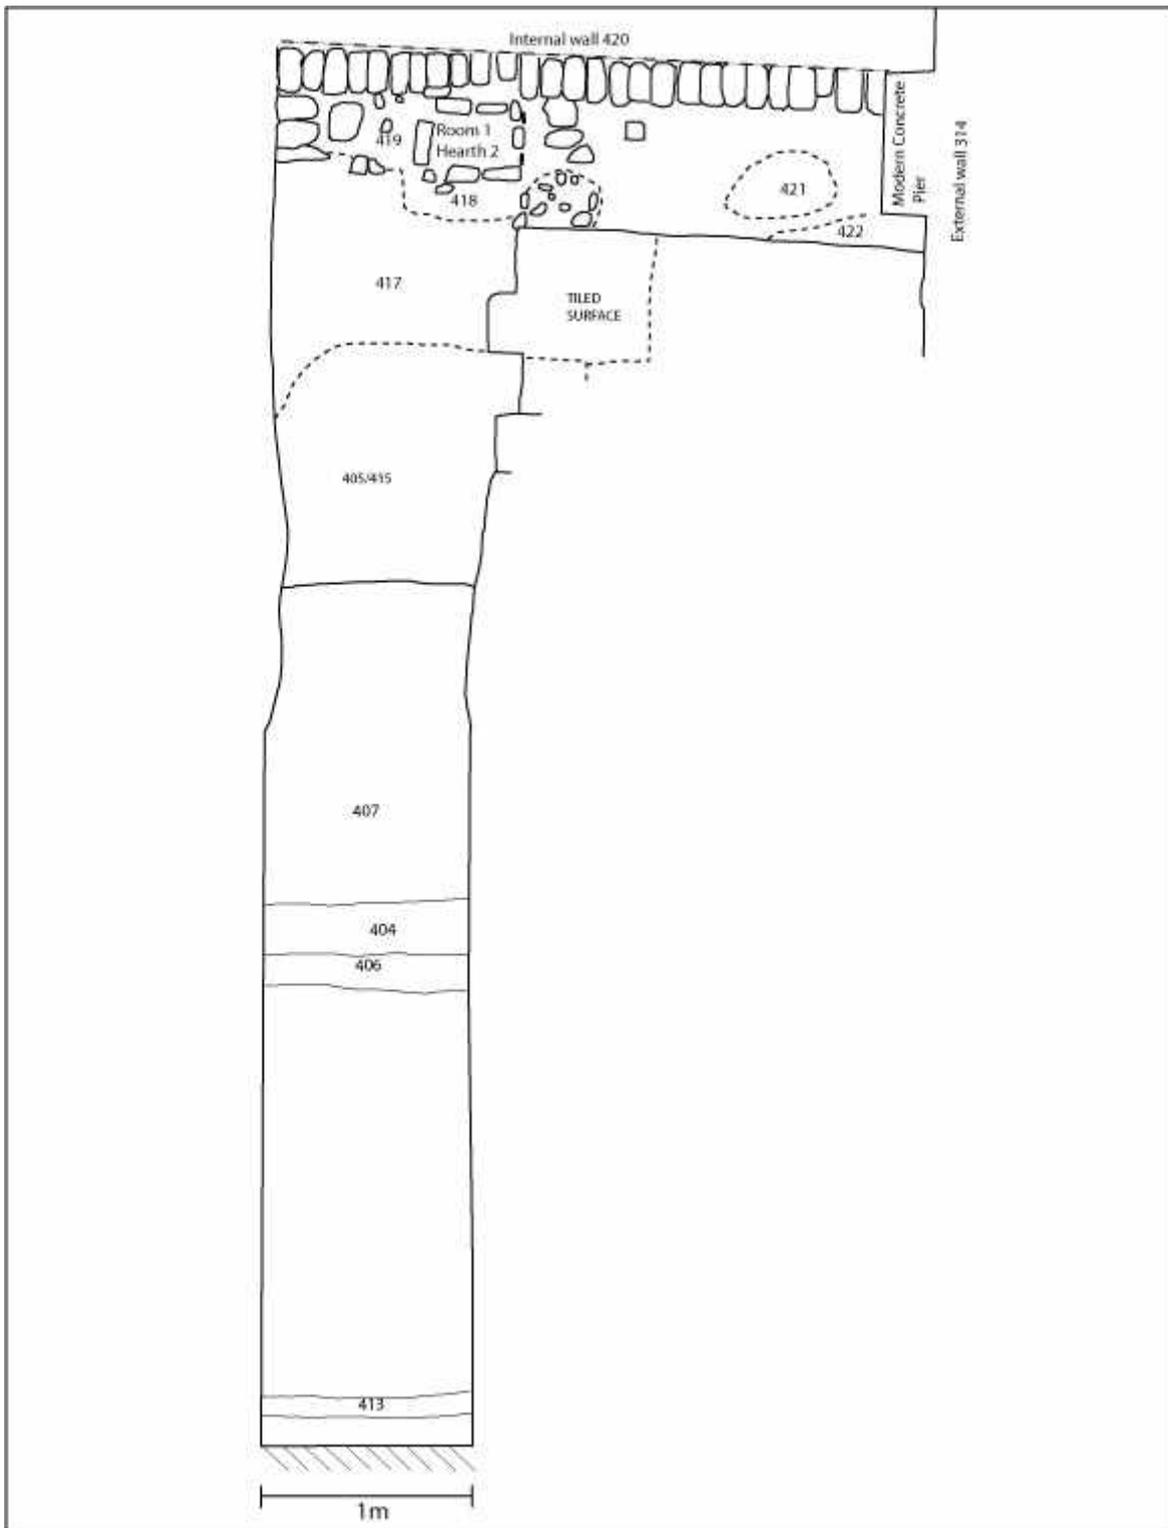
Figure 11: Trench 4 after its extension and removal of rubble from west end.

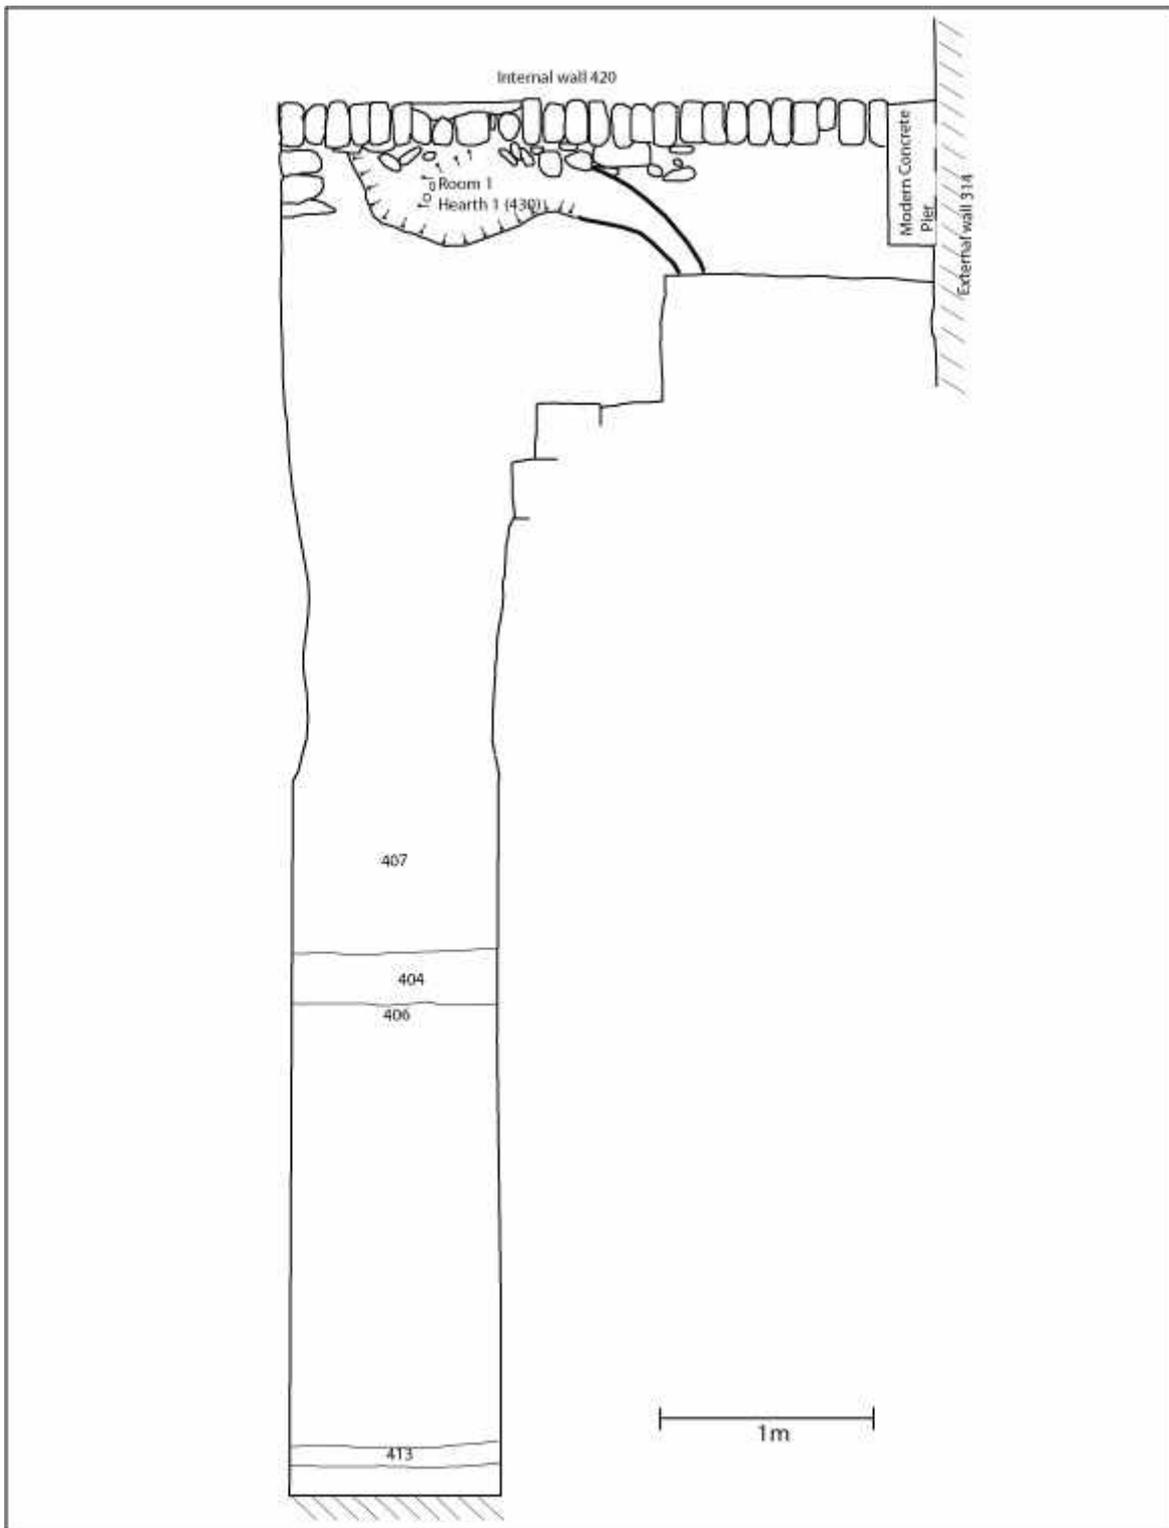
Figure 12: Plan of Trench 4 showing clay floor and hearth pit (420) with unusual curving “flu” possibly to facilitate bellows.

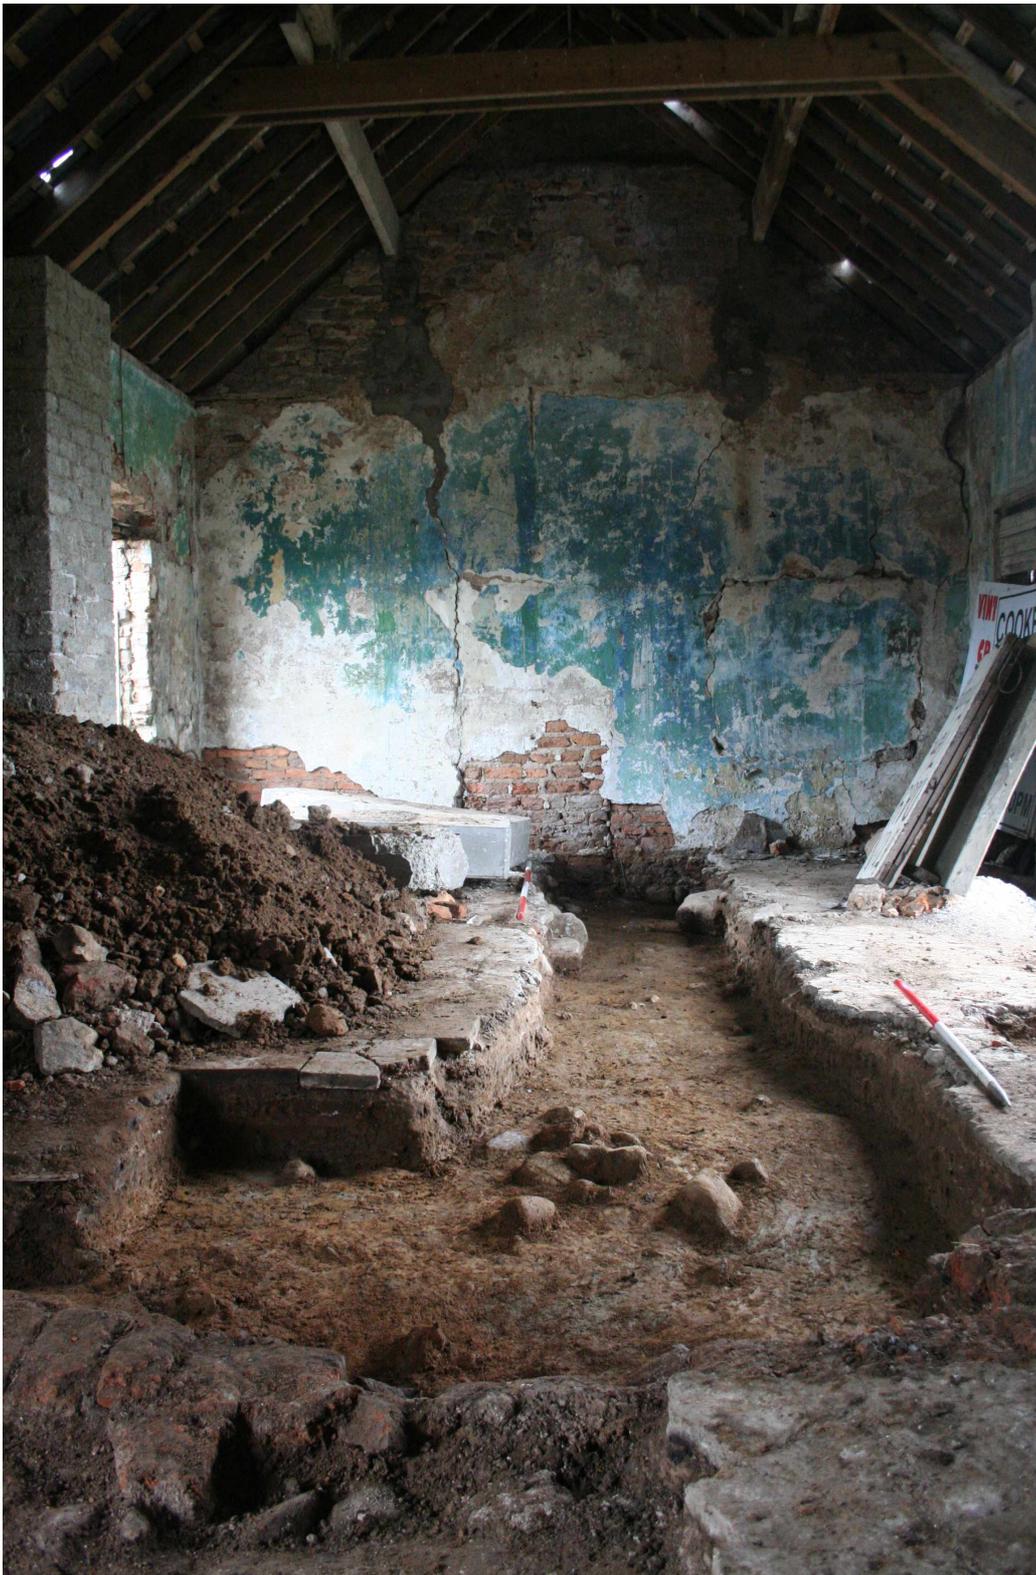
Photo 5: West gable of house showing Trench 4 after excavation, note concrete roof support pillar at left

It is evident from an examination of the interior of the west gable that the house has been heightened at some stage. Whitewash which has collapsed from this gable shows the original brickwork having been augmented to heighten the house, the outline of the original roof height and (false)chimney visible thanks to the differential brickwork (Photo 5). The east gable still has intact whitewash in place over most of its surface obscuring similar changes and alterations there (Photo 6). How this was reflected in adaptations to the cruck supported roof is now unclear, the current concrete pillars are certainly much more recent than the heightening of the roof, were the original crucks replaced with longer ones or was the roof adapted in another way? That the building was used, at some stage, as a two story house can be evidenced by the differentially coloured whitewash applied to the walls. The east gable and easterly room has blue whitewash at ground floor level, a clear band of plain uncoloured whitewash indicates the position of the ground floor ceiling / floor of the upper storey and the first floor level is differentiated by red whitewash (Photo 6). At the western end of the building the whitewash is aquamarine at ground floor level, with only patchy evidence for uncoloured whitewash above this level (Photo 5).

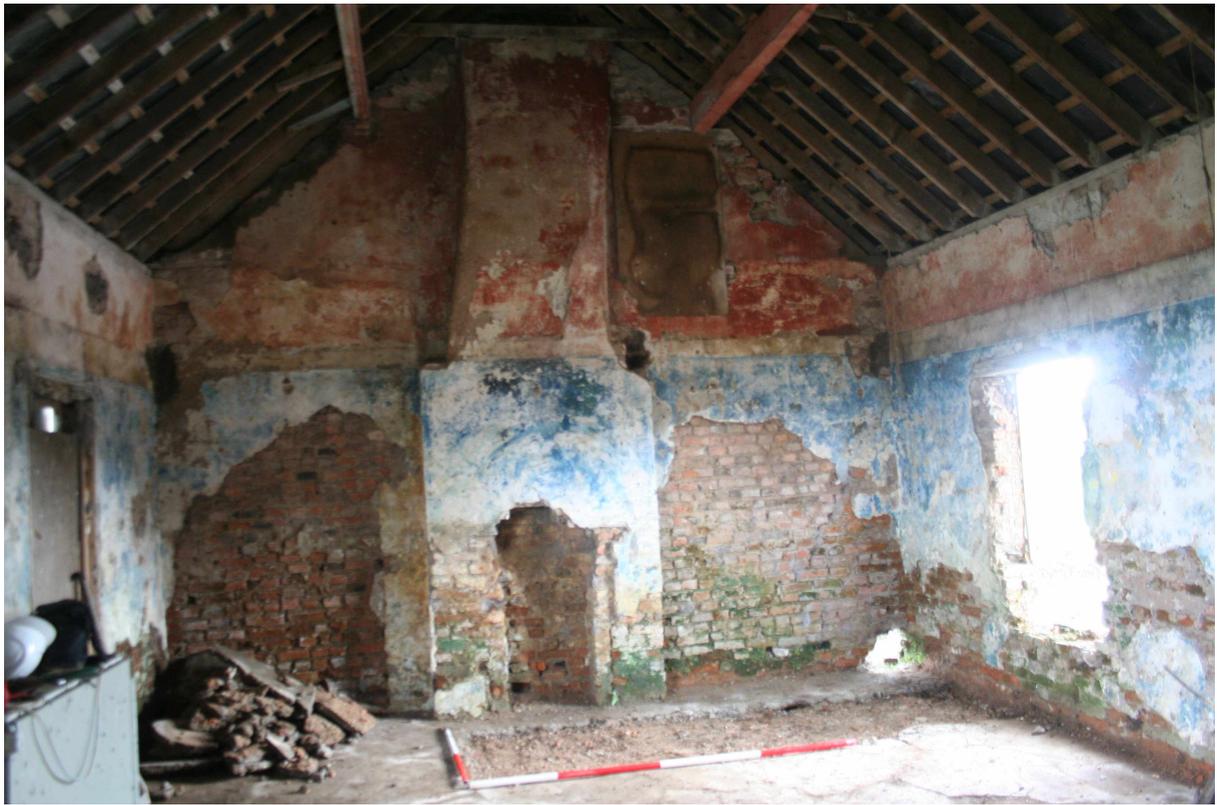
Photo 6: East gable and Trench 3 immediately after removal of concrete floor.

The eastern end of the building has a fireplace constructed from red brick against the interior gable. This fireplace measures 1.4m wide from the outside of one jamb to the other, the jambs being 45cm wide with a gap for the hearth of 54cm between them (Photo 6). The flu leans slightly to the right.

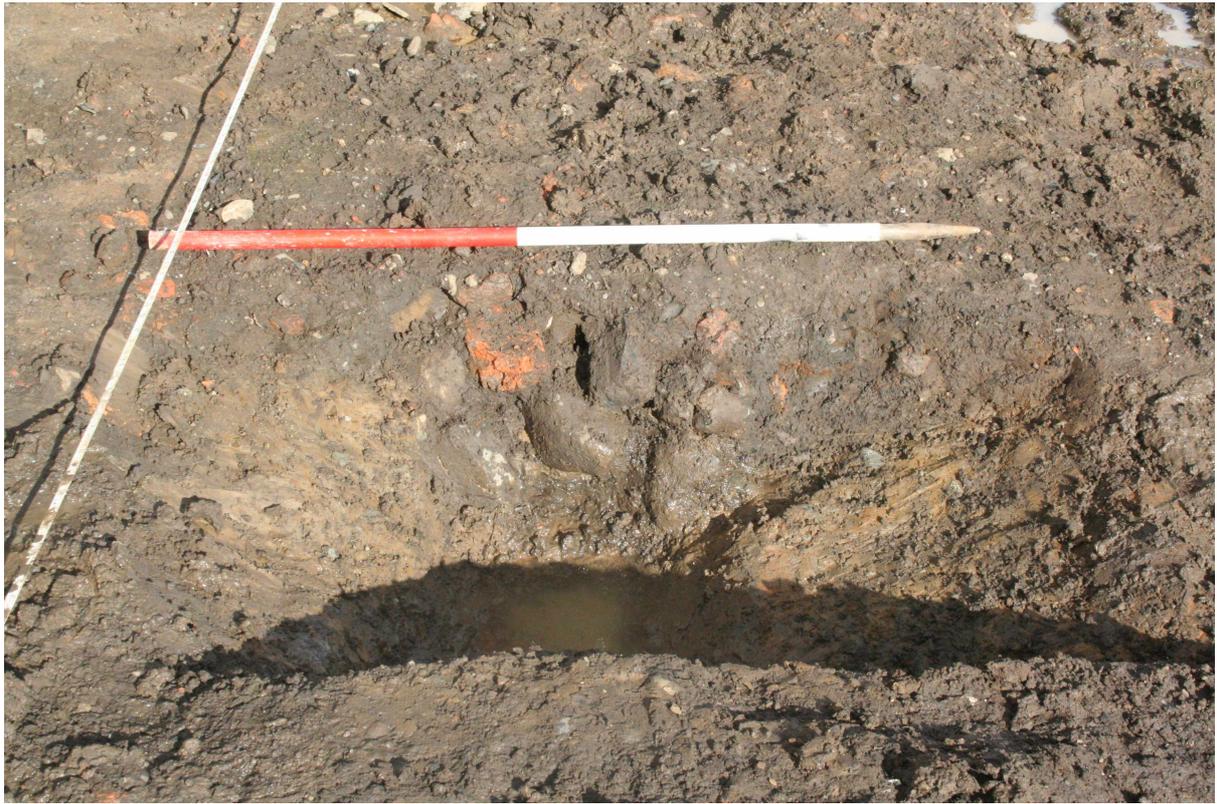
Photo 7: Drain 1003

A large drain (1003) was found running approximately east-west across the site (Photo 7). It was approximately 1m wide and 0.5m deep. It was filled by a stone and brick fragment layer (1004) which was capped by a dark grey loam/clay (1005). This cut ran close to and almost, but not quite, parallel to the north side of the house. It was perilously close to the southeast corner of the house, practically undermining it. The lower fill of this feature contained exclusively 19<sup>th</sup> century pottery, brick and glass.

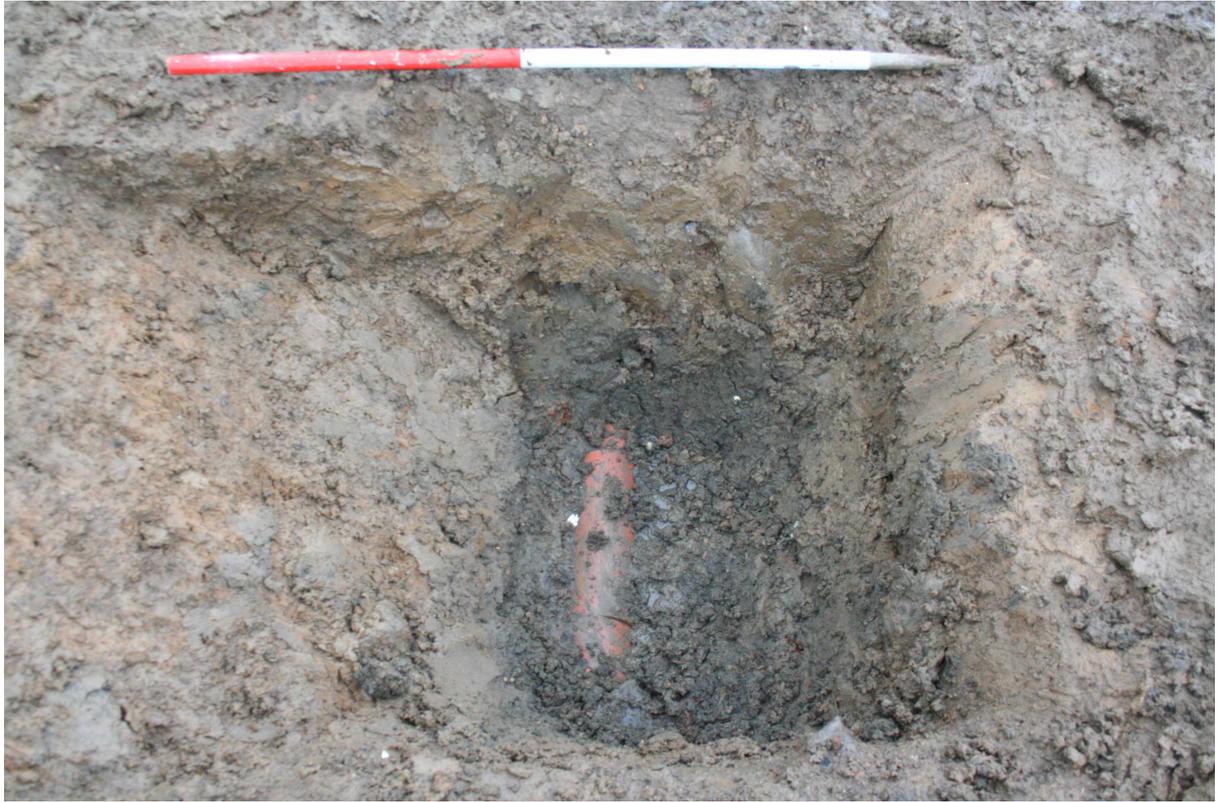
Photo 8: Gully 1008

A large gully (1012) (Photo 8) was detected running east-west some 8m south of the large drain (1003). It was initially believed to be a similar feature but when excavated was found to contain beneath an upper dark loam fill (1013) a ceramic sewer pipe of 20<sup>th</sup> century manufacture.

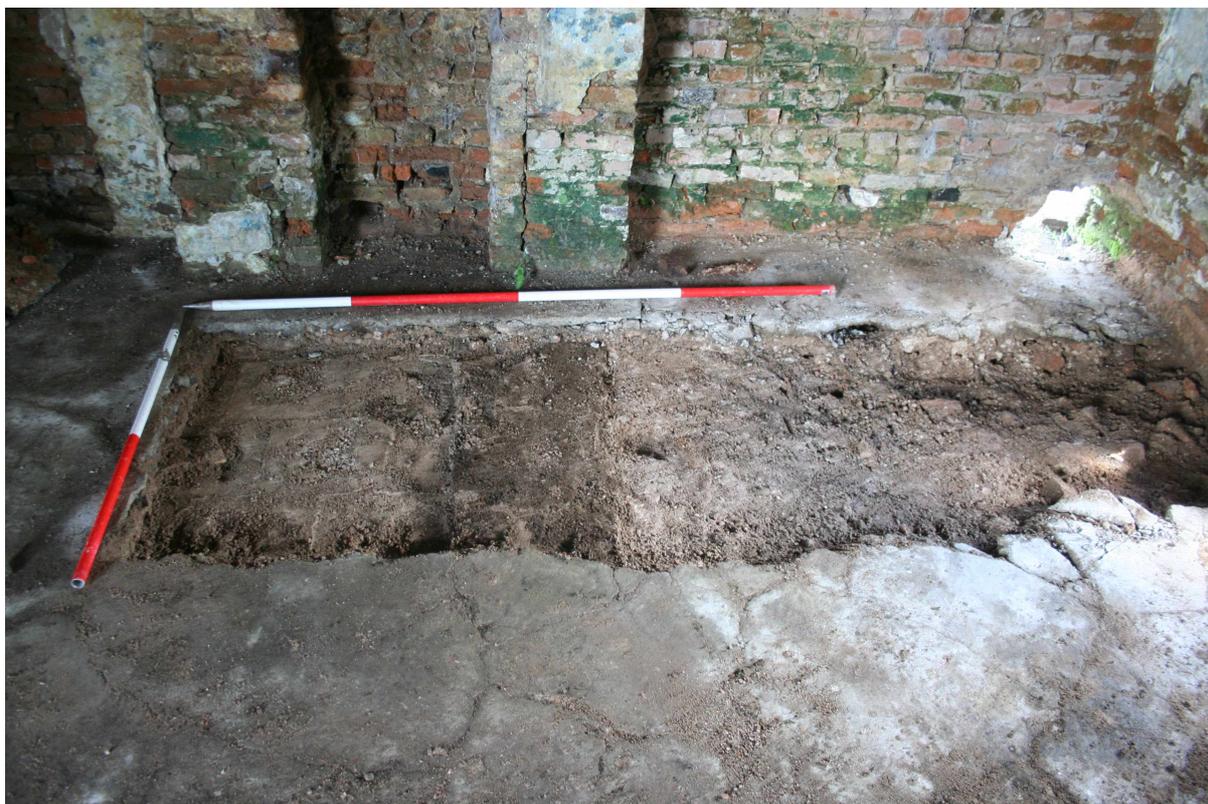
Photo 11: Photo of Trench 3 after removal of the concrete floor showing to the left (north) the mortar tile bedding layer (303), the internal partition base (304) and the mixed fills (305) and (306) above the rotted wooden floor

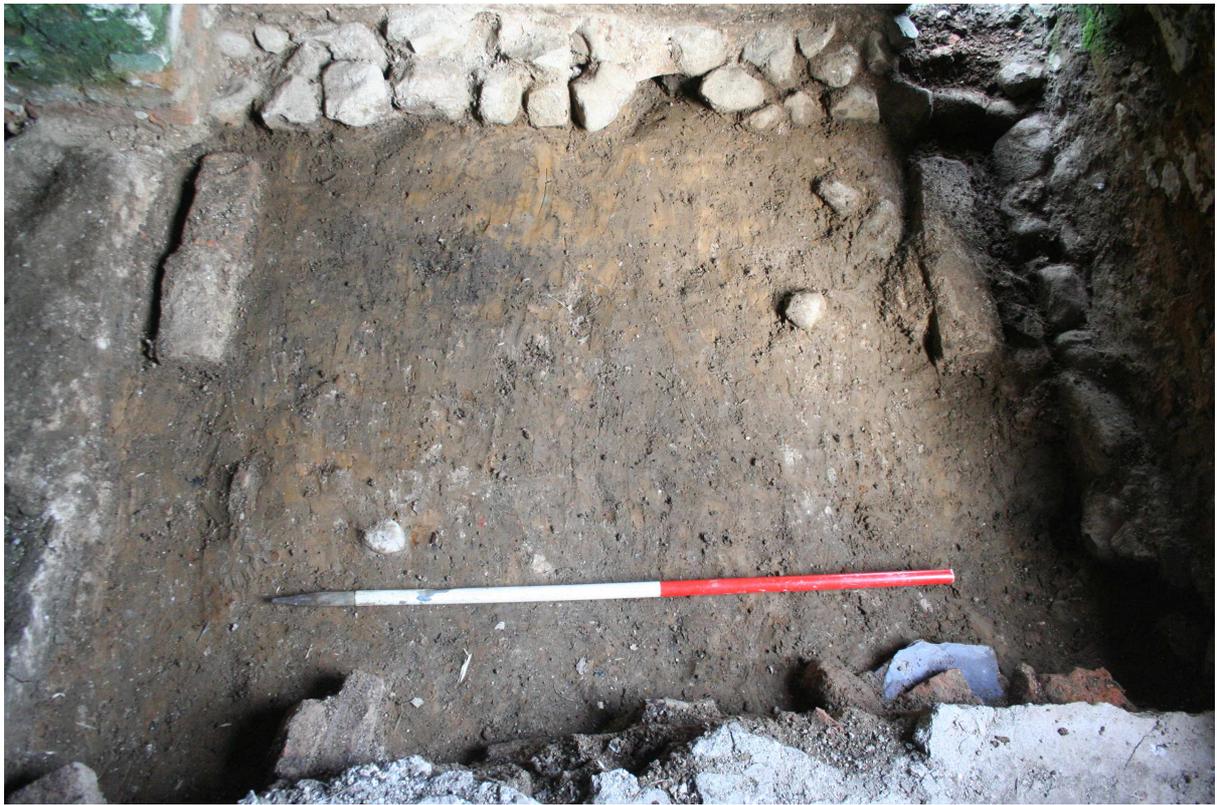
Photo 12: South side of Trench floor showing subsoil (312) and brick floor joist supports (317)

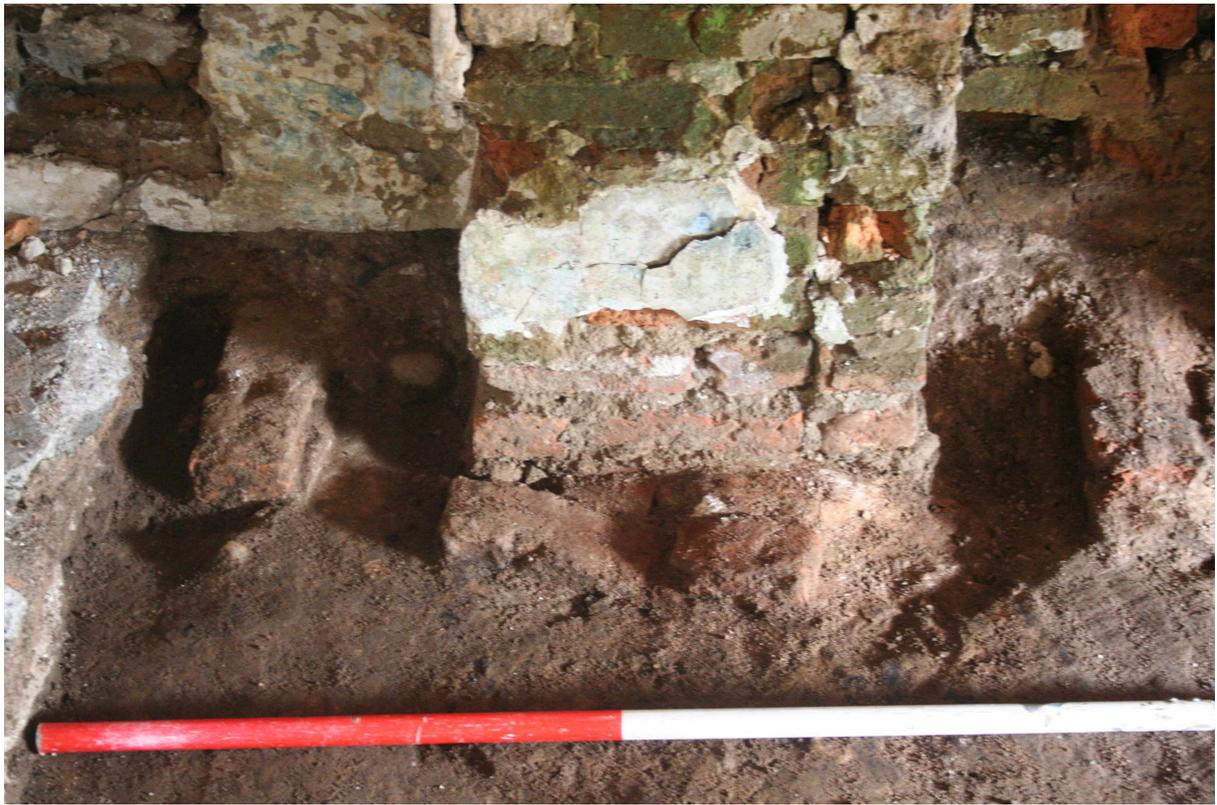
Photo 13: Brick fireplace jambs (315) and ash rich patch (316) which was sitting on mortar (303)

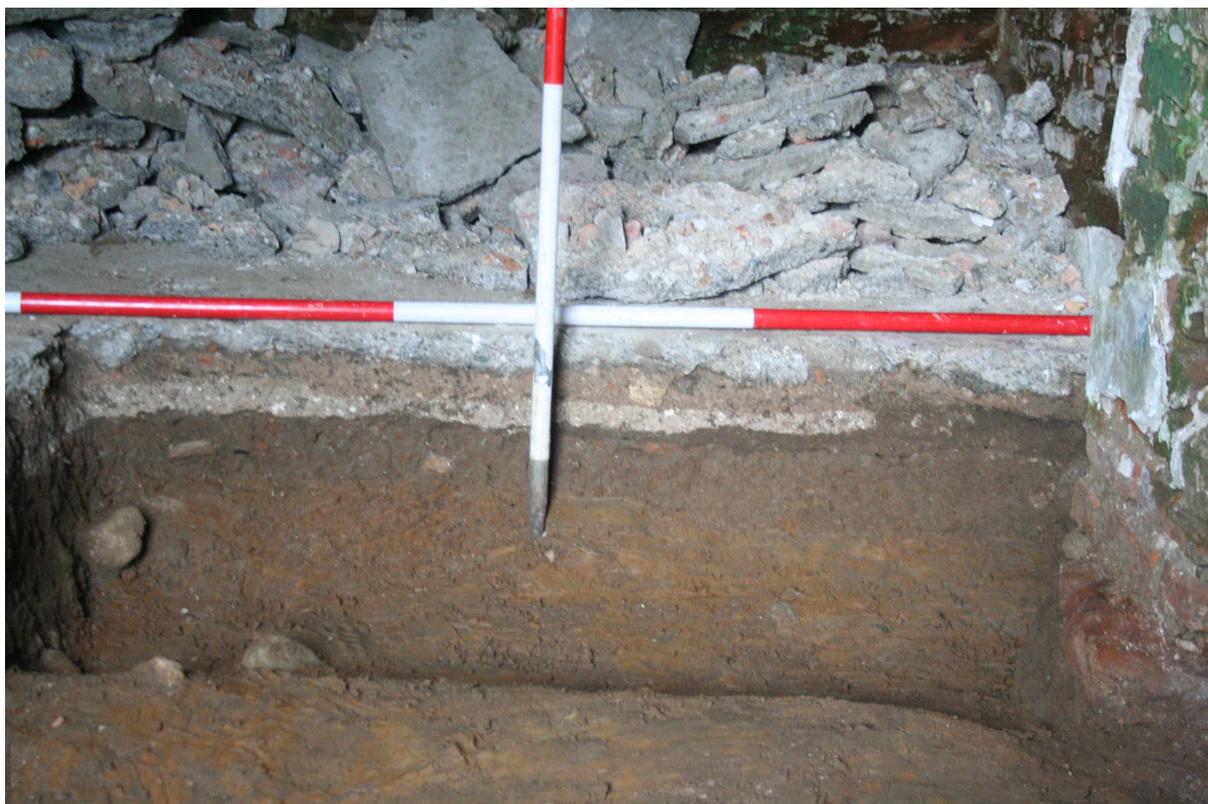
Photo 15: View of the subsoil cutting depression (320) which was filled with the floor clay (318/319).

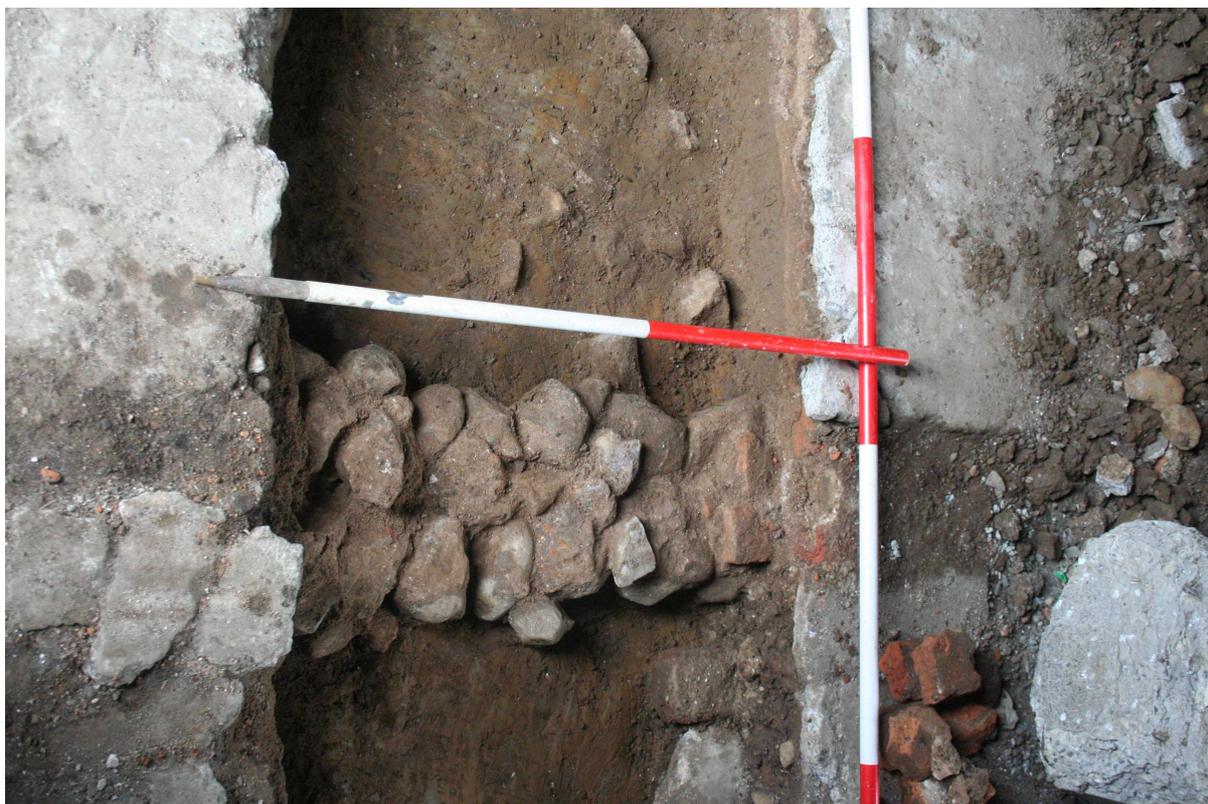
Photo 17: Photo of internal wall (404) showing cobble footing (brick upper courses removed)
