**Excavations at Drumreagh, Bendooragh, Co. Antrim**

**CAF Data Structure Report No. 102**

**Data Structure Report: Drumreagh, Bendooragh, Co. Antrim**

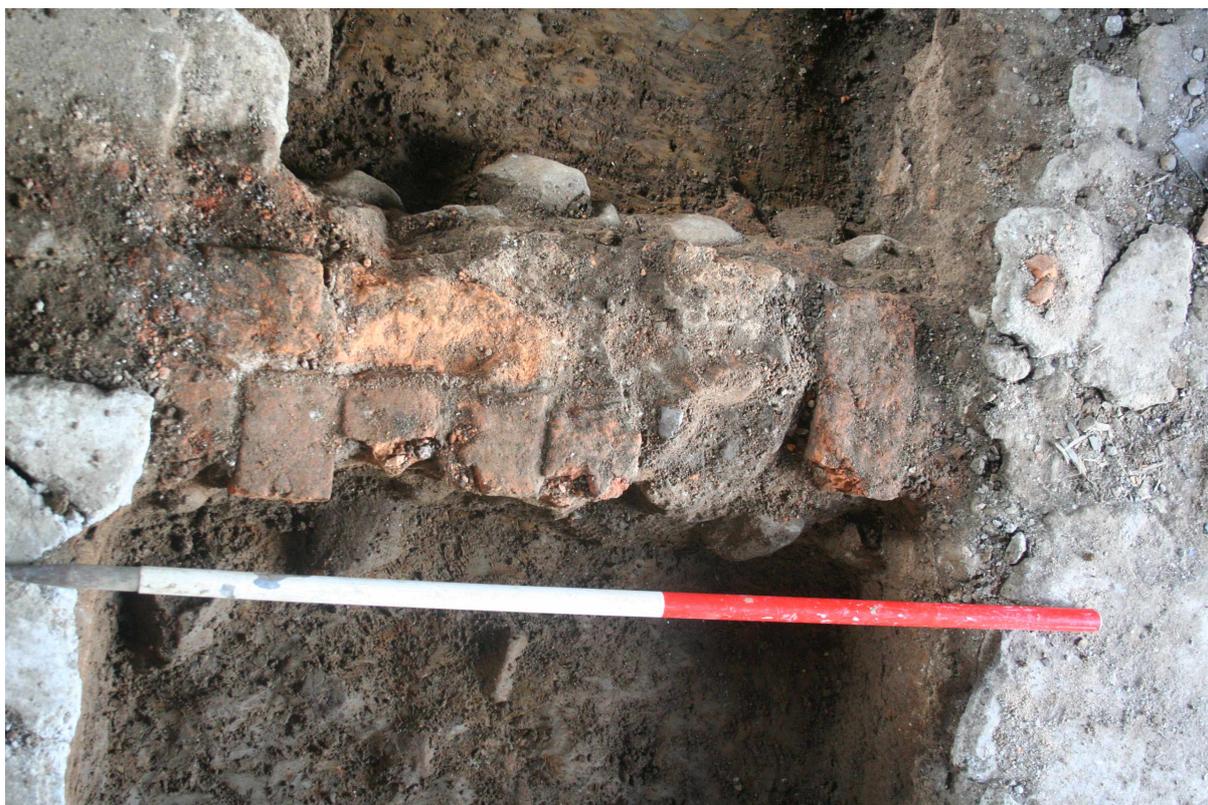
Photo 18: Photo of internal wall 404, brick courses still intact

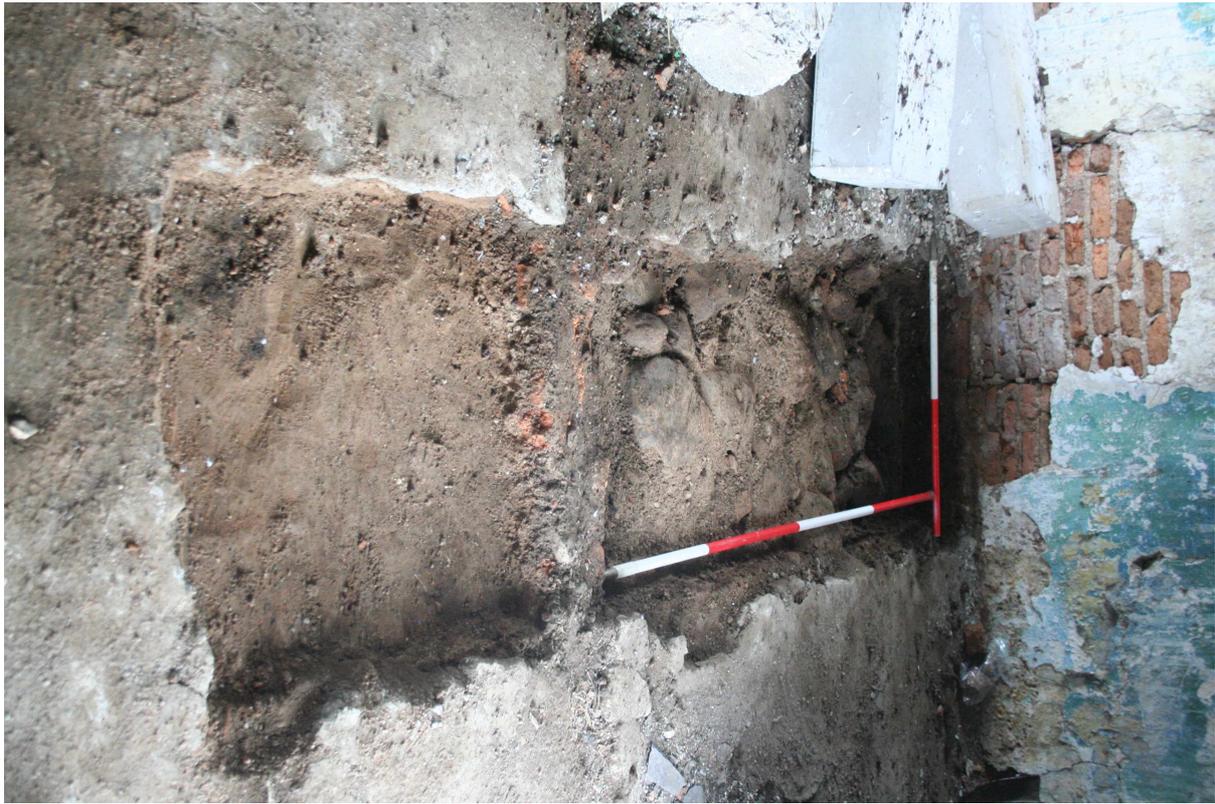
Photo 19: Photo of clay floor (407) to the left (east) of the picture, internal wall (404) in the centre and rubble fill (409/410), above the earlier wooden floor to the right (west).

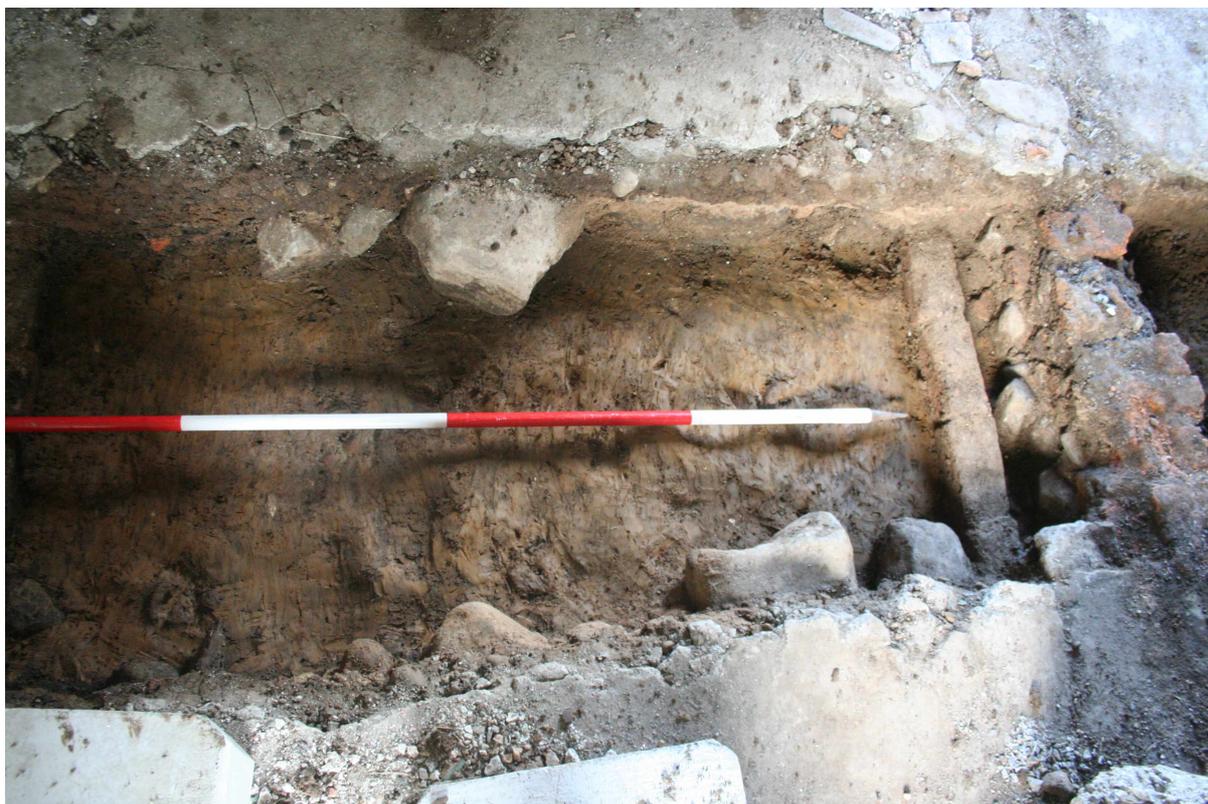
Photo 20: Photo of joist supports (413) for the wooden floor, in the west of Trench 4.

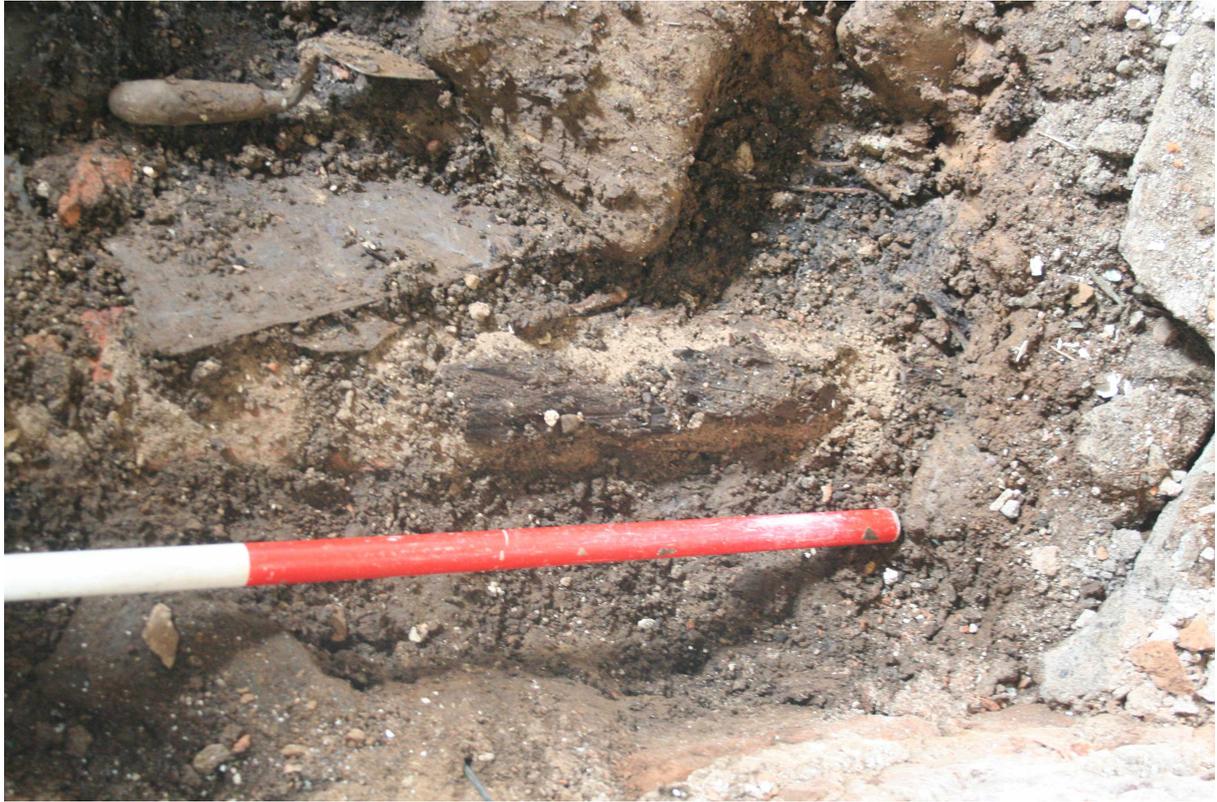
Photo 21: Remnants of wooden floor adhering to mortar on a brick joist support (413) in the extreme west of Trench 4.

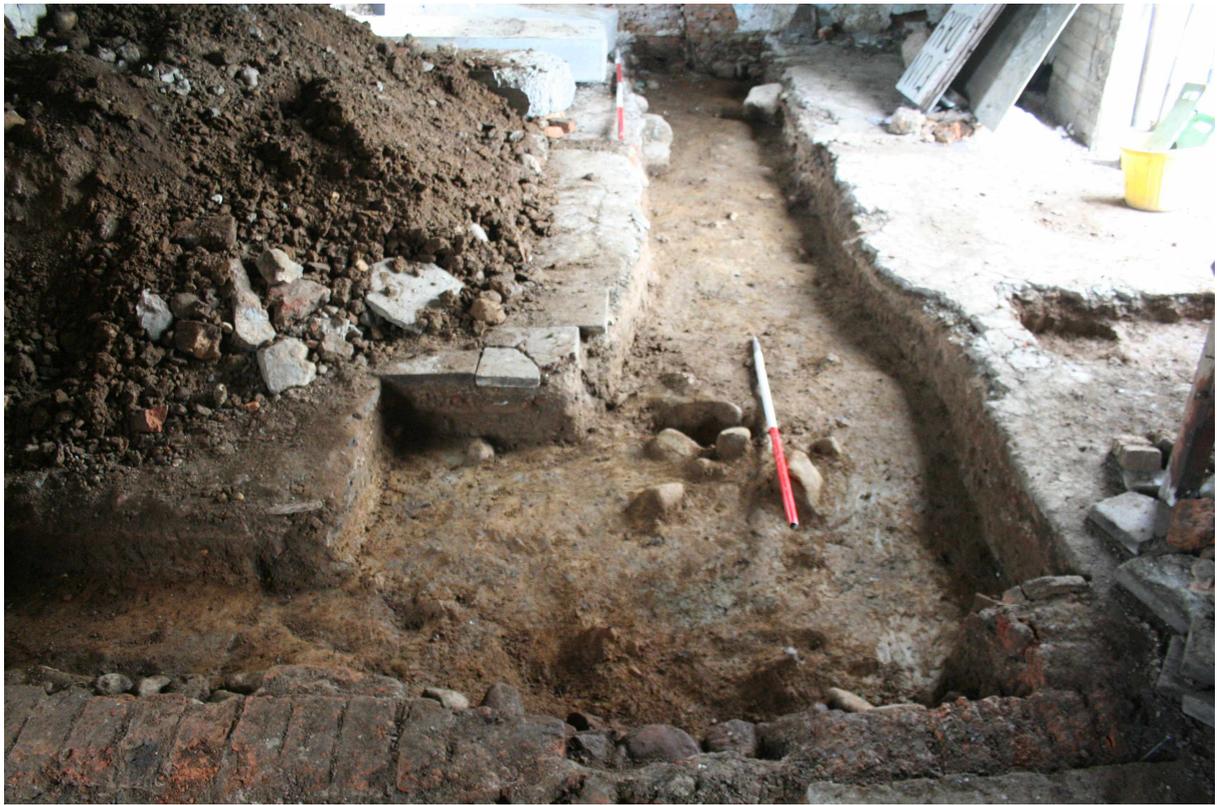
Photo 22: Trench 4 after excavation showing subsoil, pre-floor, surface.

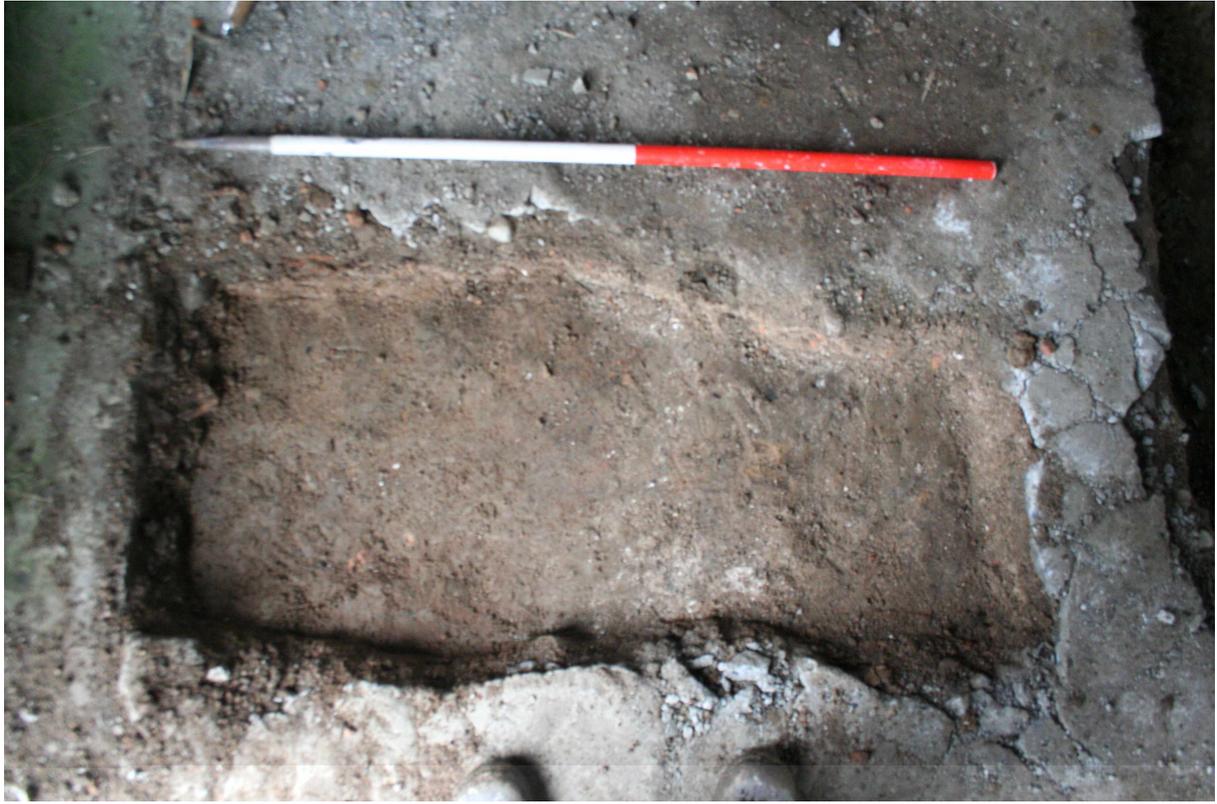
Photo 25: Trench 4b showing floor clay (407)
