Evaluation/Monitoring Report No. 129

Drummenagh Beg Churchill Derrygonnelly County Fermanagh

LICENCE NO. : AE/07/136

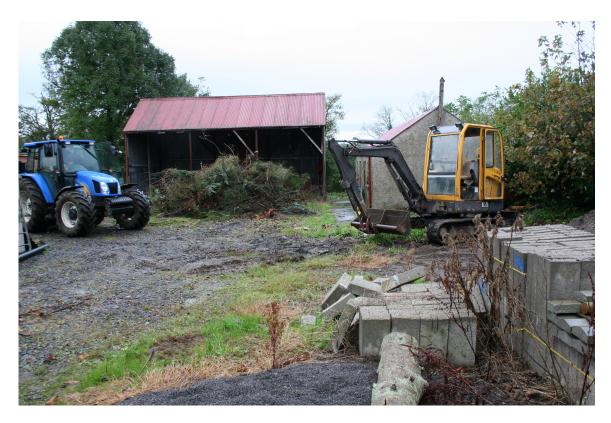
An archaeological evaluation was conducted in the townland of Churchill, Co. Fermanagh. The proposed development site is located at the northern end of the modern linear settlement, and consists of a roughly L shaped site, of maximum dimensions 30m by 20m. The majority of the site was covered with a rough concrete and packed gravel farmyard surface. Consequently, the evaluative test trenches were confined to those areas where the hard packed gravel could be removed.

Plate 1 General shot of development site showing the hard packed gravel surface.

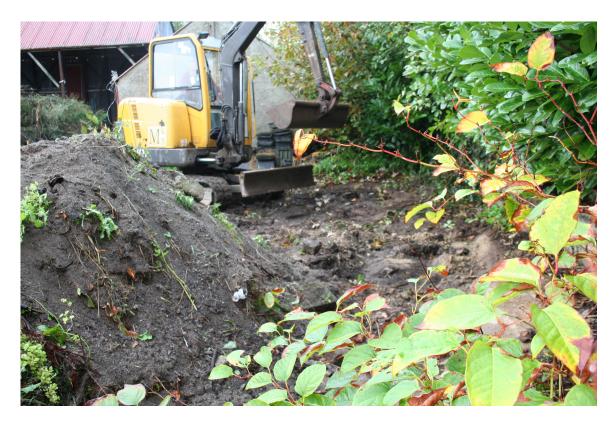
Trench A was excavated running 5m SWW – NEE between two extant outbuildings. The topsoil (Context No. 101) was a dark brown/black loam extending approximately 5cm in depth. This layer showed significant organic content, but this was considered not be the result of agricultural improvement but rather the incomplete decomposition of material as a result of the underlying layer. Context No. 102 was a layer of mixed demolition rubble, considered to be of modern date, approximately 15 cm in depth, which extended for the length of the trench.

Plate 2 Location of Trench 1, looking SW.

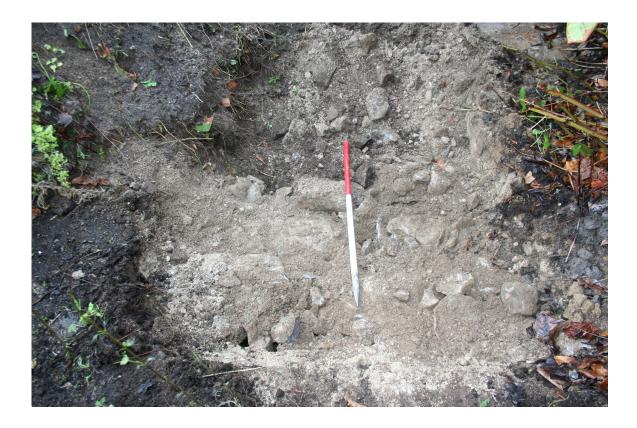
The rubble layer (Context No. 102) directly overlay the glacial boulder clay (Context 103). No finds were recorded from this trench, and no features of potential archaeological interest were recorded.

The rubble layer (Context 102) encountered in Trench 1 is considered to be modern dump deposit to level the northern end of the development site, and therefore not of archaeological significance. The majority of the site would seem to have been mechanically stripped to the base of the cultivation soil prior to the construction of the extant outbuildings.

Plate 3 Context No. 202, the rubble layer, which extended the length of Trench 1

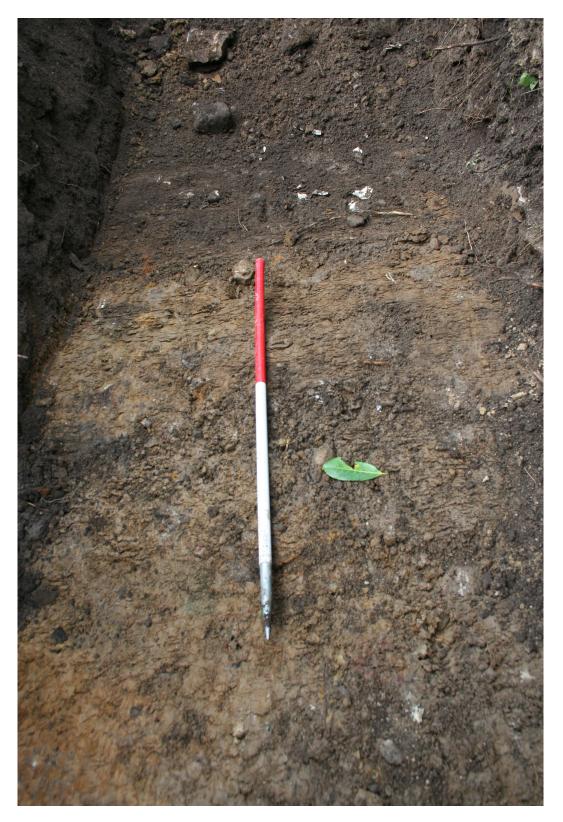
Plate 4 Post excavation shot of Trench 1, showing the light brown boulder clay (Context No. 103)

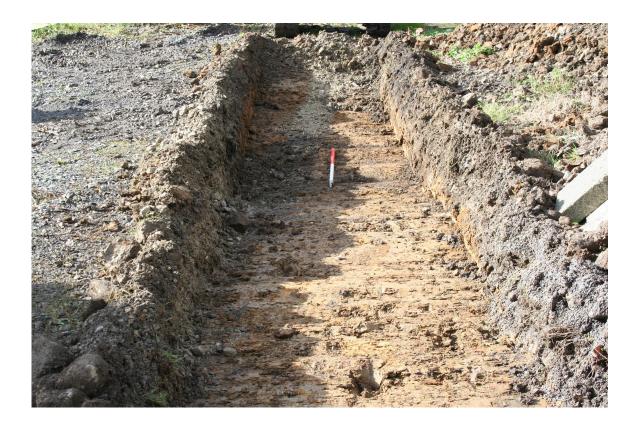
Trench B was excavated running 10m SWW – NEE. The topsoil (Context No. 201) was a dark brown/black loam, approximately 5 cm in depth. As with the topsoil layer in Trench 1, this layer contained significant organic content, and Context 101 and 201 are considered analogous. The topsoil layer (Context No. 201) directly overlay the glacial subsoil (Context No. 202), a light brown boulder clay with some stony inclusions. No finds were recorded from this trench, and no features of potential archaeological interest were recorded.

Plate 5 Post excavation shot of Trench 2, looking SW, showing the light brown boulder clay (Context No. 202)

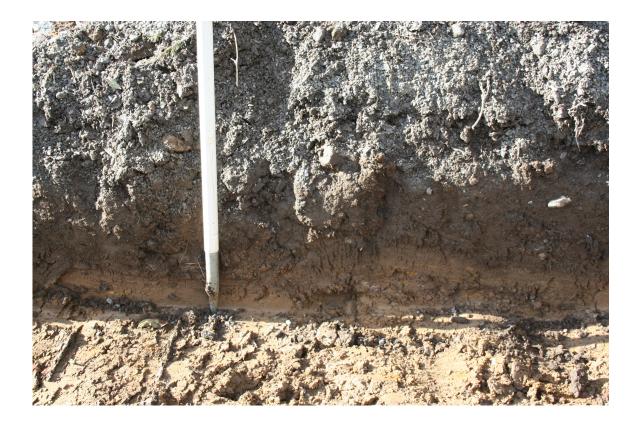
Trench C was excavated running 5 m SE – NW. The topsoil (Context No. 301) was a dark brown sandy loam approximately 10 cm in depth. The layer is considered to be mostly composed of a dump of builders sand and some material analogous to Context 101 and 201. The topsoil layer (Context No. 301) directly overlay the glacial subsoil (Context No. 302), a light brown boulder clay with some stony inclusions.

Plate 6 Post excavation shot of Trench 3 showing the dark brown/black (Context No. 301) sandy loam, lying directly on the light brown boulder clay (Context No. 302)
