ULSTER
ARCHÆOLOGICAL
SOCIETY

Survey Report

Reference: **Survey Report No. 49**

Divis Lodge, Divis Townland, Co. Antrim

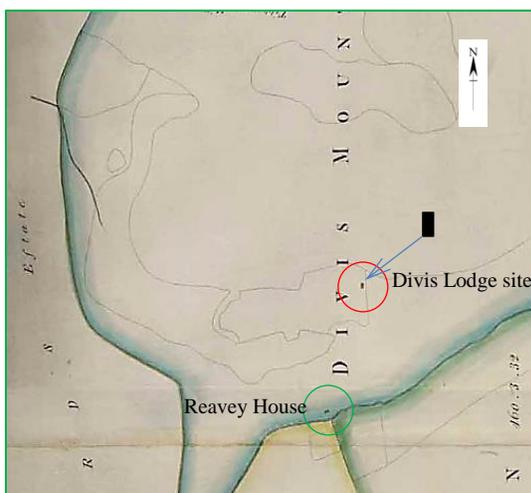
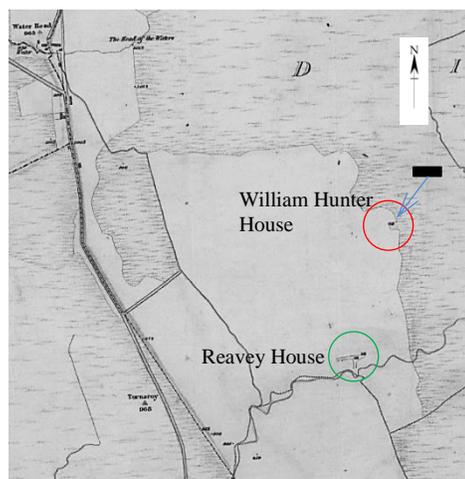
Fig 3 Extracts from James Crowe map 1767-70, (PRONI 1) and, First Ordnance Survey 1832, OS-6-1-60-1.

The 1767-70 map by James Crow shows only two buildings in the general Divis area one of which is most likely that of Divis Lodge (J727218, 874323). The other is located close to where *The Big River* crosses from Divis to Hannahstown townland at Irish Grid reference J27167, 73988 and very likely the building labelled "1b" as shown in the Griffith Valuation Map of 1857 and held by George Reavey at that time (McDonald and Catney, p 4). The First Ordnance Survey Map of Ireland dated 1831-1832 again shows a building on the Divis Lodge site but whereas the earlier Crowe map shows the building to be aligned in a north-south direction the 1831-1832 map shows the building to lie in an east-west direction much as it is today. This is illustrated in figure 2

worth less than £5 were exempt for rating purpose and no details of house or offices were to be recorded. An *Office* for Valuation purposes was a building other than a dwelling house. As can be seen in the 1832 Ordnance Survey map (fig. 2b) Divis Barn had not been built at that time consequently, only the original house (section 1 in fig. 7) would have been assessed for rating purposes. In 1859 the Townland of Divis was again surveyed but this time as part of the Primary Valuation of Ireland otherwise known as the Griffith Valuation. The Second Ordnance Survey in 1857 shows that what became known as *Divis Barn* was added to the property thereby by a creating an *Office* which was counted together with the *House* for valuation purposes. In the Griffith Valuation the £5 lower limit on valuations was removed and all houses together with offices were assessed. However, only houses with a £3-10s-0p valuation rate were measured with the measurements recorded in a site register or Valuators Field Book (PRONI 4). In comparing the two valuations, whereas the land area measured was reduced marginally by 3 Rood the value applied to the land had increased by £22-1s-1p which would have been a sizeable sum in 1859.

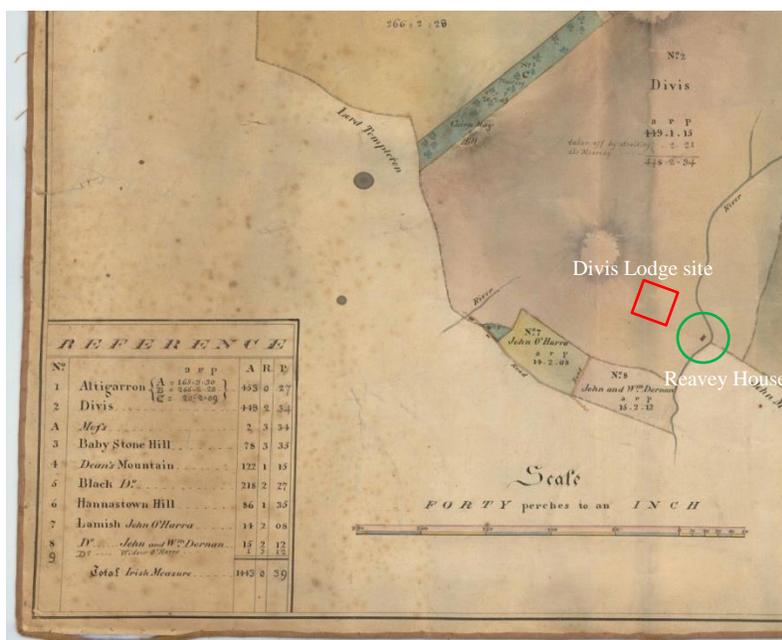
Fig 4 Extract from Thomas Pattison map 1820
Divis Lodge Site vacant – Reavey House circled (PRONI 2)

The Pattison map of 1820 shows the Reavey House close to the Big River as is shown in the Crowe and First OS maps, however, the Divis Lodge building is noticeably absent in the 1820 Pattison record of the area as illustrated in figure 3 above,

This would suggest that the building at the Divis Lodge site, recorded in 1767/70 had collapsed sometime before 1820 and was replaced after 1823 when Mr William Hunter had leased part of the townlands of Altigarron, and Divis from Lord Donegall - (ibid, p 11).

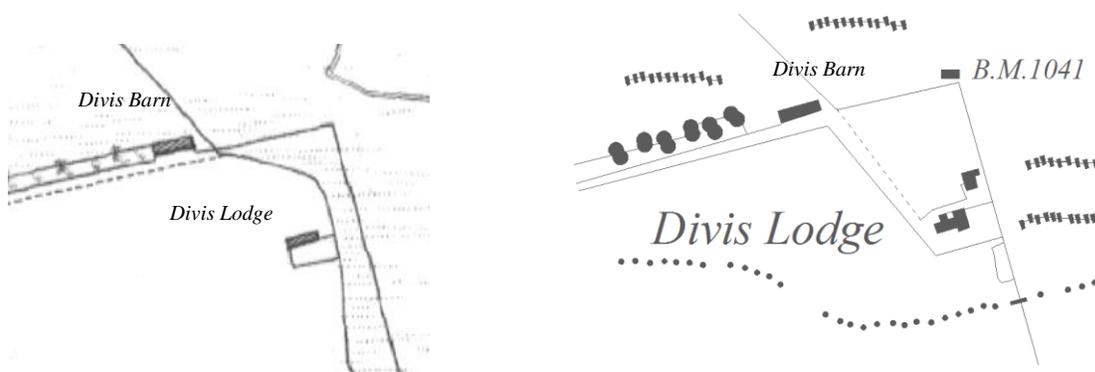
a) OS - 6 - 1 - 60 - 2 (1857) extract b) OS - 6- 1 - 60 - 3 (1901) extract
 Fig 5 Divis Lodge - structural change between 1857 and 1901

Between 1832 and 1857, the date of the Second OS survey, there was no noticeable change recorded in the outline of the Divis Lodge building. Divis Barn had been built sometime between 1832 and 1857. However between 1857 and 1901, as can be seen in figure 4 below, the Divis Lodge complex had developed from a simple rectangular building into what is visible today. It can also be seen that sometime during that period an outhouse had been built close to Divis Lodge. The complex represented in the Ordnance Survey Third edition map dated 1901 remained unchanged up until and including the Fifth edition map which was published in 1947. A current map for the Divis Lodge area indicates that a rectangular unit had been added to the Lodge complex sometime after 1947.

As shown in the Cartographic evidence the Divis Lodge complex had, sometime between the Second Ordnance Survey of 1857 and the Third Ordnance Survey of 1901, been developed from a simple rectangular building into the outline shown in the surveyed plan view, figure 8. Sections 2 and 3 were added to what was a simple rectangular long house after 1857. The canted bay in section 2 was built entirely in brick with a slate roof.

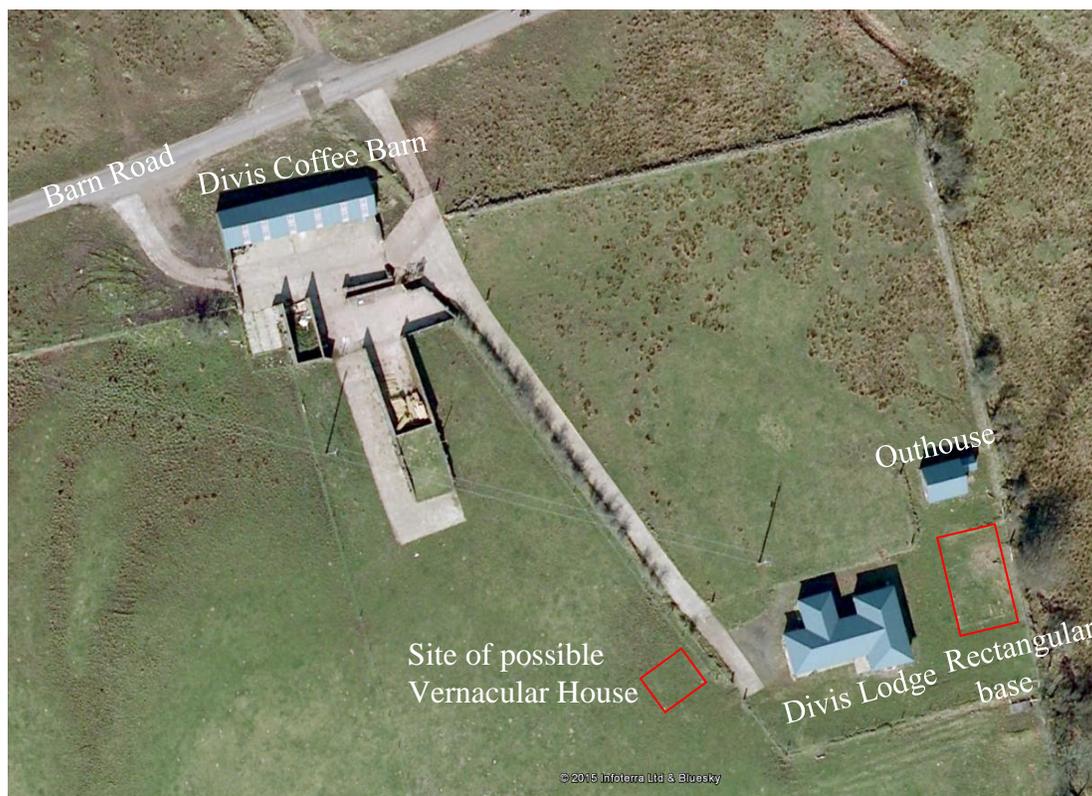
Fig 7 Divis Lodge complex - Google Earth™ view

- Structure 1 - Divis Lodge
- Structure 2 - an Outhouse
- a rectangular Base

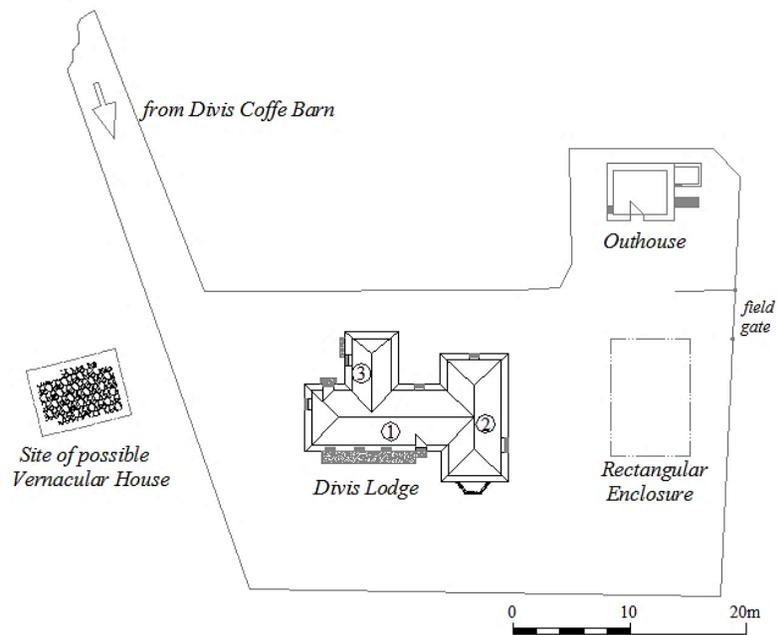
Fig 8 Site plan of Divis lodge complex

The Lodge is a single story building with an outline as shown in figure 8. The present roof is in modern metal sheeting and fully hipped. The building can be considered to have been constructed in three sections as shown in the plan view (fig. 8). No chimneys are apparent today although as earlier photographs (P1 2 and P1 4) show the building had two chimneys, namely, one in section 1 and the other in section 2. As P1 4 illustrates these chimneys were constructed in distinct yellow brickwork.

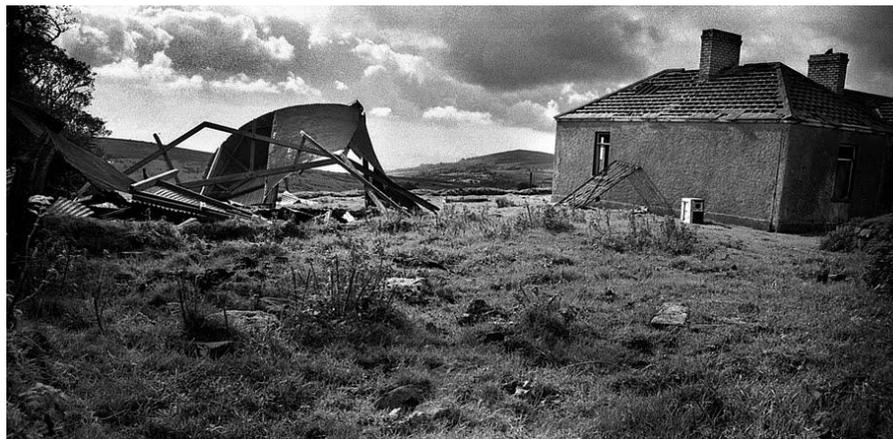
Pl 2 Divis Lodge viewed from north-east, possibly taken in c1968.
(NT photographic collection)

Photographs Pl 2 and Pl 3 show that the walls were harled, but in places the coating has weathered to show basalt rubble masonry in lime mortar with red brick trim on corners and apertures. Plate Pl 4 shows the canted bay window at a stage of demolition. On the day of the survey this feature had been completely demolished and the canted bay opening closed off with concrete blocks. A course of red brick set in mortar at ground level provides a physical reminder of the outline of this canted bay window.

Photograph Pl 2 on page 10 shows a shed in keeping with the observations made during this survey.

The rectangular base would most likely have carried the shed shown in photograph Pl 2 on page 10. This unit was not placed on the Ordnance Survey Maps until after the publication of 5th Edition of the 6 inch county series in 1947. The existence of the shed is shown on current Ordnance Survey maps of the area. It would therefore seem that this building was erected sometime after 1947 with both the Shed and Divis Lodge falling into disrepair sometime before photograph Pl 2 was taken possibly in 1968.

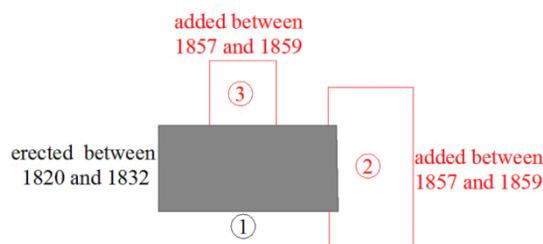
Fig 11 Divis Lodge – construction dates

the size of the House in 1859 was the same as that taken for valuation purposes up to 1929. Taking the Valuation records together with the Ordnance Survey Maps it can be said that the modifications made to the original William Hunter House, which changed it from a simple rectangle to the present outline form, was carried out by James Hunter sometime between the Second Ordnance Survey of 1857 and the Primary Valuation carried out in 1859. The Third and subsequent Ordnance Maps from 1901 show Divis Lodge in outline as it is at present. The 1901 OS map was the first to register the change in outline and the first to label the house *Divis Lodge* with the O.S.6 inch Map Revisions after 1901 having retained the name “*Divis Lodge*”.

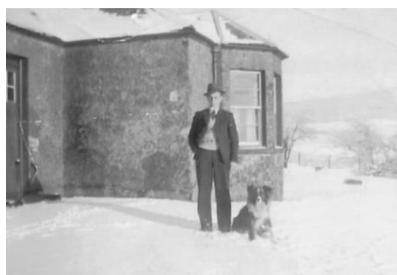
Pl 5 Divis Lodge showing glazed front door and canted bay window

The 1901 Census of Ireland recorded that the Divis Lodge house was a “*private dwelling*” occupied by a Mr Robert Darling, a single man of 30 years of age, who was described as being a “*Gamekeeper*”. The house was described under the heading of “*HOUSES*” as having Walls graded category 1 meaning the walls were built using Stone, Brick or Concrete. The Roof was in category 1, meaning that it was constructed using Slate, Iron or Tiles. The number of Rooms was in category 4 meaning that the house had 7, 8 or 9 rooms. The house had 4 windows in the front. Under the heading of “*FAMILIES*” the number of occupied rooms was 8. The landlord on the 31st March 1901 was “*Lord Templeton*”. It is worth noting that a second occupied house existed in the Divis townland at that time. It was a 2 roomed thatched house occupied by a Mr Robert J Milliken (27) his wife Jane (26) their son Andrew (4) and daughter Margaret (2). Mr Milliken was described as being a Herdsman. In the 1911 Census Divis Lodge house was the only occupied house in the Townland of Divis. It was occupied by a Mr John Smith (26) his wife Margaret (22) and daughters Sarah Jane (2) and Margaret (7 months). John Smith was described as being a “*Shepherd*”. The house was again declared to be a private dwelling with the walls and roof the same as in 1901. However, by 1911 the number of occupied rooms was reduced from 8 to 5. Again, by 1911 the number of windows in the front of the house had increased by 1, i.e., from 4 to 5. The increase in the number of windows can be accounted for if the front door had been changed from a plain solid door to one with a glazed top section with the glazed top section subsequently counted as a window.

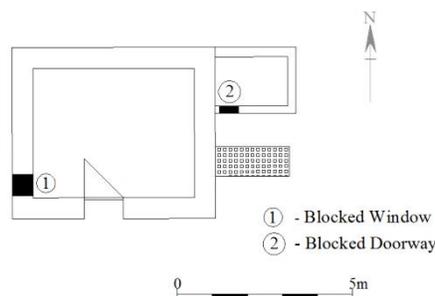
Fig 12 Plan view of outhouse

The main part of this building is a rectangle about 5.5 metres east to west by about 4.5 metres north to south (not taped). A small extension projects east of this and is roofed at a lower level. Both parts share the long north wall.

The bond of the walls makes clear that both parts were built at the one time. The walls are basalt rubble and lime. At the corners and openings are the same brick quoins as on the Lodge. Repairs have been made in Portland cement. Both roofs are modern metal sheeting with ridges running east-west supported on gables. The main front has a central door facing south, but no windows. Above the door the masonry has been rebuilt. A steel beam carries three courses of bricks laid in stretcher, and above that rubble stone in cement. The west wall has a small window close the south corner. It has a sill of yellow sandstone and is of the same proportions as, though smaller in size than, those in the Lodge. The north wall had two square openings at a high level, but both are now blocked with brick and cement. There is no opening on the east gable wall, but a horizontal skim of cement, level with the eaves of the extension, suggests there was once a lean-to roof here. Access was granted to the main block. It contains no partition walls and has not been plastered. There is no internal communication between the main building and the extension. No fireplace was seen. The wall is 0.50 metres (taped) thick at the door. Each of the gable walls has a small square niche positioned south of the ridge line, as though to take opposite ends of a beam capable of carrying a half loft. Roofing timbers are fresh.

The extension has a door facing south next to the main block. There are no windows, but on the east wall, a little above ground level, is an arch of brick headers, below which the gap is cemented flush with the wall leaving a hole approximately 3" in diameter (not taped) penetrating to the interior. The north wall of the extension has suffered a recent collapse of facing stone from the upper courses. As the door was closed with concrete blocks and cement the interior was not inspected. The open area, bounded on two sides by the internal angle of the main building and its extension, has a concrete floor grooved in two directions. The revetment of boulders runs from the field boundary behind the extension and then turns, closing against the north wall of the main building. A small yard is thus formed behind the extension. The revetment recommences beyond the west wall. The red bricks measure 230 x 103 x 77 millimetres. The loss of mortar between bricks at the corner allows examination of the bottom and top which are neither frogged nor perforated. However three bricks have been set flat into the east gable apparently as a repair. One has three perforations and the others, twenty.

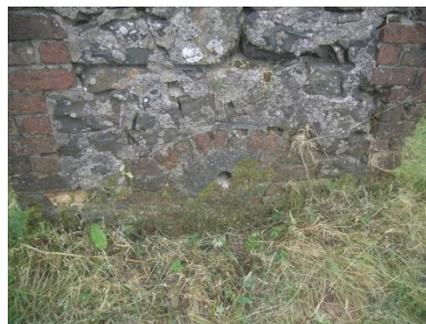
Pl 9 Blocked opening in east wall of outhouse projection

A brick arch in the east wall of the projection has been closed off with concrete with a smooth 80 mm diameter hole penetrating at least to the depth of the stone wall. The 1901 and 1911 Census returns state that there was a *Fowl House* on the Divis Lodge property. The projection unit may have been the fowl house. The brick arched opening may possibly have been to provide for a chicken run.

The Staff at Divis Lodge have speculated, that before it was blocked up this small unit may have more recently been converted to provide a toilet facility at the site. The 80mm bore in the opening blocking material looks like it has been made using a modern diamond core drill bit.

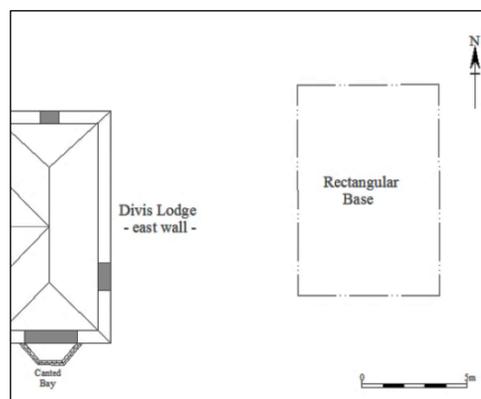
Fig 13 Relative size and position of rectangular base to Divis Lodge

The base is approximately 8 metres long north to south and 6 east to west. The remains do not exceed 0.1 metres in height and are masked by herbaceous growth.

At the corners are the truncated remains of I-section iron columns. Between these a course of concrete bears the rippling imprint of vertical corrugated sheeting on the west, south, and east sides. No evidence was found on the north side.

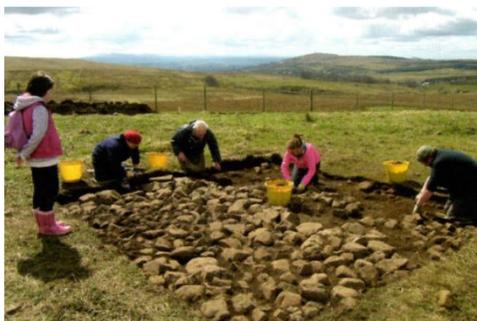
Pl 11 BHP/UAS excavation at the site of a possible Vernacular House, 2014.

A building with dimensions of 5m x 4m, almost square in plan, was not recorded at or near the Divis Lodge location on the 1767 to 1770 James Crowe map mentioned earlier, nor on any map of the area to date. This would suggest that this unit had collapsed or was replaced by the house shown in the Crowe map in figure 2a above. It may have existed from some time in the seventeenth century up until the latter part of the eighteenth century which may account for the finds made during the 2013 excavation. This particular site in the Divis Lodge complex has been comprehensively covered in the Ulster Archaeological Society Report No. 41 *“Survey of Vernacular House at Divis Barn, Divis, County Antrim”* by Harry Welsh, published in 2013

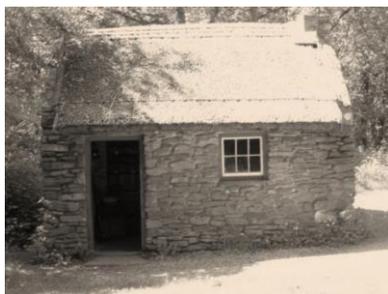
An example of a single room Irish Vernacular House can be seen at the Ulster Folk and Transport Museum, Cultra, County Down under the name *“Meenagarragh Cottier House”*. It is a one room house with an *“Outshot”* at the rear to accommodate a bed.

Fig 14 Meenagarragh Cottier's House Exhibit, (UFTM, Cultra)
